Borough of Garwood

2012 Walkable Community Workshop

Pedestrian Safety and Accessibility within Walking Distance to the Garwood Train Station

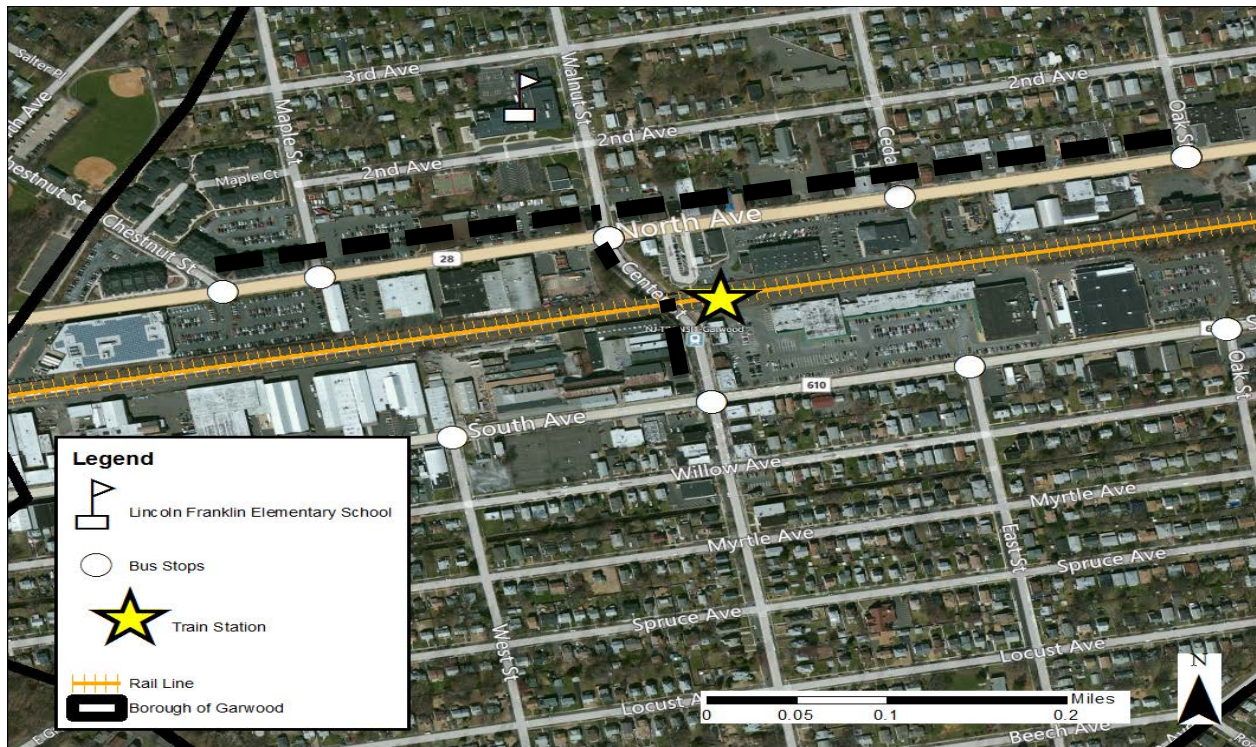
Figure 2: Aerial View of the Workshop Study Area

** Dotted lines denote the path of the Workshop walking audit*

All of the roadways examined during the audit provide sidewalks, while a majority of the intersections have Americans with Disabilities Act (ADA) compliant curb ramps, crosswalks and pedestrian count-down signal heads. In addition to rail service, North Avenue is also served by NJ TRANSIT Bus Routes 113 and 59, which provide access from Dunellen, through the City of Elizabeth, to midtown Manhattan (Bus Route 113) and the City of Newark (Bus Route 59). North Avenue is lined with a number of retail stores that include big-box retail chains and local shops, as well as an event center, a health club, mixed-use housing, and offices.

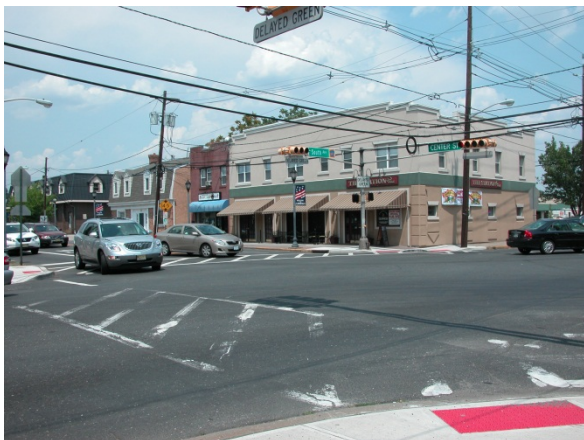
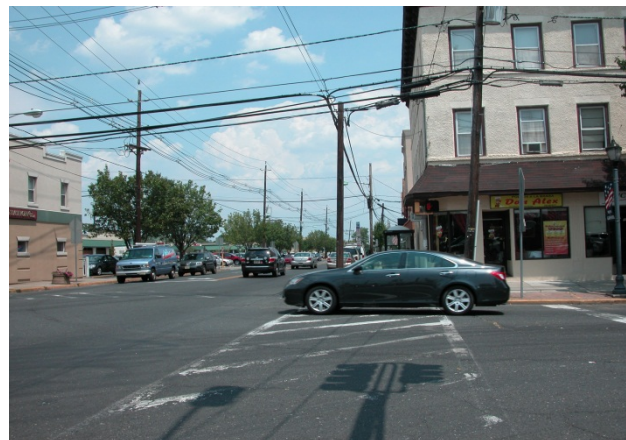
Intersection of Center Street and South Avenue (CR610)

This intersection is a block from the Garwood Train Station resulting in significant usage by pedestrians who access the east-bound platform via a staircase on Center Street. Ensuring that the pedestrian signal head buttons are working is essential. A workshop participant, who crossed at the intersection the day of the walking audit, noted that the button was not responding. Following the workshop, the Borough of Garwood fixed the button and it is now working properly. In addition to addressing the pedestrian signal button, the workshop participants also recommended the following:

- Repaint crosswalks with ladder striping to improve visibility for both pedestrians and motorists.

- Repaint the stop bars. A stop bar is a solid white line, 12 – 24 inches wide, extending across all approach lanes to a traffic signal. The stop bar indicates the point where vehicles are required to stop at a red light.
- Re-time signals for a Leading Pedestrian Interval (LPI) to reduce pedestrian conflicts with turning vehicles at the intersection. Pedestrians are given a three-to-five second “head start” over drivers, allowing them to establish themselves in the crosswalk, before the driver is given the green light to begin a left turning movement. LPIs have been proven a low cost strategy in reducing pedestrian injuries at intersections.
- Upgrade traffic signals for improved motorist visibility.

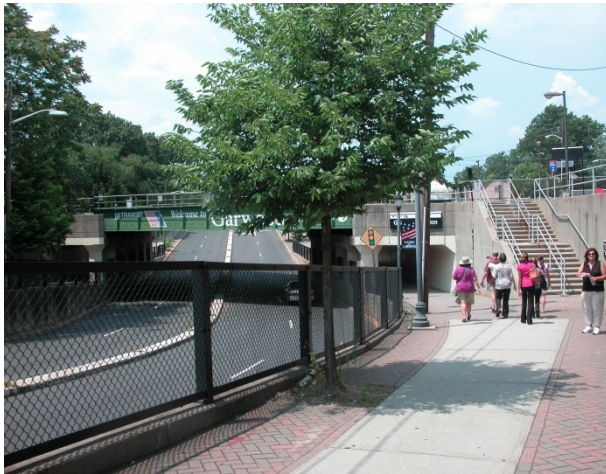
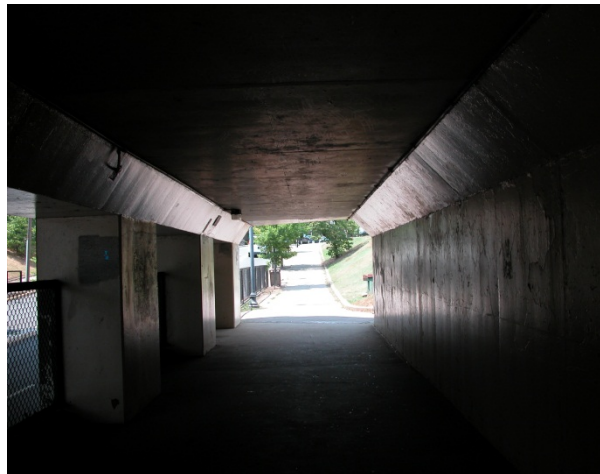
Elevated Center Street Sidewalk under the Raritan Valley NJ TRANSIT Rail Line

This underpass is the only pedestrian crossing opportunity between the northern and southern portion of the Borough. The Raritan Valley NJ TRANSIT rail line dissects the municipality between the northern and southern portion of the community. Workshop participants recommended the following:

- Provide additional lighting and/or brighten existing lighting in the pedestrian walkway under the NJ TRANSIT train tracks to improve visibility particularly at night. There are currently only two light fixtures along each side of the underpass and WCW participants observed they are dimly lit in the evening and night time hours. Additional and/or enhanced lighting at this location would be the responsibility of the roadway owner, the Borough of Garwood.
- Support a colorful mural on the underpass walls to make it a more inviting walking experience. WCW participants suggested reaching out to the high school art department.

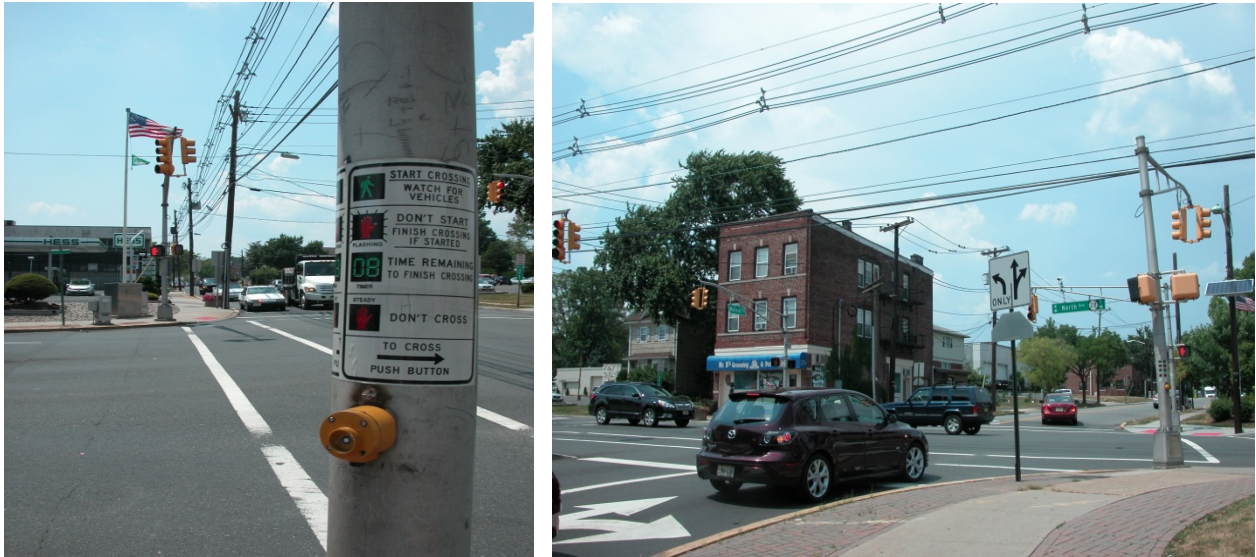
Intersection of Center Street and North Avenue (SR28)

WCW participants have observed aggressive driving at this intersection as motorists turning left from Center Street attempt to “beat” the red signal. The workshop participants recommended the following:

- Assess whether the signal timing can be extended to better accommodate left turning movements from Center Street to North Avenue.
- Assess whether a Leading Pedestrian Interval (LPI) to reduce pedestrian conflicts with turning vehicles is feasible. An LPI provides pedestrians a three-to-five second “head start” over drivers allowing them to establish themselves in the crosswalk before the driver is given the green light to begin a left turning movement.
- Restripe the crosswalks in a ladder style or textured pattern to make them more visible to drivers, and add a visual cue so left turning motorists are more alert for pedestrians in the crosswalk. Between 2006 and 2011, four pedestrians were injured at and near this intersection, which is one block from the Borough’s elementary school and train station.

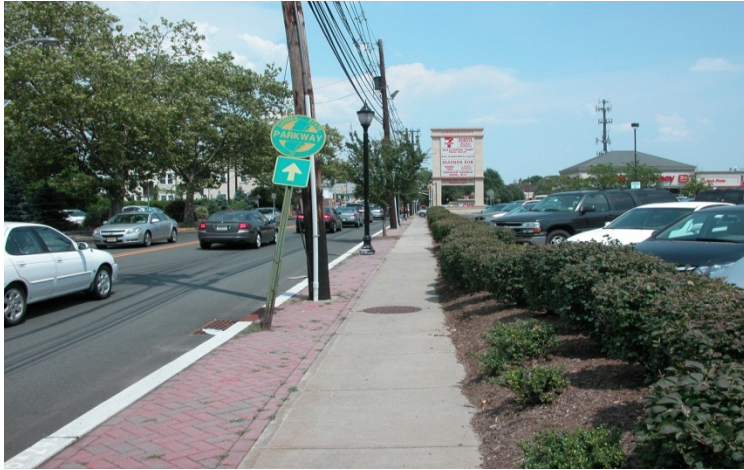
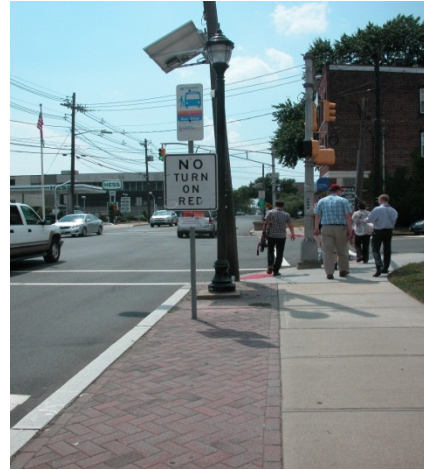
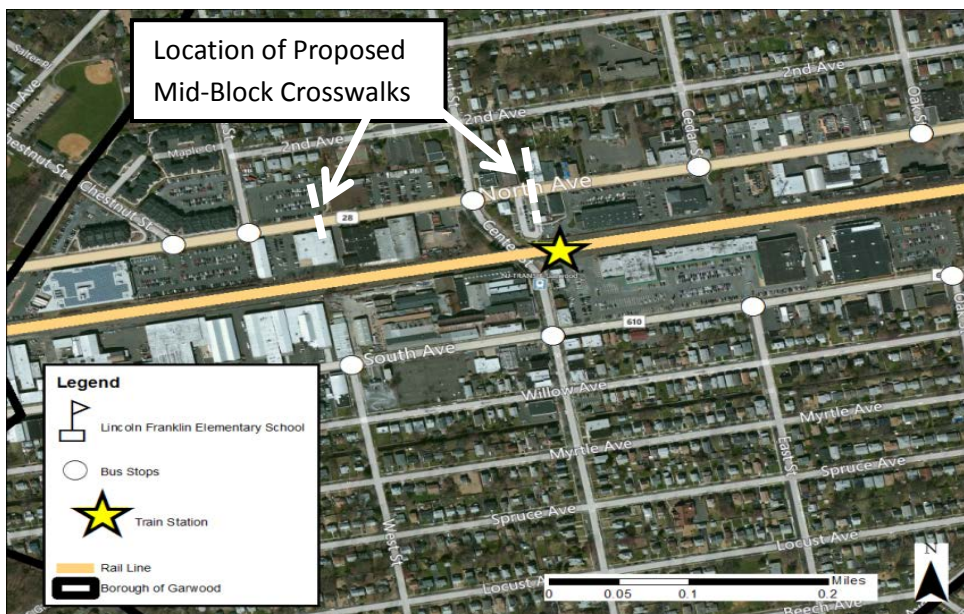
North Avenue (SR28)

North Avenue provides sidewalks, some equipped with ADA compliant curb ramps, and numerous driveway entrances to retail parking lots. WCW participants observed speeding along the roadway, which is posted at 35mph. It is important to note that the speed limit on North Avenue drops to 25 mph in neighboring Cranford and Westfield. WCW participants were in favor of traffic calming techniques to slow motorists' speeds, particularly in light of concerns about pedestrians who are crossing mid-block. Workshop participants recommended the following:

- Install a mid-block crosswalk, with signage, at locations where parking is provided on the opposite side of destinations such as the fitness center and retail shops. WCW participants noted that a pedestrian crossing sign is located in front of the fitness center suggesting that a mid-block crosswalk may have been there at one time. (The roadway was recently repaved, so the crosswalk appears not to have been repainted.) A possible contributing factor for speeding along North Avenue is the distance between signalized intersections. Mid-block crosswalks may help to reduce speeding as motorists are forced to slow down to allow pedestrians to cross.

- Consider access management planning along Route 28, pursuant to the State Highway Access Management Code, to encourage driveway consolidation and reduce potential pedestrian and motorist conflict.

- Adopt development patterns where buildings are located on-street with a sidewalk setback and parking in the rear. This allows for a more inviting experience for pedestrians (“wallets on foot” that support the economic development of the Borough’s businesses), and eliminates the need for them to walk through a large parking lot to shop. Plan4Safety crash data analysis shows that a number of the pedestrian injuries reported between 2006 and 2011 occurred in private parking lots along North and South Avenues. Thirteen (13) of the thirty-one (31) crashes involving a pedestrian injury within the Borough occurred in a parking lot.

- Encourage on-street parallel parking as a traffic calming technique and buffer between the sidewalk and vehicular traffic.
- Consider, as part of future planning efforts, installing wider sidewalks (minimum of 5-feet in width) to better accommodate pedestrians walking in opposite directions.

- Improve bus stop amenities for NJ TRANSIT riders, including installation of a bench at the east-bound bus stop near the corner of North Avenue and Center Street. (NJ TRANSIT participated in the workshop and has agreed to install the bench.) Additional information on bus stop amenities and maintenance can be found in the NJTPA’s Bus Stop Safety Toolbox:
<http://www.njtpa.org/plan/studies/documents/BusStopSafetyToolboxweb.pdf>

- Install ADA compliant curb ramps where missing to allow people with wheelchairs, strollers or luggage to easily travel from sidewalk to street level. Also install truncated domes to alert pedestrians with visual impairments that they are about to leave the curb.

- Install edge striping along North Avenue to delineate on-street parking from the traffic lane. Since North Avenue is a bus route, lane width from the center-line to the edge striping should be 12-feet to accommodate bus and vehicle traffic.

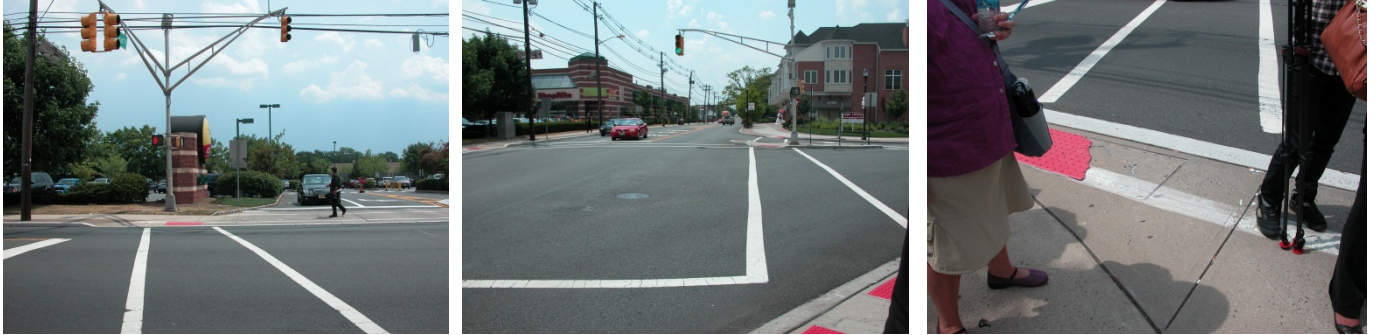
Intersection of Chestnut Street and North Avenue (SR28)

This intersection was recently upgraded by the NJDOT to include ADA compliant curb ramps, pedestrian signal heads and crosswalks. WCW participants voiced concern about crossing the north leg of this intersection because it's difficult to see right turning vehicle movements from North Avenue to Chestnut Street when drivers are turning to travel north.

- Extend the north-east corner curb to reduce vehicle turning speeds, shorten the pedestrian crossing distance and make pedestrians more visible to the driver.
- Install improved pedestrian signage on the pedestrian countdown signal head pole indicating which pedestrian signal leg the push button actuates. Only one push button is provided at each corner as opposed to two.
- Replace the truncated dome at the south-west corner of the intersection so that it is ADA compliant. The current truncated dome is in poor condition.
