APPENDIX C

Bus Stop Field Audit Reports

Pedestrian Safety at and Near Bus Stops Study

Bus Stop Field Audit

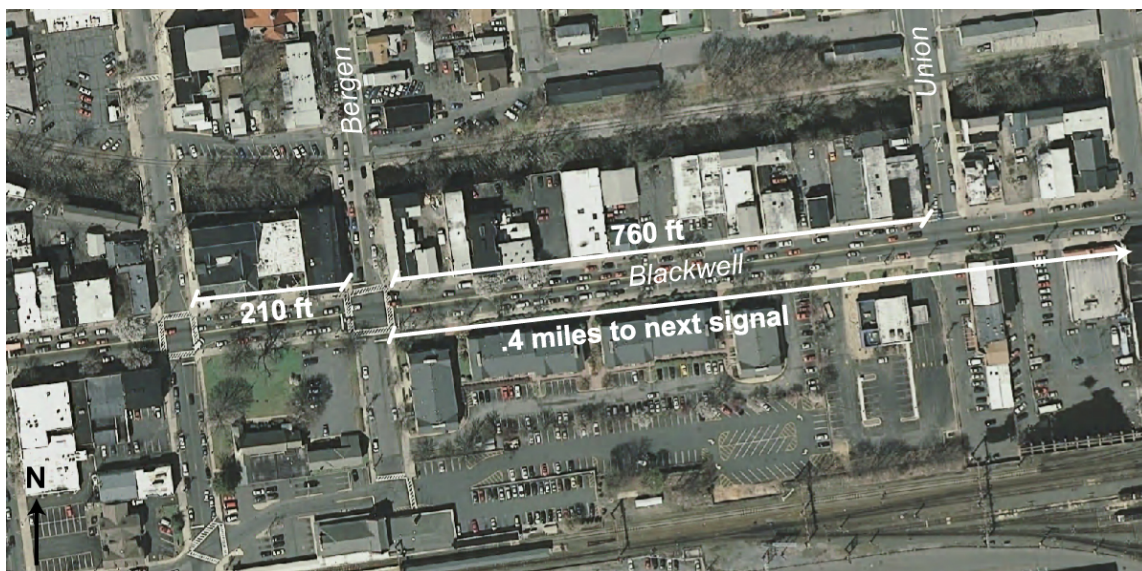
Figure 2: View of Blackwell and Bergen Street

Four of the crashes occurred when eastbound traffic on Blackwell Street turned left onto Bergen Street to travel north. These left-turn crashes are likely a result of the long distance between Bergen Street and the next intersection to the east at Union and Blackwell Streets. As shown below, west of Bergen Street the street grid takes on a typical urban pattern, with blocks spaced approximately 200 feet apart. To the east of Bergen Street, the next intersection is more than 750 feet away, and it is not signalized. The nearest signal is 0.4 miles away. This results in a steady stream of traffic heading toward the Bergen Street intersection without any signals to control traffic progression. Thus, drivers making a left-turn from Blackwell Street, to north on Bergen Street, likely become impatient waiting for a gap, and when they see one, they make the left turn quickly, without checking the crosswalk on the north leg of the intersection. In addition, right-turning traffic was observed to pull far into the crosswalk to look for an opening in traffic.

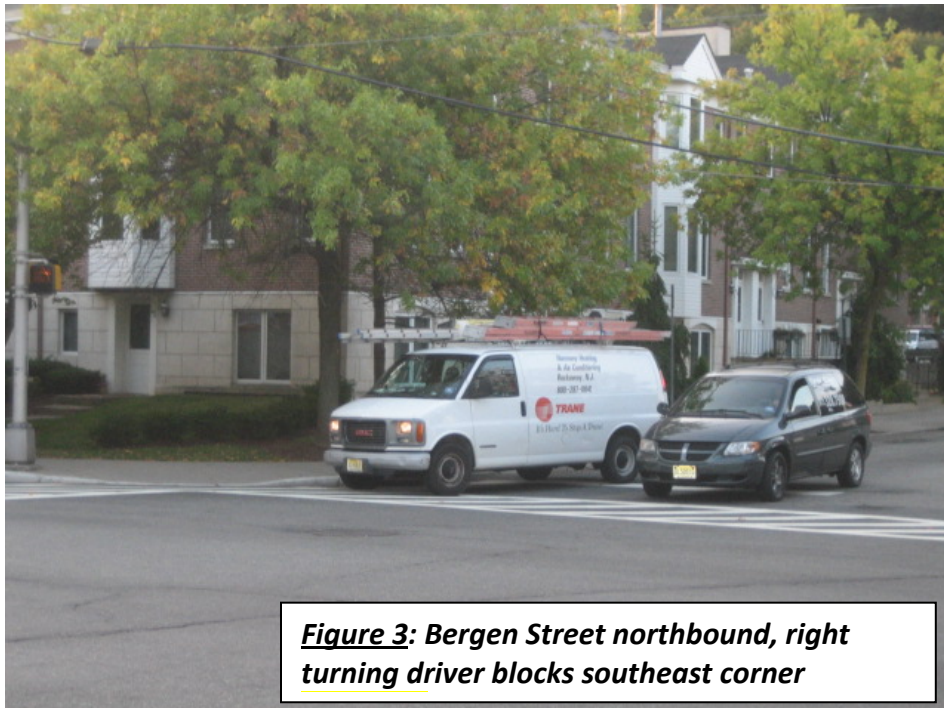
Figure 3: Bergen Street northbound, right turning driver blocks southeast corner

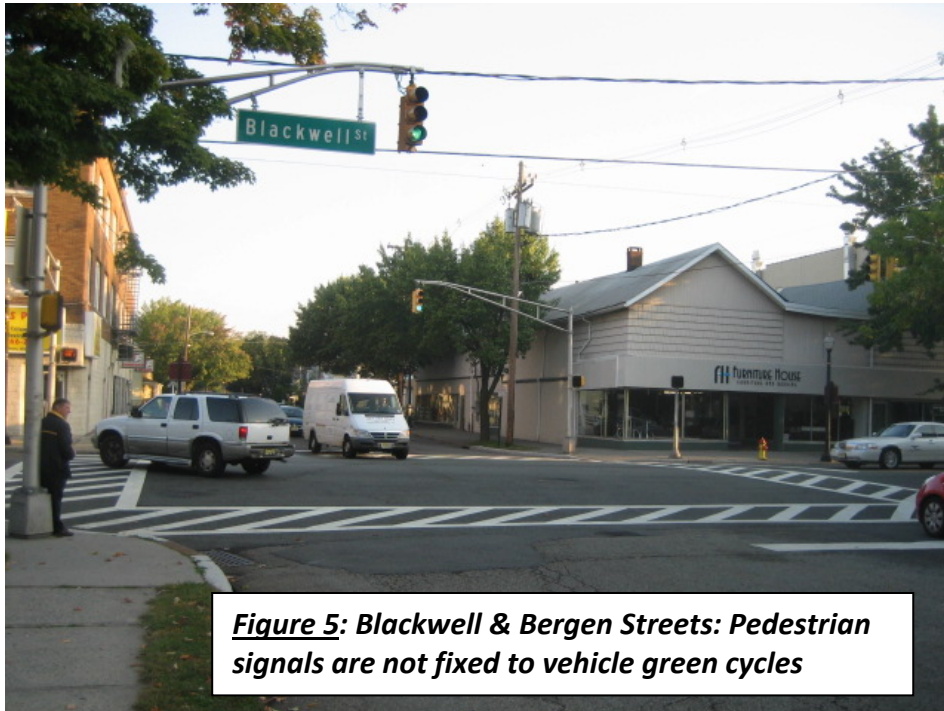
On-street parking should be provided on both sides of the street on all intersection legs. For a downtown district, on-street parking is important to patrons and business owners. It can, however, impede sight distances of drivers, as shown below. Curb extensions make pedestrians more visible by placing them past the view corridor of the parking lane. Curb extensions also shorten the crossing distance, which helps all users, especially older people or children who walk at slower speeds. The following diagram provides a visual demonstration of sight distance when attempting to cross the street and how curb extensions enhance sight distance to help the pedestrian see and be seen.

The recommended curb extensions should have a curb radius of 10 feet, meaning passenger vehicles will take the turn at a low to crawling speed.¹ This is crucial as the severity of injury in a crash increases dramatically when a pedestrian is struck by a driver traveling over 20 mph. At corners where buses must make right turns, such as the northwest corner of the intersection, curb radii should be 20 feet. This additional length allows a bus to complete the turn without having to cross over the double yellow line into the other lane of traffic. Since the intersection's west leg is 43 feet, the bus stop

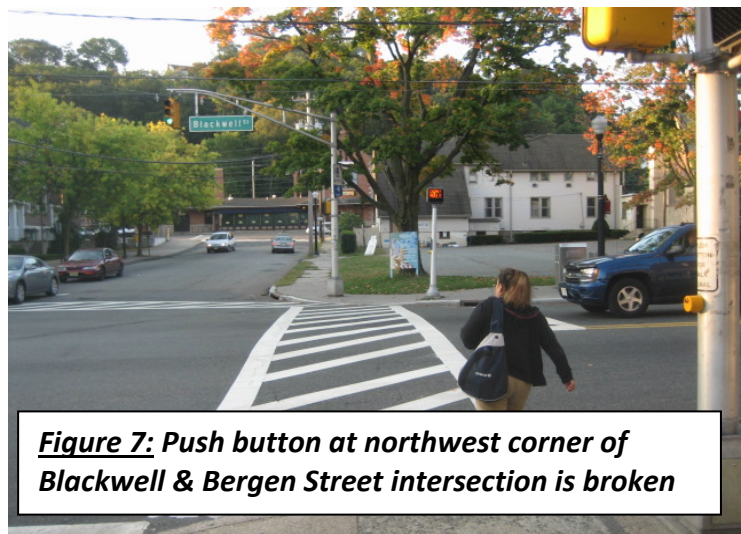
The crossing of Blackwell Street is actuated for pedestrians; however, two push buttons (on the northeast and northwest corners) were not working during the one-hour field audit. Pedestrian signals are not coordinated with vehicle signals, meaning that the WALK sign does not appear with every green vehicle signal automatically; the pedestrian must push the button to trigger the WALK sign. In addition to pedestrians, bicyclists were observed on both Blackwell and Bergen Streets.

1. Make pedestrian signals fixed-time rather than actuated. As observed during fieldwork, two of the actuated signals on the northeast and northwest corner of the intersection were not working. Fixed-time signals provide optimal service for consistent opportunities to cross the street and signals to the driver to be alert for pedestrian crossings.² Recommend using countdown signals.
2. Add a Leading Pedestrian Interval (LPI) of 5 seconds during all signal phases. Since six out of eight pedestrian injuries occurred when drivers were turning left, an LPI allows pedestrians to establish their presence in the crosswalk before vehicles begin turning.
3. Install STOP FOR PEDESTRIANS IN CROSSWALK signs approaching the intersection from all directions.

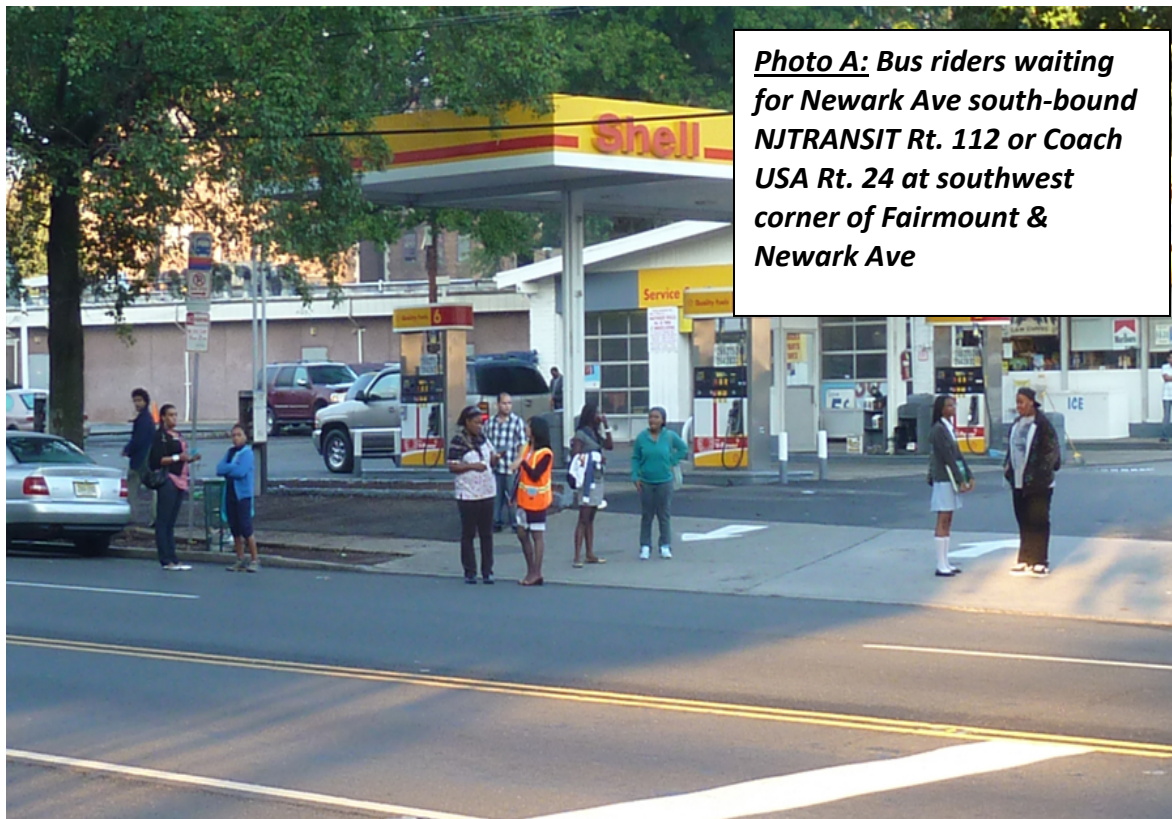
During a one-hour observation period on September 14, 2010 from 6:30-7:30 AM, a large number of students were seen waiting for school buses on Fairmount Avenue and at the public bus stop at Newark Avenue southbound heading toward New York City. The bus serving this stop, New Jersey Transit route 112, runs every 15 minutes during the morning peak, with up to a dozen passengers waiting for bus arrival at one time. The other route serving the intersection, Coach USA route 24, runs more frequently but appeared to pick up fewer riders than the 112. As passengers waited for the oncoming bus, they typically stepped out into the street to scan traffic. The presence of on-street parking beyond the bus stop likely engenders a feeling of safety for passengers to do this. However, it makes the bus stop prone to safety issues, especially since it is a few feet from the Shell gas station driveway and bus riders tend to wait in the middle of the driveway as seen in the image below.

Photo A: Bus riders waiting for Newark Ave south-bound NJTRANSIT Rt. 112 or Coach USA Rt. 24 at southwest corner of Fairmount & Newark Ave

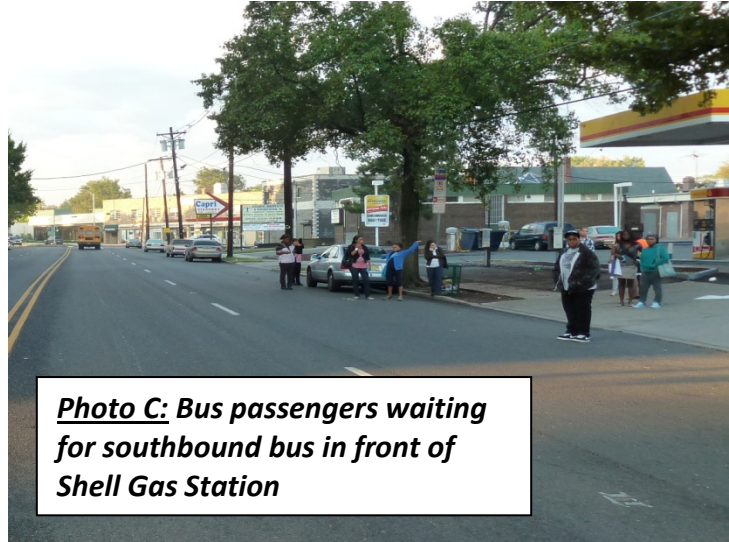
Photo C: Bus passengers waiting for southbound bus in front of Shell Gas Station

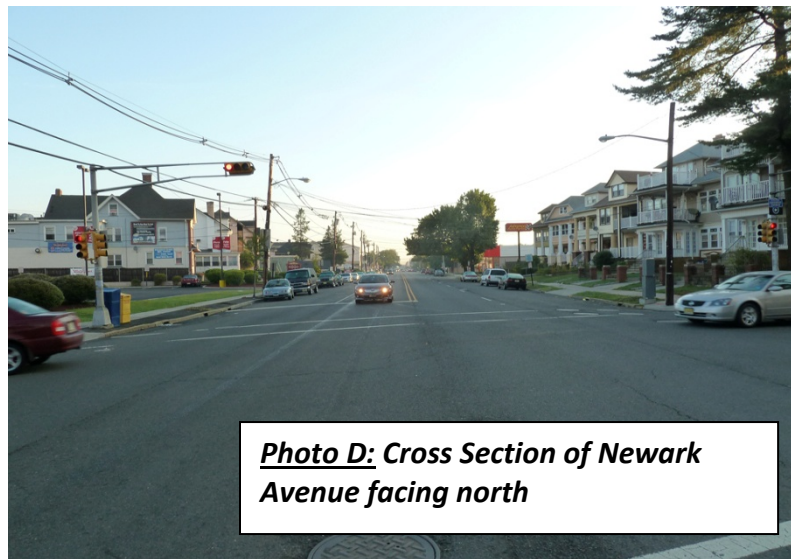
8. Create bus bulbs along Newark Avenue at both public bus stops. Bus bulbs are basically curb extensions that run the length of the bus stop. On Newark Avenue, which is fairly wide, bus bulbs will help decrease motorist speeds by narrowing the line of vision and will give passengers more waiting room. Since no parking is allowed at the bus stops, bulbs will not decrease on-street parking.

Ensure that the bus bulbs have an actual vehicle turning radius of 15 feet, meaning passenger vehicles will take the turn at a low to crawl speed¹³. This is crucial, as the severity of injury in a crash increases dramatically when a pedestrian is struck by a driver traveling over 20 mph, as illustrated in the chart below. The near-side bus stop on Newark Avenue northbound is recommended to remain near-side. One reason for this is that residents from the apartment buildings along the southeast corner of the intersection were observed as using the bus stop, meaning that moving the stop far-side would force them to cross the street. For convenience, the stop seems well-used where it is. The second reason is that buses heading westbound on Fairmount Avenue must make a right turn onto Newark Avenue northbound. A far-side bus bulb on Newark Avenue might make the turn difficult for bus drivers.

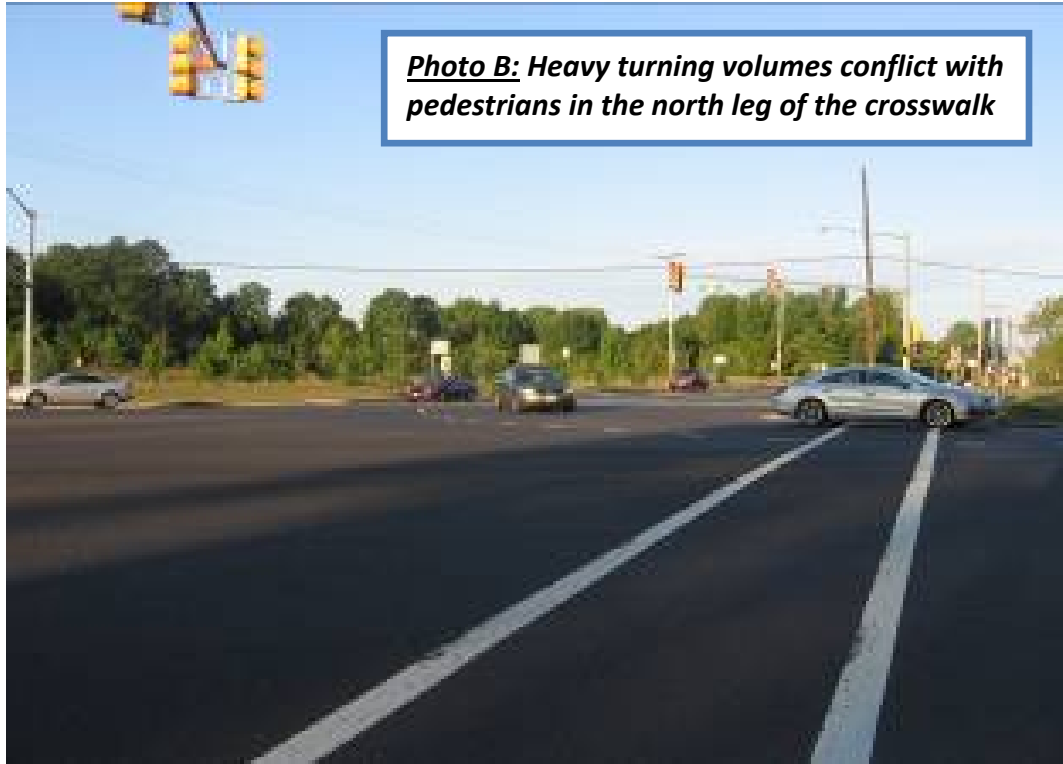
opens up into a large parking lot for a Walgreen's and Acme. The northbound bus stop has a shelter; however, like many U.S. 9 bus stops, the southbound bus stop does not. Since the direction of travel is heavily skewed toward northbound passengers boarding in the morning and southbound passengers alighting in the afternoon, few passengers are waiting for southbound buses, lessening demand for shelters.

A two-line crosswalk exists along the north, west, and east legs, along with pedestrian signal heads. During fieldwork conducted on two separate mornings, monitors observed very high turning volumes on Adelpia Road eastbound turning onto U.S. 9 northbound. Two left turn lanes exist to handle these vehicles. During both fieldwork visits, drivers did not yield to pedestrians crossing with the WALK signal in the crosswalk, which made it difficult for the pedestrian to cross safely. The U.S. Route 9 and Adelpia Road intersection did not have high ridership at both bus stops on the day of field observation; as such, coupled with low density land uses, motorists are less likely to expect pedestrians crossing in the intersection as they make turning movements towards the crosswalk with the WALK signal.

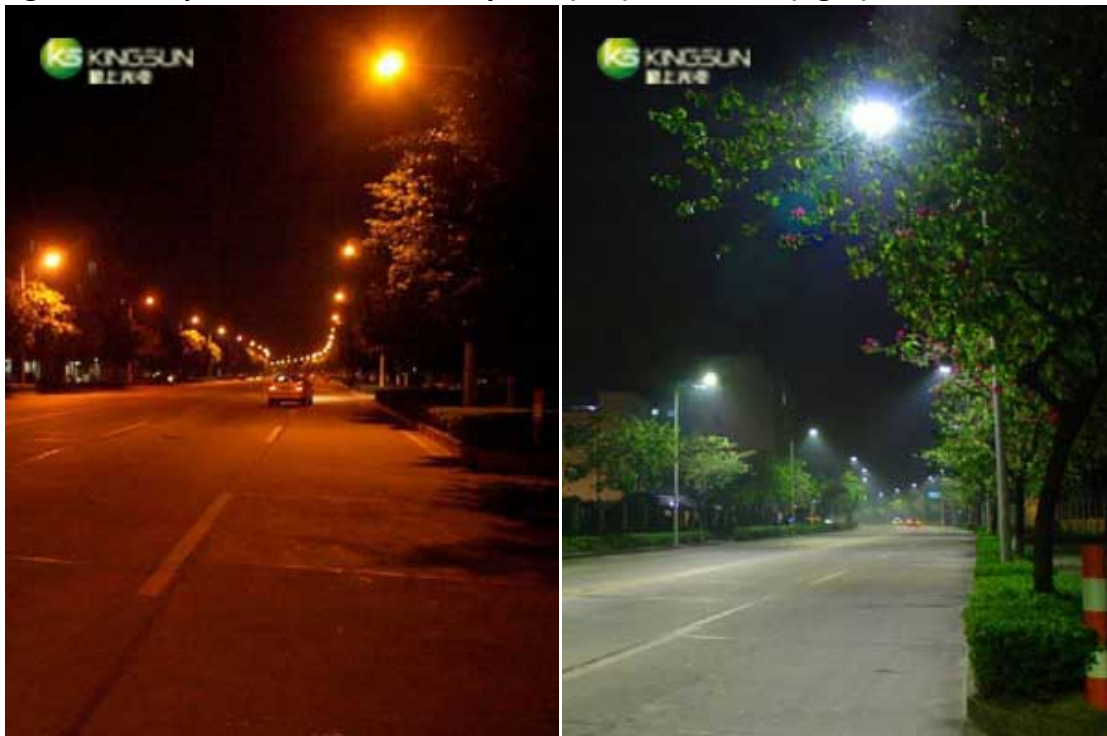
Figure 3: Comparison of a street lit by HPS (left) versus LED (right)

Lighting for pedestrians at the U.S. Route 9 and Adelphia Road is minimal with cobra head lamps. Traditionally, jurisdictions have installed street lighting using High-Pressure Sodium (HPS) lamps in cobra head fixtures. Three other technologies, metal halide, induction, and Light-Emitting Diode (LED) are also available. Communities often rely upon HPS lamps because they are low cost and last a long time, but consideration should also be given over to the quality of the space that is created. HPS lamps give off a yellowish glare, whereas newer technologies like LED have high-quality color rendering. Although LED lamps are more expensive up front, they also last much longer than HPS bulbs.

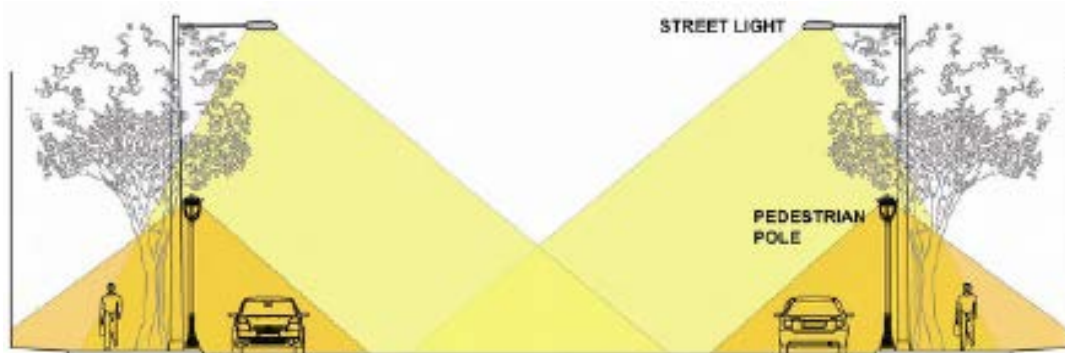
Figure 4: Post Height for Drivers Vs. Pedestrians

The height of lamps is also important. Light posts for drivers are typically installed at 20-30 feet high, and in the cobra head design the lamps are placed to illuminate the road, not the sidewalk. Pedestrian-scale lighting consists of lamps placed at 10-15 feet high.

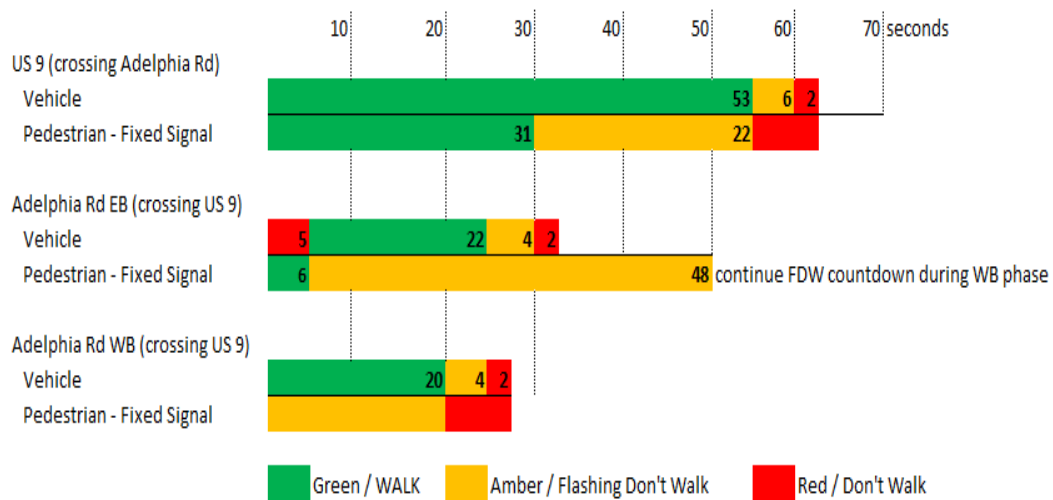
Figure 6: Pedestrian Clearance Times for U.S. Route 9 & Adelphia Rd. Intersection

2. Consider adjusting pedestrian clearance times at the intersection to comply with the Manual on Uniform Traffic Control Devices' 3.5 feet per second recommendation. Currently, if a pedestrian pushes the button to cross U.S. Route 9, the person is given a WALK time of 25 seconds and Flashing Don't Walk of 13 seconds, for a total of 38 seconds¹⁵ for 4.6 feet per second. Since the intersection is slightly skewed, the crossing of U.S. Route 9 measures 175 feet, requiring a crossing time of 50 seconds per MUTCD. Currently, pedestrians only have the opportunity to cross U.S. Route 9 during the Adelphia Road eastbound phase. To provide more crossing opportunities, and given the recommendation to stripe a new crosswalk on the south leg of the intersection, the pedestrian WALK signal should be extended to both eastbound and westbound phases on Adelphia Road. An example of how the signal timing might work on the current 120-second cycle (which is in effect from 6:30 am to 10 pm) is shown above. The signal timing would require further study by NJDOT; however, this is a starting point to consider.

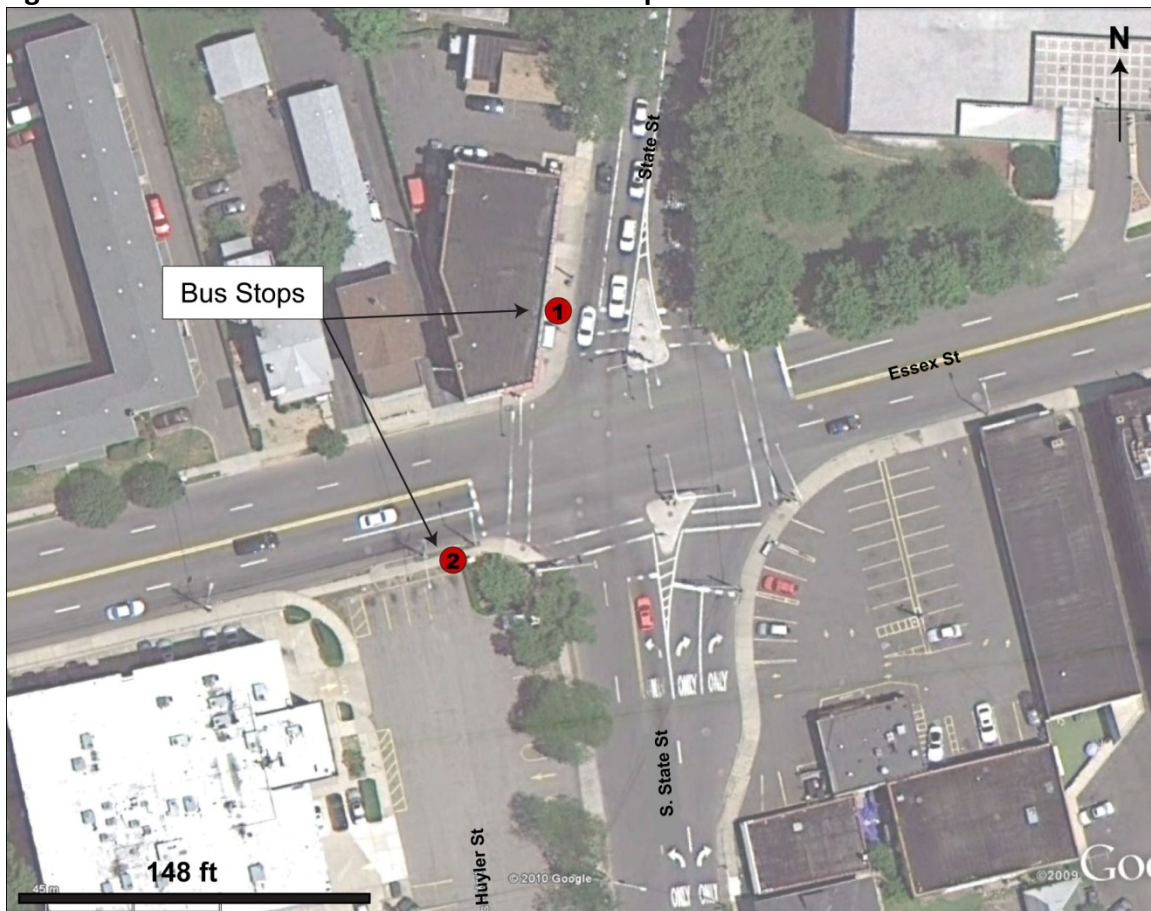
Figure 1: Aerial of Essex and State Street Bus Stops:

Essex Street (County Route 56) is an east-west, four-lane, two-way street in Hackensack, Bergen County. This street is intersected by State Street; which is three lanes one-way from the north, and three lanes of bidirectional traffic that expands to five lanes at Essex Street from the south, providing a unique circulation pattern. The current bus stops and bus travel pattern are (1) State Street at Essex Street traveling south along State Street, and (2) Essex at State Street traveling east along Essex Street.

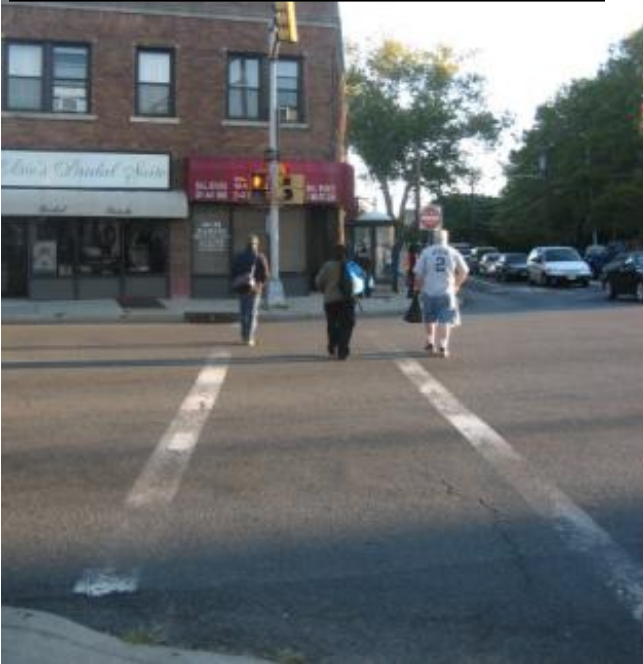
Photo A: Pedestrians cross the west leg of the Essex & State St. intersection during a break in traffic since the WALK signal is actuated

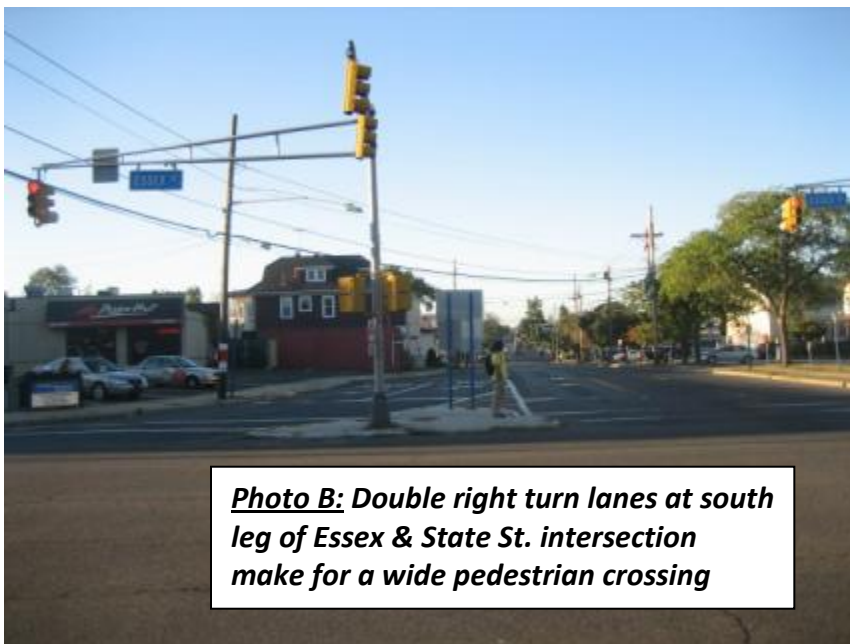
Photo B: Double right turn lanes at south leg of Essex & State St. intersection make for a wide pedestrian crossing

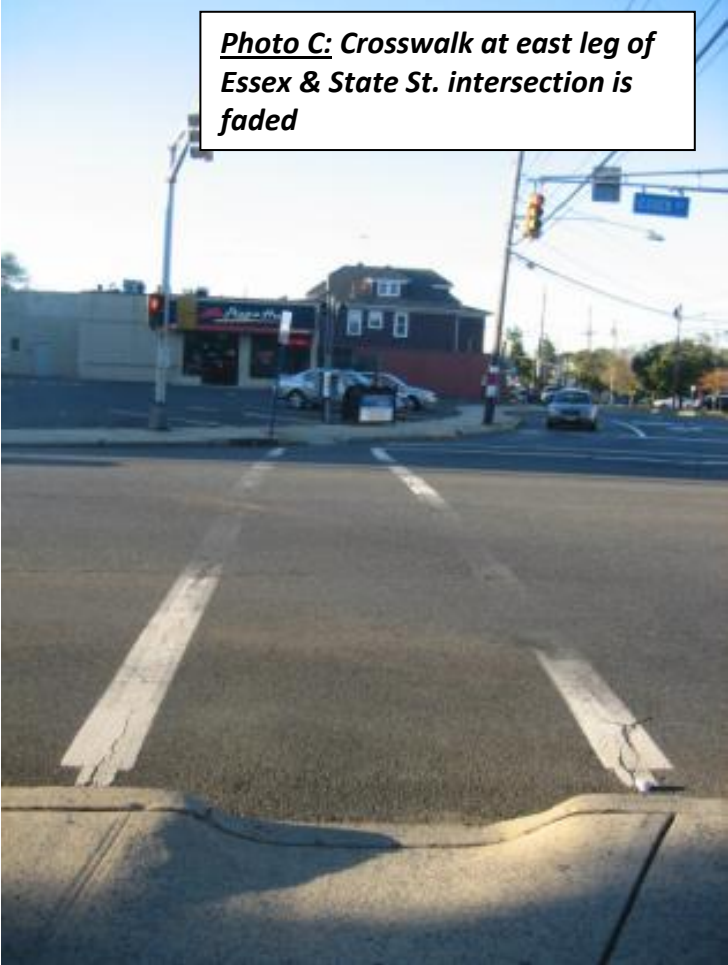
Photo C: Crosswalk at east leg of Essex & State St. intersection is faded

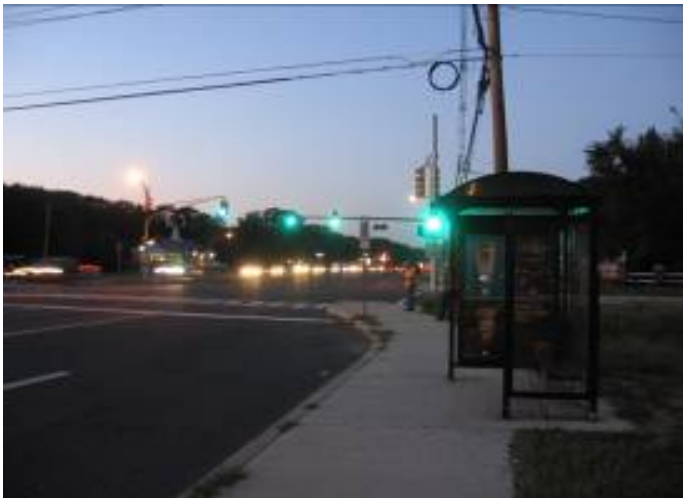
Photo A: Bus Stop “(2)” southbound, Intersection of Route 9 & Fairway Lane

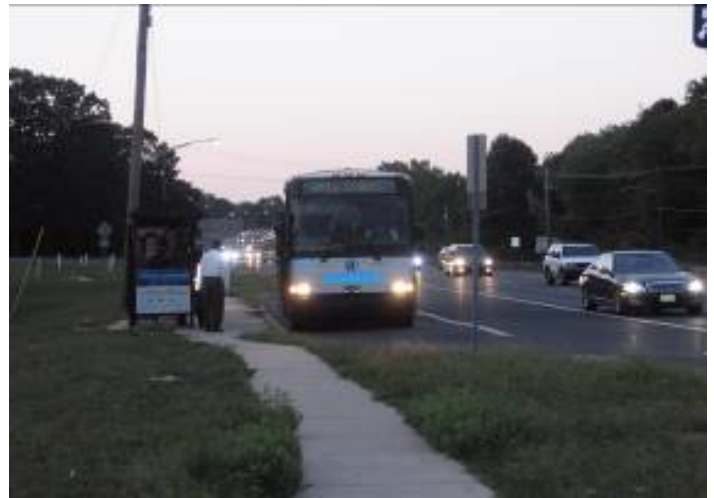
Photo B: Bus Stop “(1)” at Route 9 northbound, Intersection of Route 9 & Fairway Lane

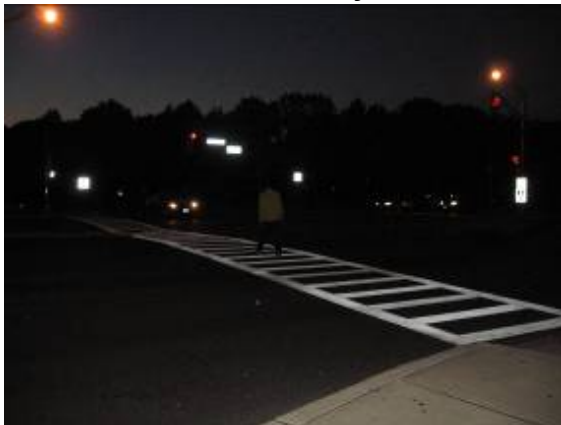
Photo C: North crosswalk of intersection

3. On a road as wide as U.S. Route 9, lighting in the median illuminates the crosswalk and those using it. Pedestrian-scaled lighting should be installed in the median, at the corners, and at the bus stop for bus stop and street crossing illumination. Given how early people catch the bus, lighting is important both for safety and security. During fieldwork in September, the bus stop is completely dark at 5:30 AM. The pedestrian in the photos below is barely visible.

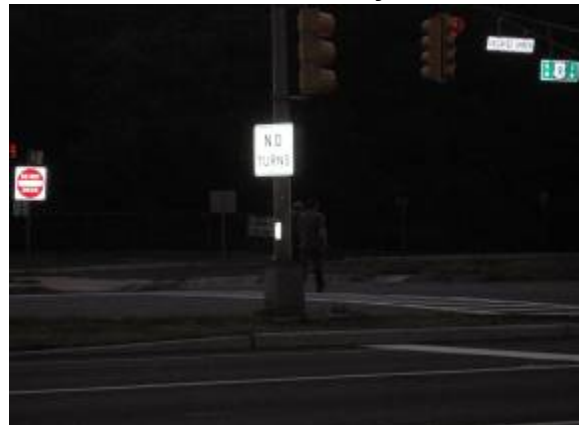
Photo D: Northeast corner of intersection

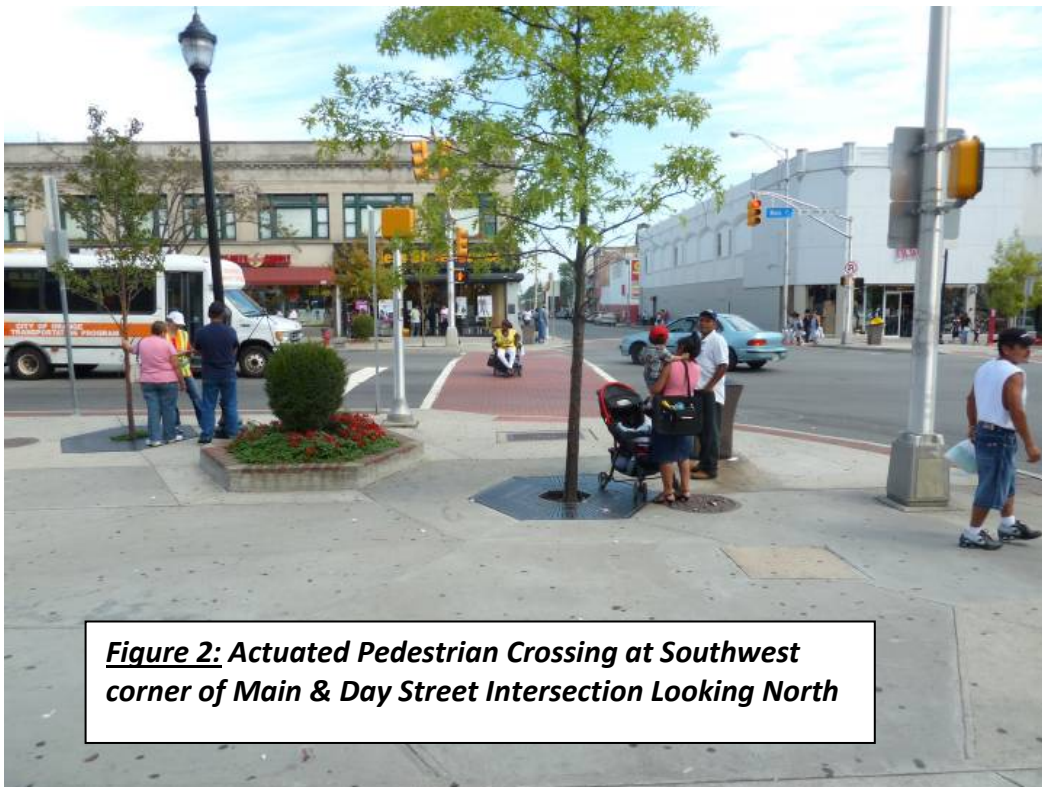
During a one-hour field survey from 11 AM-Noon on September 25, 2010, more than 450 pedestrians were observed crossing at crosswalks and midblock. While Main Street is very wide, with approximately 56 feet available for two lanes of travel, speeding was not observed as an issue. The presence of so many pedestrians, many of whom cross midblock most likely puts drivers on alert to proceed with caution. The pedestrian signal to cross Day Street is fixed with the vehicle green cycles. In order to cross Main Street, pedestrians must use a push button. During fieldwork, 159 people crossed Main Street. Given this high level of pedestrian activity, the WALK sign to cross Main Street should also be fixed with vehicle green cycles. Photos and the tracking survey are shown below.

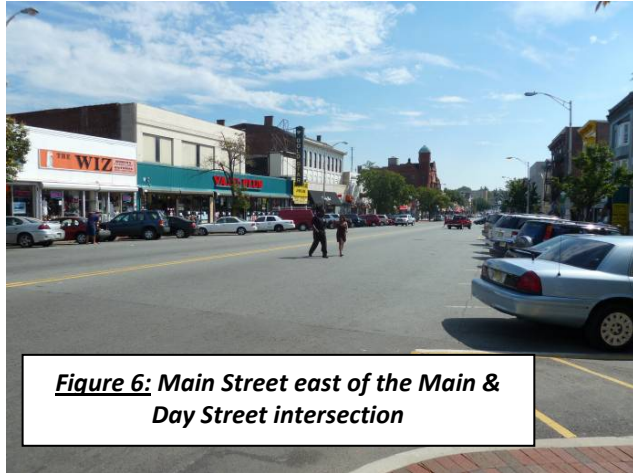
Figure 6: Main Street east of the Main & Day Street intersection

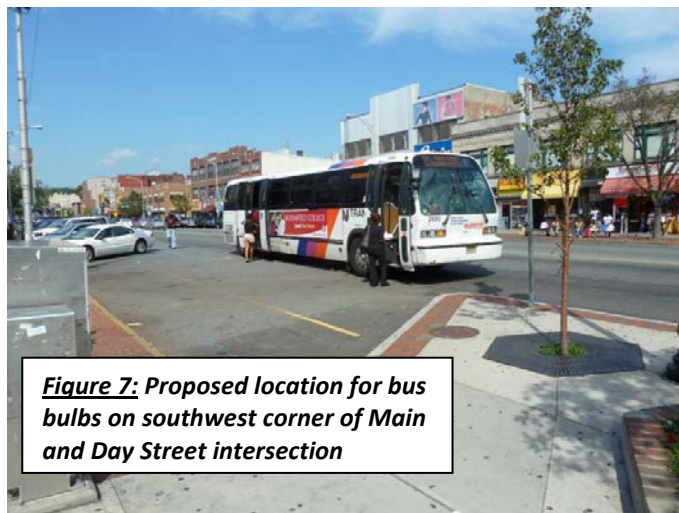
4. The intersection of Main & Day Streets has curb extensions, which decrease the crossing distance and improve visibility. However, Main Street's curb extensions do not extend through bus stops 1 and 2 pictured in Figure 1. While parking is restricted at the bus stops, this zone is not long enough for the bus to pull over to the curb and pull out again into traffic. NJ TRANSIT operators were therefore observed stopping in the travel lane to pick up and drop off passengers, as shown in Figure 7. The bus routes serving Main Street operate at short headways. This means that often times two buses stop at bus stops 1 and 2 at the same time. Since the parking restriction at the bus stop only accommodates one vehicle, riders boarding and alighting the second bus must thread their way through parked cars. A bus bulb 85 feet in length will accommodate two buses loading and unloading simultaneously and will facilitate boarding and alighting activity.

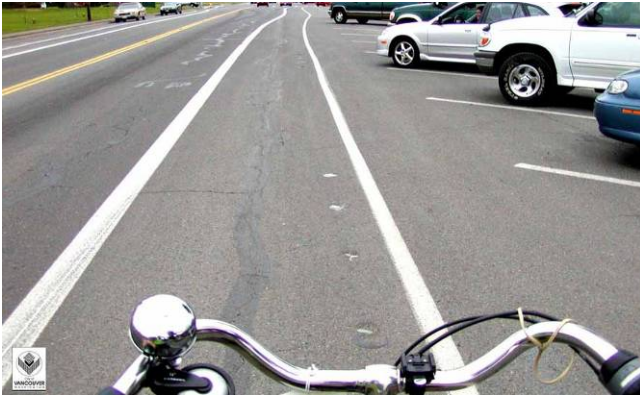
1. Improved visibility and increased field of vision. Motorists are able to see oncoming traffic as they enter the travel lane from their parking spot.

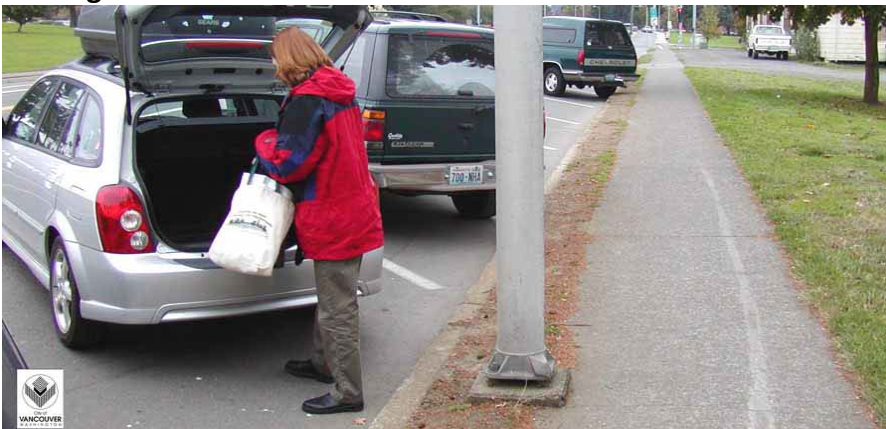
Loading a car on the curb rather than in the street

2. Reduces crashes because the motorist no longer has to back up blindly.
3. Improved safety for children (car doors open in a manner that ushers children to the sidewalk rather than the street) and cyclists.
4. Improves loading and unloading because trunks are adjacent to the sidewalk.

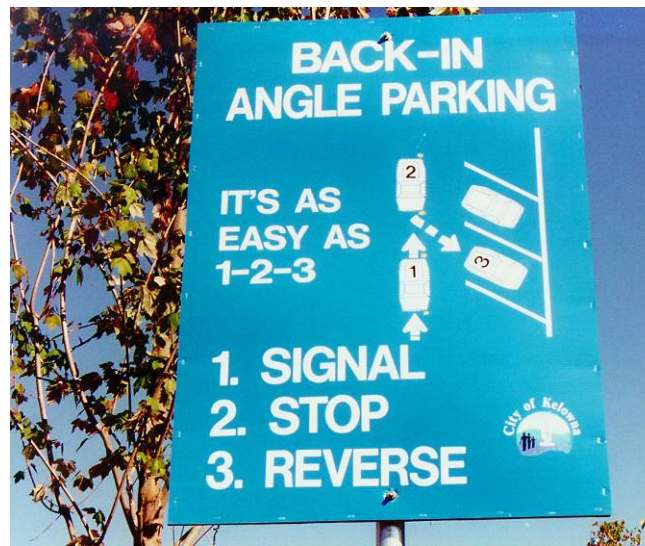
Below are a couple examples of signage to illustrate back-in angle parking to drivers.
