MARIN BOULEVARD ROAD SAFETY AUDIT

Jersey City, Hudson County, New Jersey

REPORT

>> December 2014

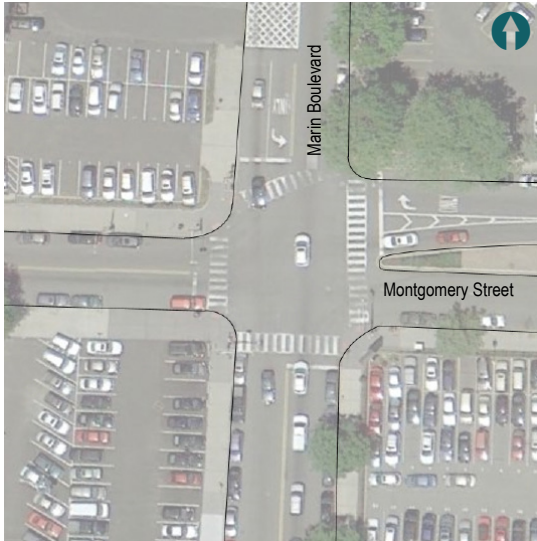
Figure 4 – Montgomery Street

Montgomery Street and Marin Boulevard

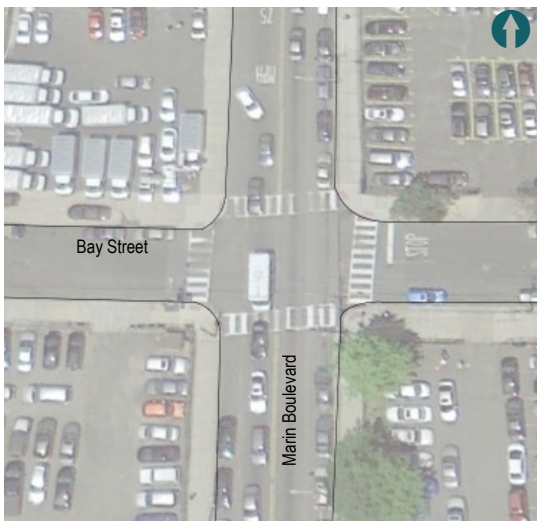
Figure 6 – Bay Street

Bay Street and Marin Boulevard

- Unsignalized, with STOP signs on east/west minor street
- Southbound approach: 40' curb to curb. One lane for through/right-turn/left-turn with curbside parking. One receiving lane with floating curbside parking. Depressed curb on west side for a 90' and 45' wide driveway entrance
- Westbound approach: 33' curb to curb. One lane for through/right-turn/left-turn with curbside parking. One receiving lane with floating curbside parking.
- Northbound approach: 40' curb to curb. One lane for through/right-turn/left-turn with curbside parking. One receiving lane with floating curbside parking.
- Eastbound approach: 30' curb to curb. One-way receiving lane with floating curbside parking on both sides of street

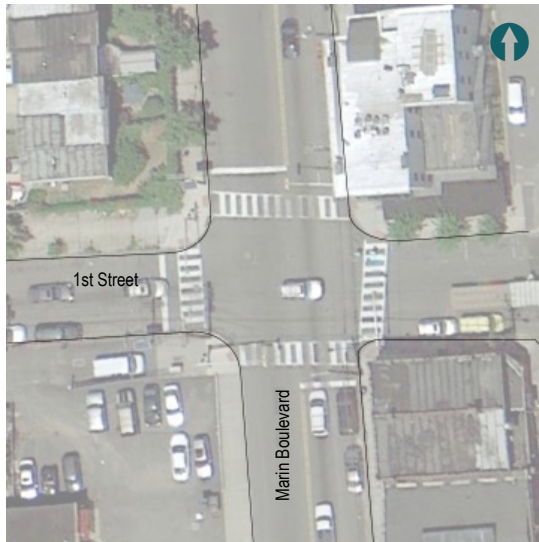
Figure 7 – First Street

First Street and Marin Boulevard

- Southbound approach: 48' curb to curb. One lane for through/left-turn with curbside parking. One receiving lane with floating curbside parking
- Westbound approach: 33' curb to curb. One receiving lane with floating curbside parking on both sides
- Northbound approach: 40' curb to curb. One lane for through/right-turn with curbside parking. One receiving lane
- Eastbound approach: 30' curb to curb. One-way left-turn/through/right-turn lane with floating curbside parking on both sides of street

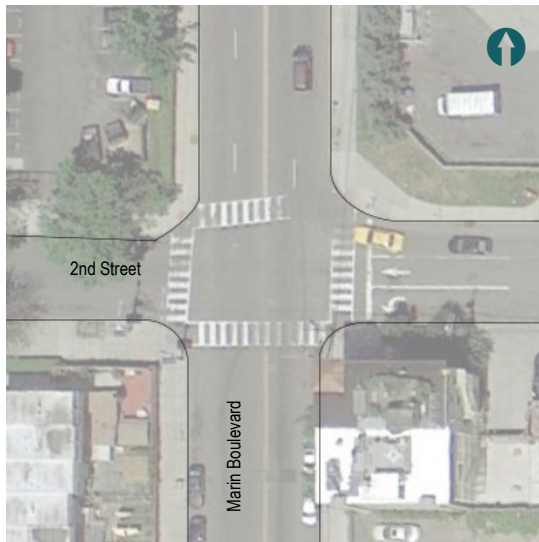
Figure 8 – Second Street

Second Street and Marin Boulevard

- Southbound approach: 47' curb to curb. Two through lanes, the rightmost of which is also a right-turn lane. Two receiving lanes
- Westbound approach: 36' curb to curb. One right-turn lane, one through lane, and one left-turn lane. 56' driveway entrance for delivery trucks on north side 60' east of intersection
- Northbound approach: 47' curb to curb. One lane for through/right-turn/left-turn with floating curbside parking. One receiving lane with floating curbside parking
- Eastbound approach: 30' curb to curb. One receiving lane with floating curbside parking on both sides. Driveway entrance to parking lot 20' west of intersection on north side

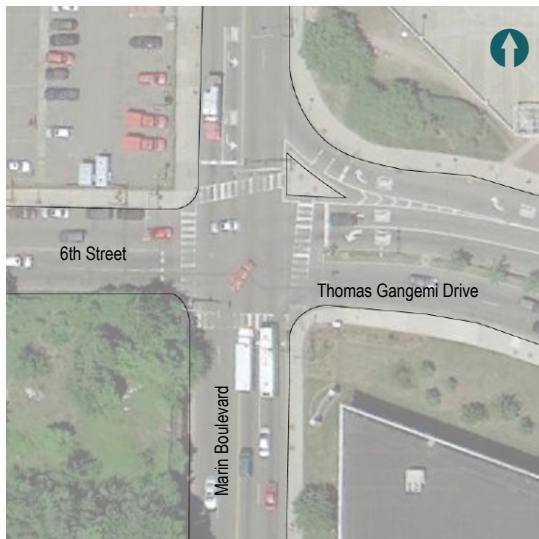
Figure 9 – Sixth Street/Thomas Gangemi Drive

Sixth Street/Thomas Gangemi Drive and Marin Boulevard

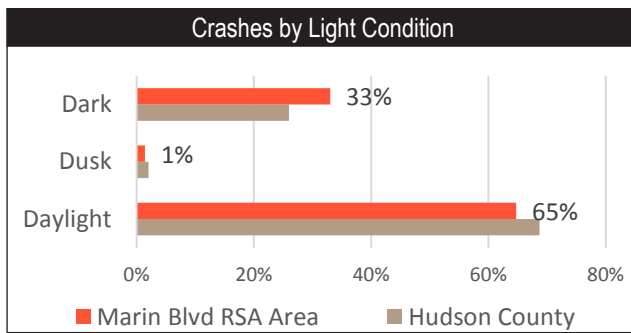
Figure 18 – Crashes by Light Condition (2010–2012)

Percentage-wise, there are more crashes in the RSA area at night (33 percent of RSA area crashes, compared to 26 percent of countywide crashes) than during the daytime, suggesting that lighting may be a factor in crashes. Wet roadway conditions may also be a contributing factor since there is a higher percentage of RSA area crashes occurring on wet roadway conditions (18 percent in RSA area, compared to 15 percent countywide).

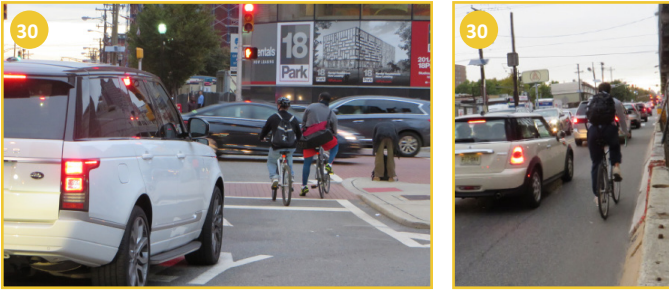
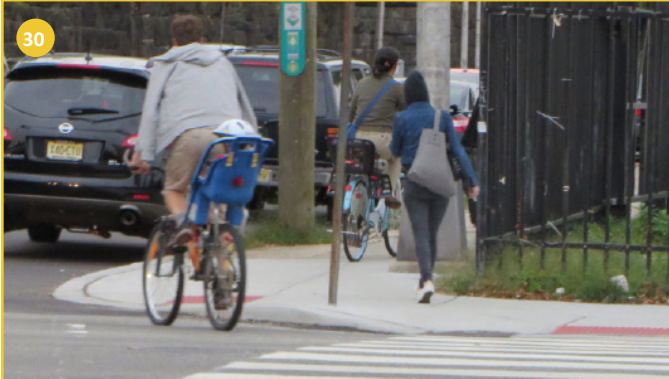
Lack of Cycling Facilities

Lack of safe cycling facilities for individual adult cyclists and children mounted onto the back of adult bikes. Cyclists choose to either travel on the edge of the travel lane (often with inadequate space) or use the sidewalks for riding.

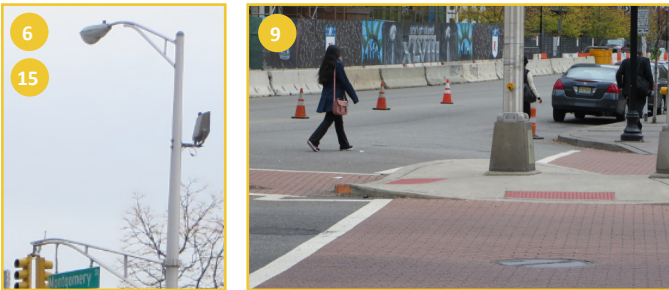
Few pedestrian-level lighting fixtures (left); pedestrian desire lines not reflected in straight, point-to-point crosswalk placement (right)

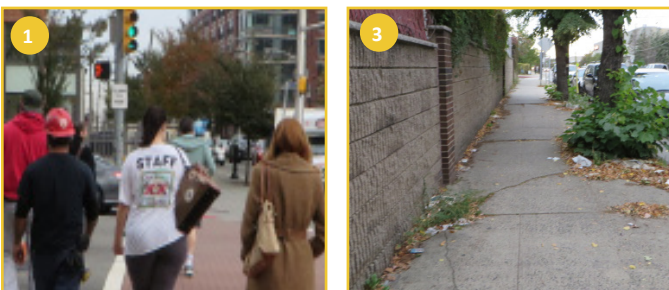
Pedestrians crossing against signals (left), broken sidewalks (right)

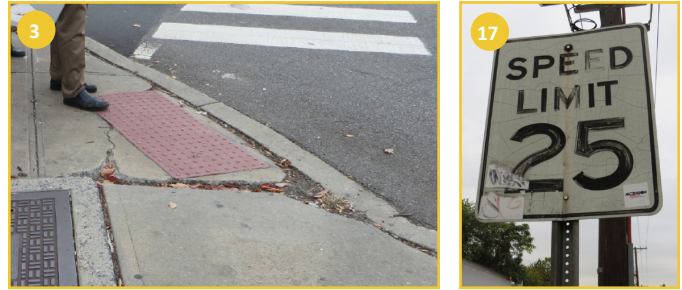
Broken sidewalks (left), faded signs (right)

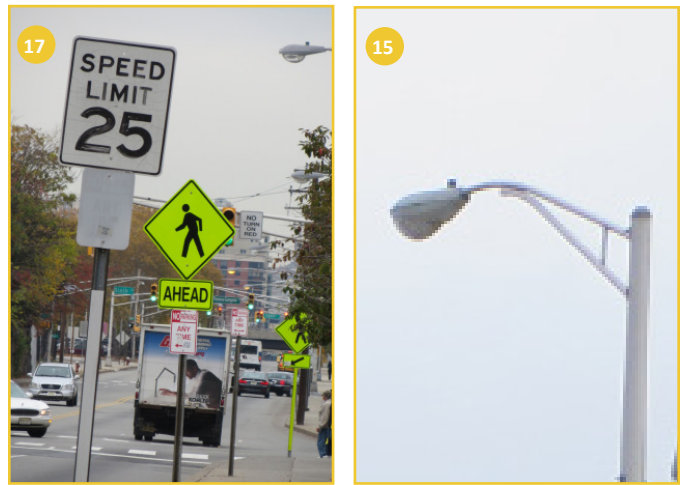
Sign clutter (left) and seemingly broken street lights (right). The merit of installing breakaway posts was also discussed.

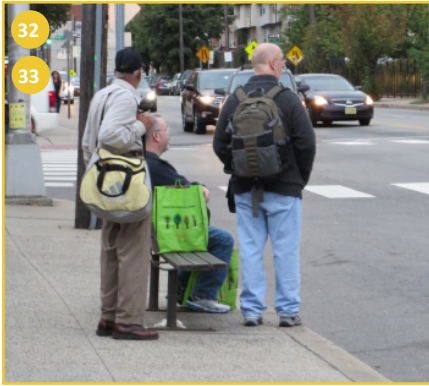
Bus stop facilities do not accommodate high user demand, as evidenced by lack of seating near bus stops and lack of shelters.

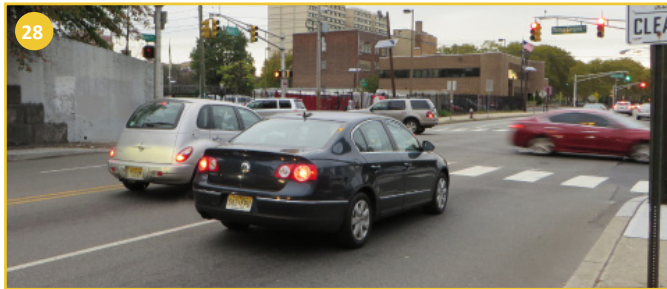
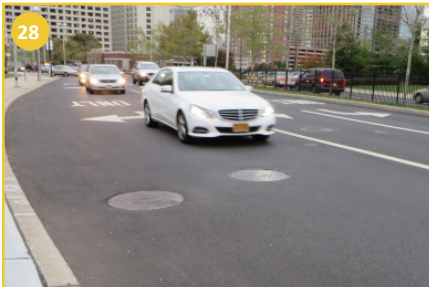
Wide lanes are often associated with speeding and aggressive driving (above and left)

Many intersection curb lines do not align (right)

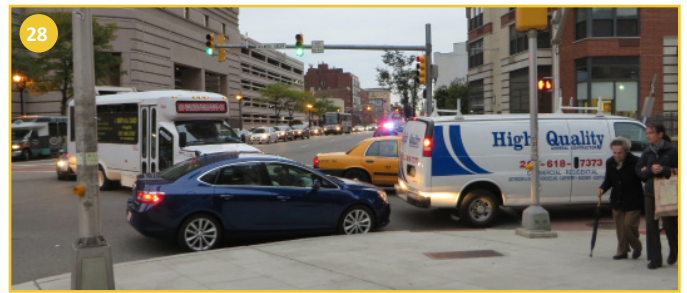
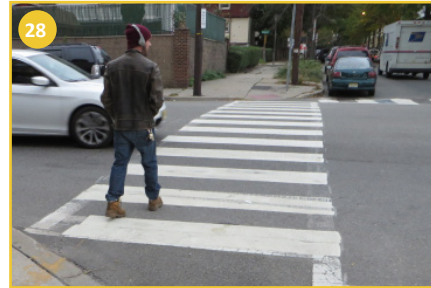
Heavy traffic during evening peak hours (above)

Motorists not stopping for pedestrians in crossing (left)

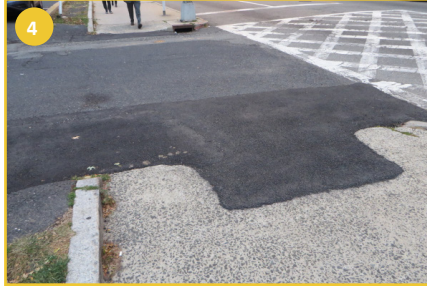
Uneven sidewalks at driveway entrances

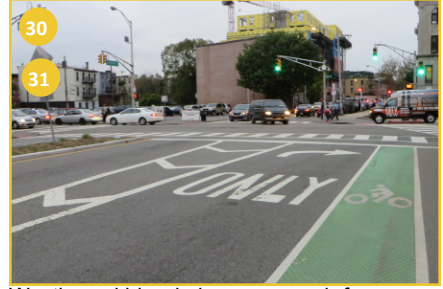
Westbound bicycle lane approach for straight-through movement conflicts with right-turning vehicles

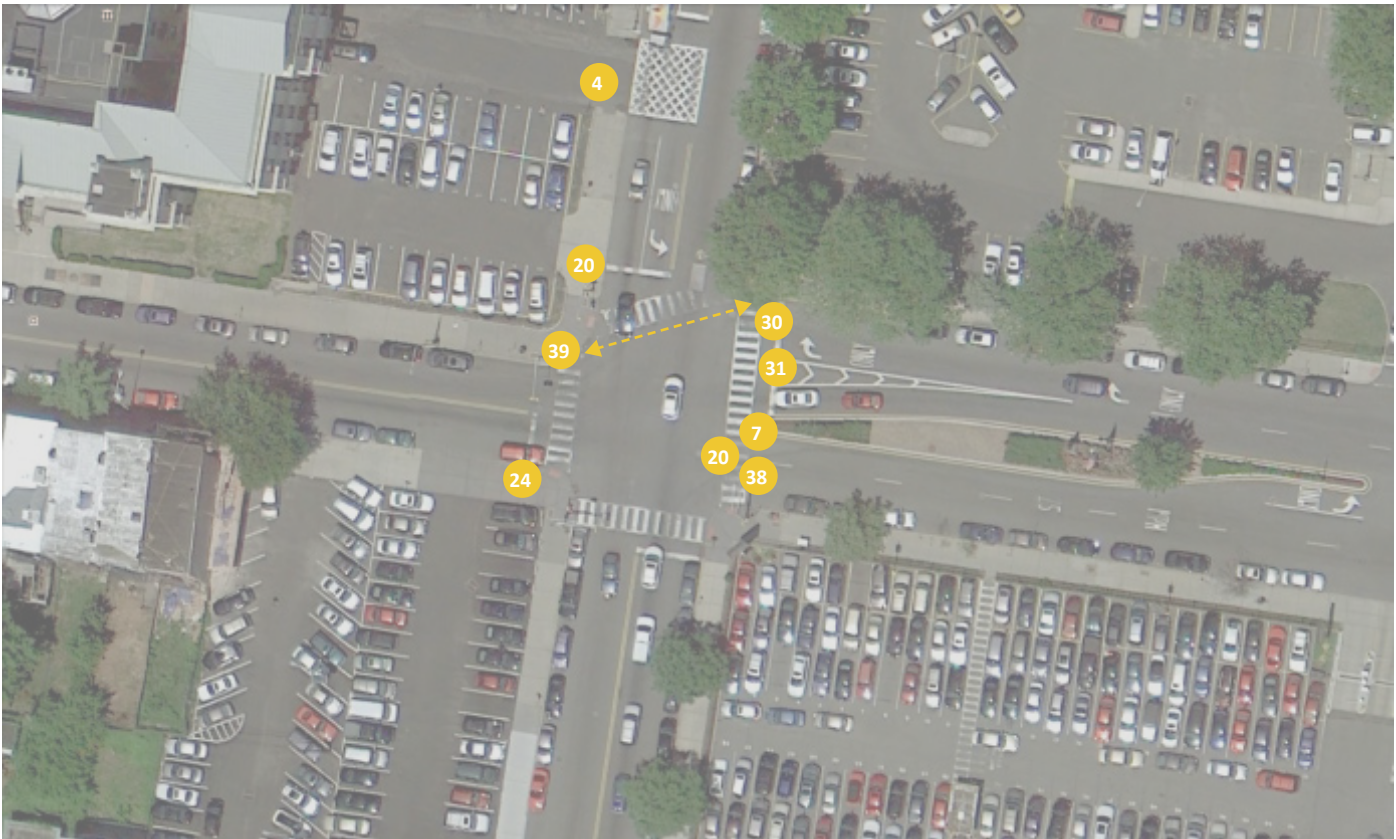
- 24 Illegally parked vehicles too close to the intersection
- 20 Stop bar located in driveway entrance

39 Curbs on the north side of the intersection do not align, creating a longer crosswalk and “dead” street space (hatched area between through and right turn lane on Montgomery Street westbound)

20 History of left-turn crashes striking pedestrians in crosswalk

7 Long crossing distance with short crossing time. Pedestrians observed to begin crossing only to become stranded and exposed on median

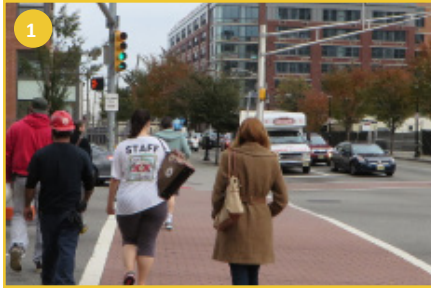
1 Pedestrians crossing against the signal when vehicles have a lead-left, causing left-turning traffic to back up into the intersection. Crossing distance in the crosswalk (90 feet) is the longest of the legs.

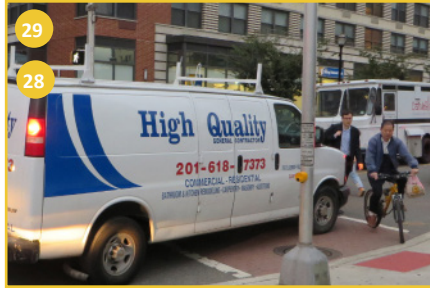
29 Aggressive driving where car blocks crosswalk. Cyclist using sidewalk facilities instead of on-street facilities

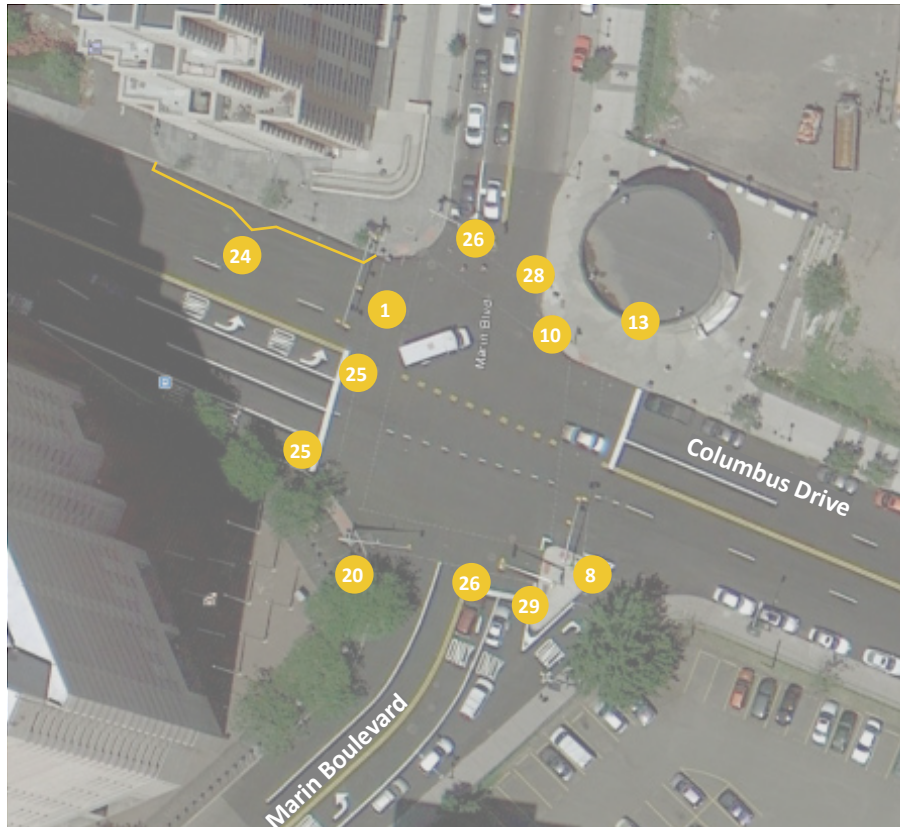
25 Vehicles observed using the bus stop lane as a right-turn lane

26 Vehicles observed utilizing both lanes (one of which is a dedicated left-turn lane) to travel southbound or northbound. There are two southbound receiving lanes.

19 Speeding, especially along Columbus Drive

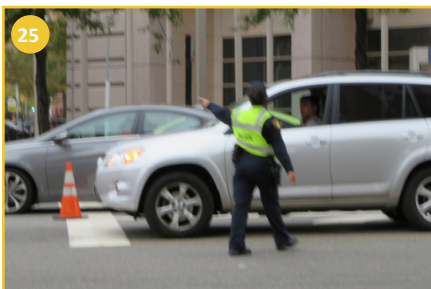
25 Vehicles illegally entering bus-only left-turn lane

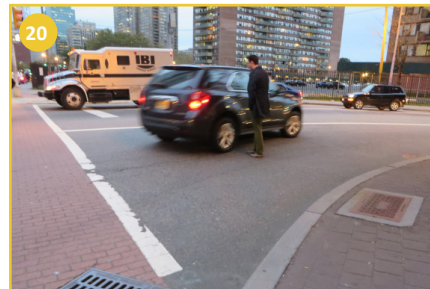
20 Pedestrian crossing outside of crosswalk nearly getting struck by vehicle making wide right turn at the southwest corner

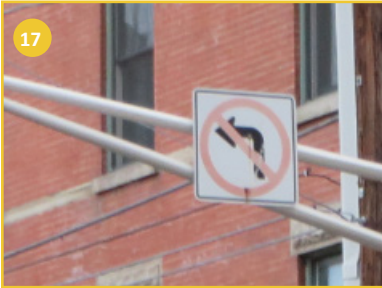
Faded signs

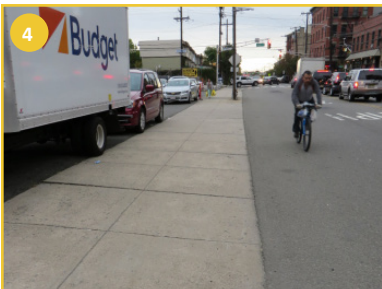
Two wide driveway entrances (45-foot wide and 80-foot wide)

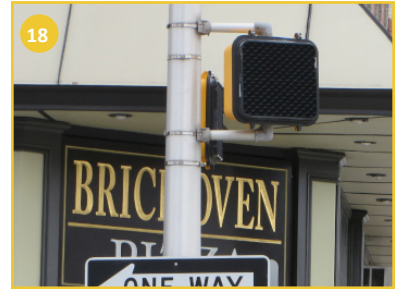
Nonfunctioning pedestrian walk signal

Location	Safety Benefit	Jurisdiction	Time Frame	Cost	Issue Ref. #
E-3	Improve daylighting with stanchions	Medium	Jersey City	Short	\$	24
E-4	Repair broken walk signal	High		Short	\$\$	18
Second Street						
F-1	Create single southbound travel lane north of the intersection	Medium	Jersey City	Short	\$	27, 38
F-2	Conduct warrant analysis to potentially signalize intersection	High	Jersey City	Long	\$\$\$	19
Sixth Street/Thomas Gangemi Drive						
G-1	Relocate curbside parking to accommodate shifted eastbound travel lane	Medium	Jersey City	Short	\$	40
	Adjust geometry for calmer traffic flows					
G-2	Align intersections by reconfiguring slip lane as squared off right turn lane	High	Jersey City	Long	\$\$\$	39
	Create safer facilities for left-turn movements					
G-3	Head to head left turns on north-south approaches	Low	Jersey City	Medium	\$\$	40
G-4	Head to head left turns on east-west approaches	High	Jersey City	Long	\$\$\$	40

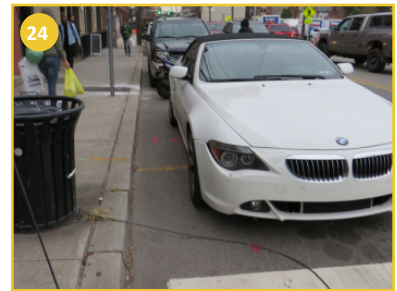
Cars parked too close to the intersection, blocking sight triangles

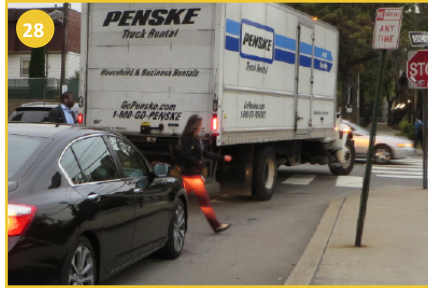
Vehicles blocking crosswalk

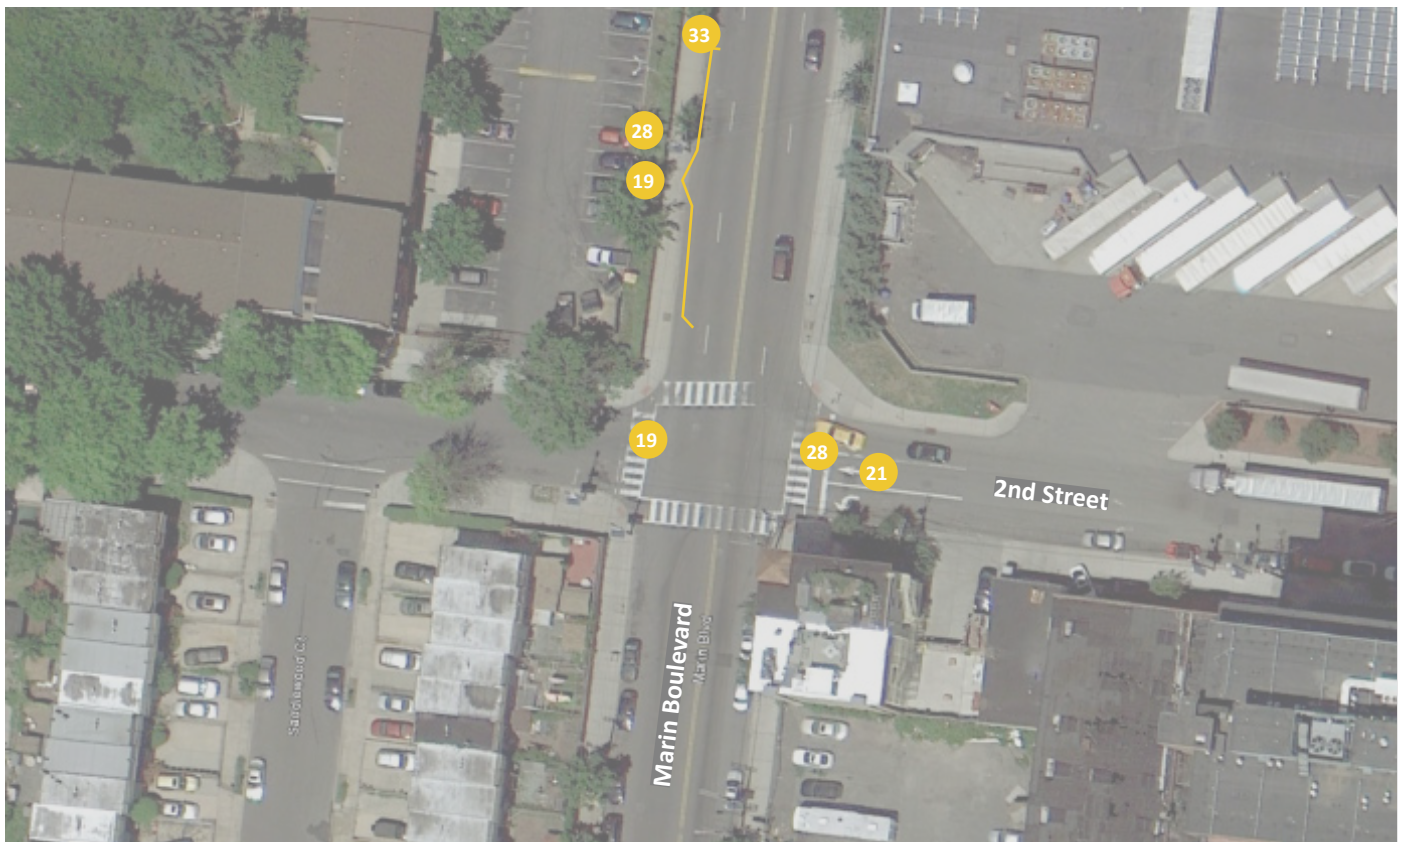
Lack of pedestrian amenities to separate sidewalk from fast-moving southbound traffic, creates a vehicle-oriented character rather than a pedestrian-oriented character

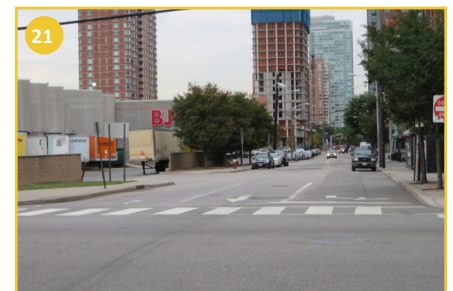
The eastern leg approach has a strong right angle crash history

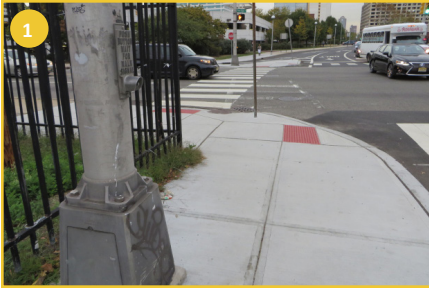
1 Push buttons are located far from intersection, and appear to be underutilized

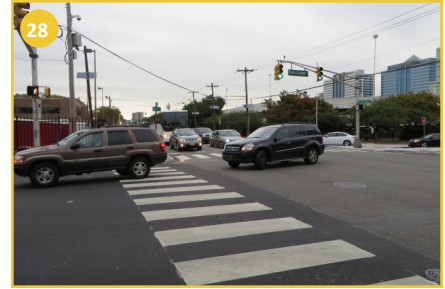
28 Aggressive driving behavior, blocking intersection

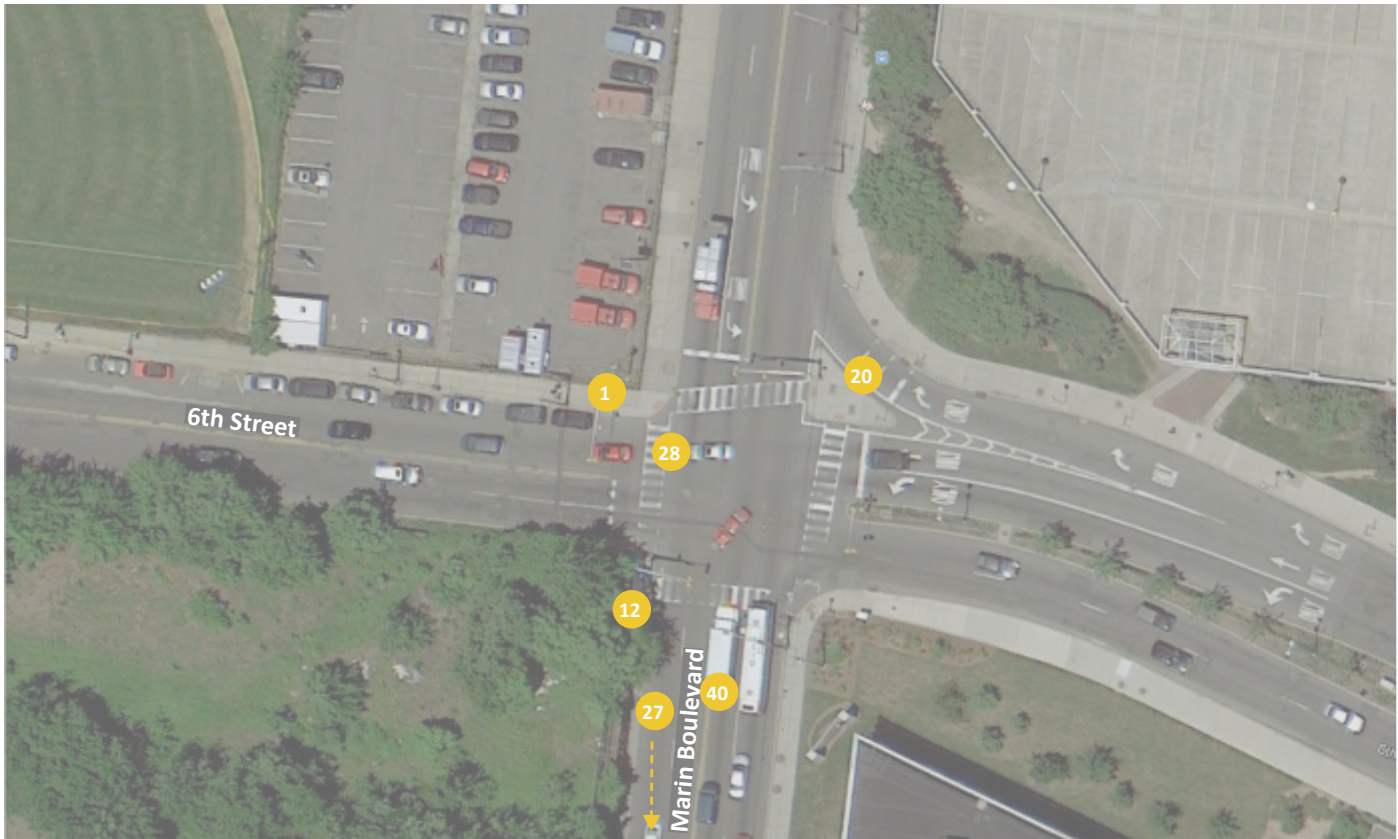
40 Negative offsets on the northbound and southbound approaches may be the reason for the high frequency of left-turn crashes

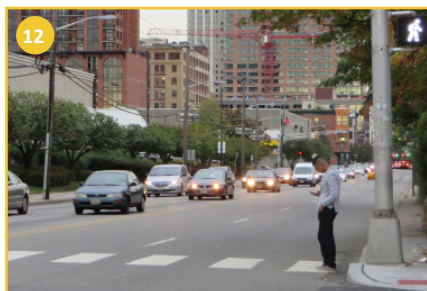
12 Narrow sidewalk

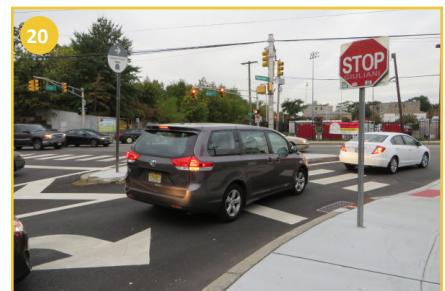
20 Turning conflicts with pedestrians at slip ramp

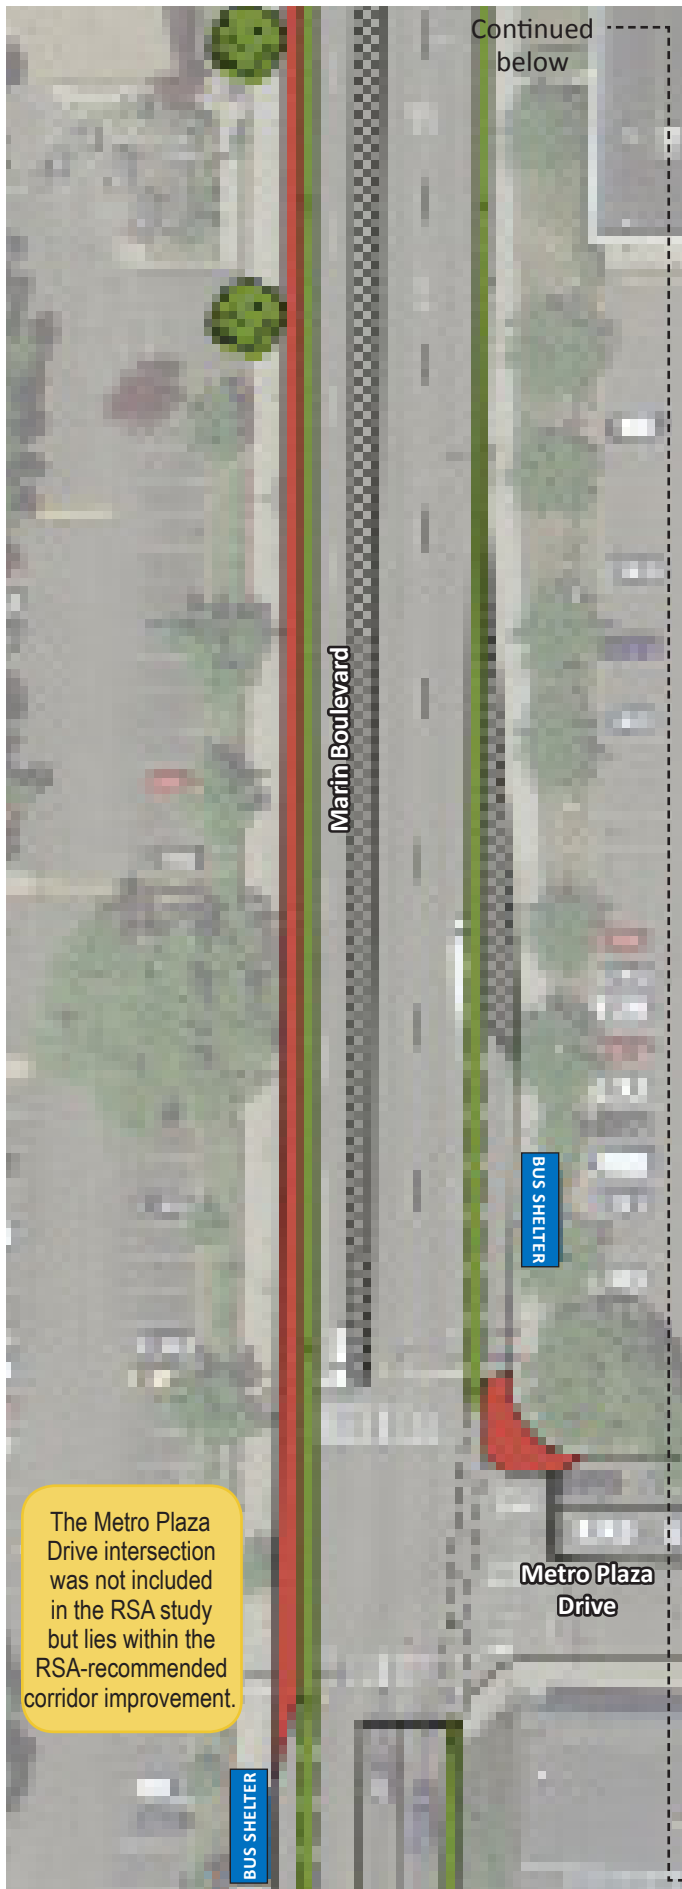
The RSA team recommended corridor improvements between Sixth Street and Second Street. Design concepts along this segment include:

- Intersection square-off at Sixth Street intersection
- Sidewalk extension on west curb (south of Sixth Street)
- Elimination of one southbound travel lane along Marin Boulevard between Sixth Street and Second Street
- Median extension for refuge island
- Ergonomic crosswalks
- Marked bicycle lane
- Street amenities (such as trees, where sidewalk space permits)

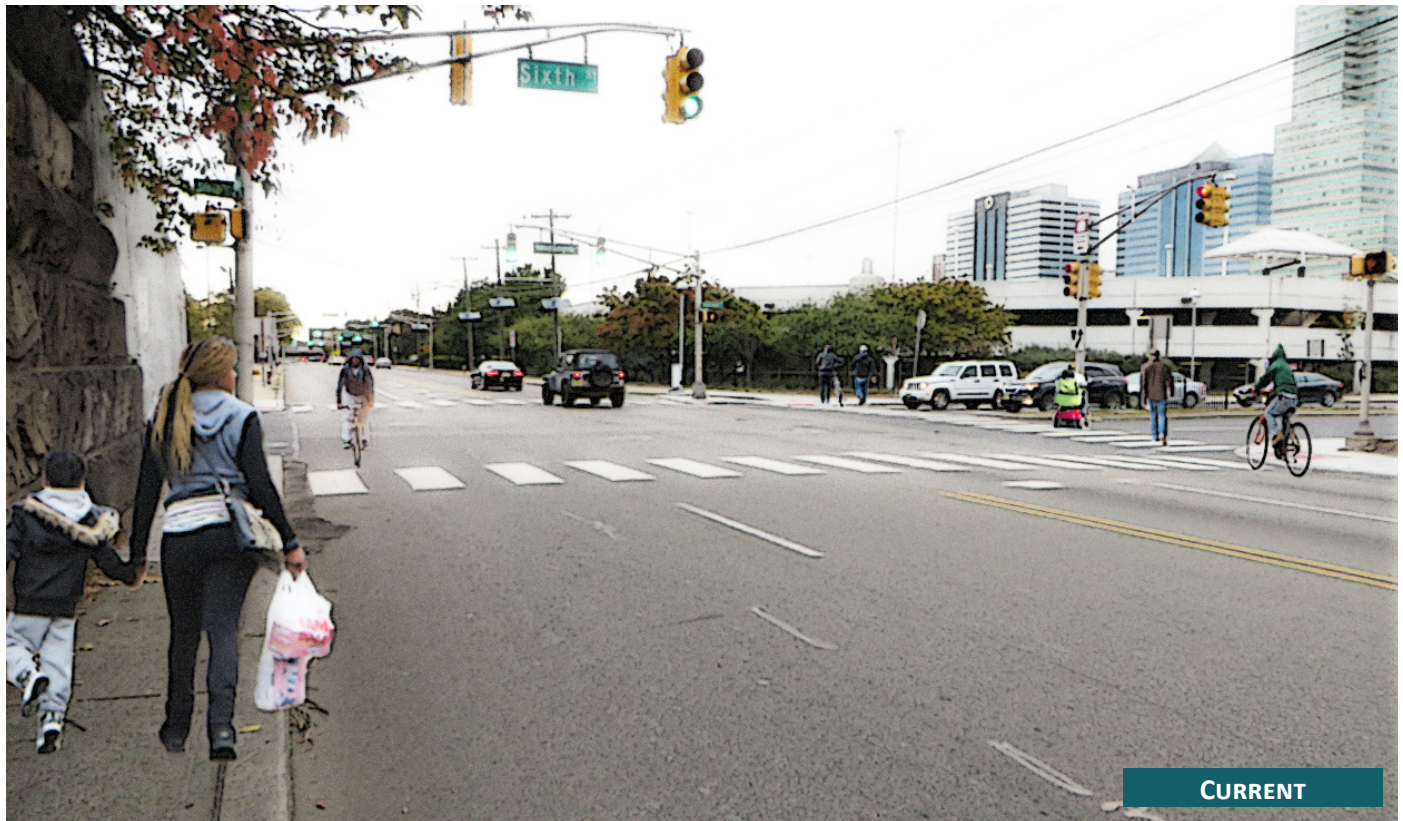
CURRENT

The photo simulation below illustrates many of the recommendations for the Sixth Street/Thomas Gangemi Drive intersection, including:

- Intersection square-off at Sixth Street intersection
- Sidewalk widening
- Elimination of one southbound travel lane along Marin Boulevard between Sixth Street and Second Street
- Median extension for refuge island
- Marked bicycle lane
- Shifted centerline for head-to-head left turns

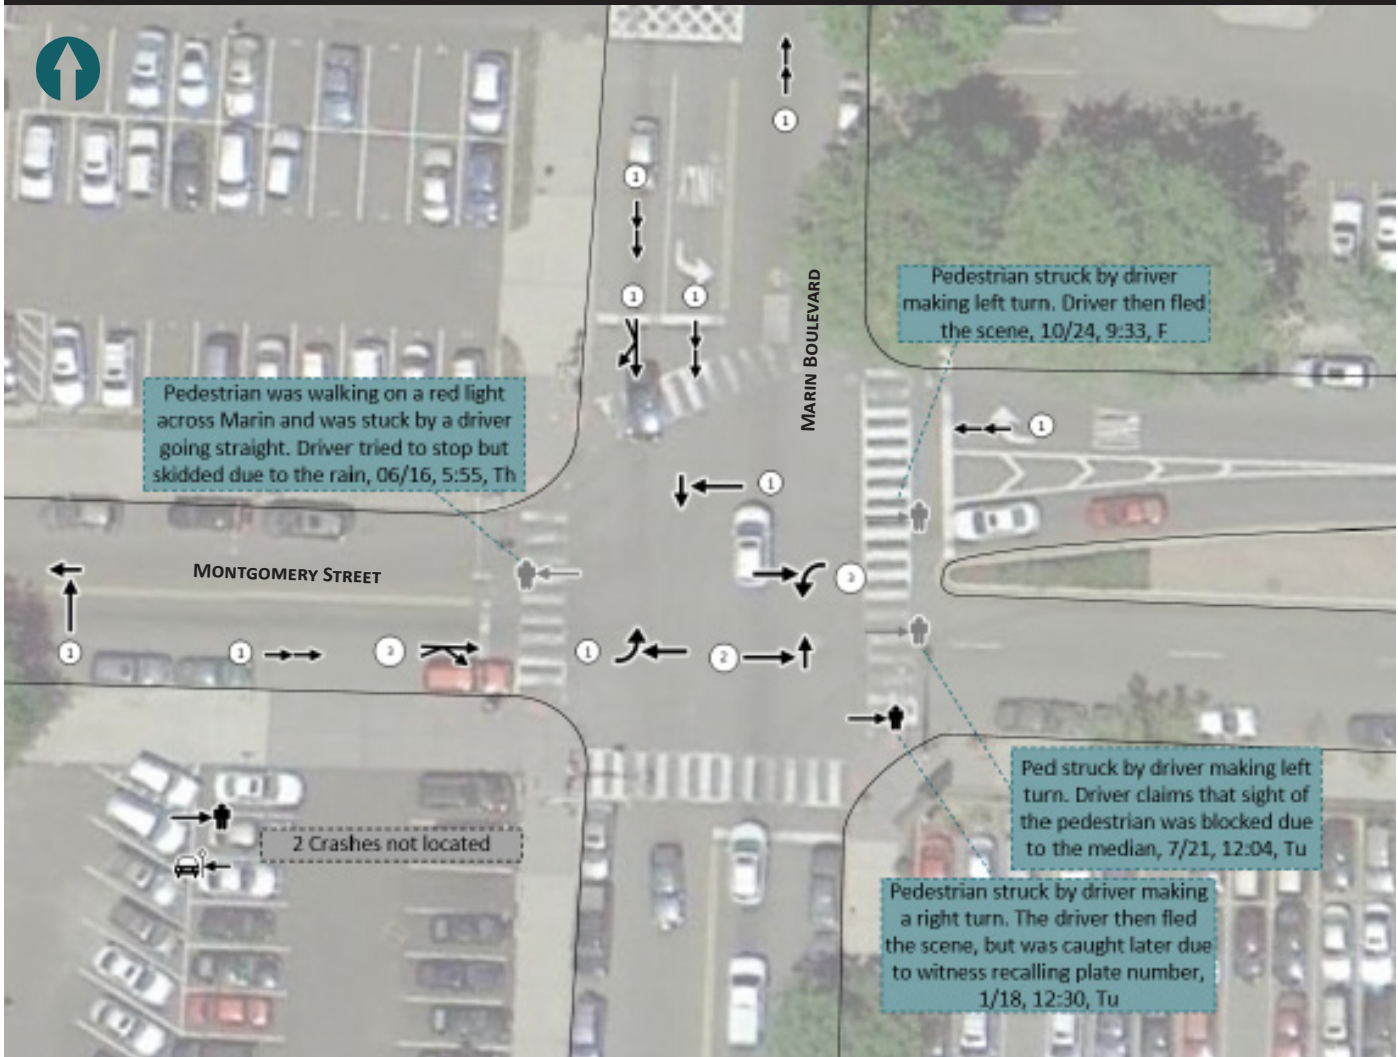
7.2 MONTGOMERY STREET AND MARIN BOULEVARD

All pedestrian and cyclist crashes from 2008–2012 have a brief crash narrative included in the diagram and are color-coded by severity. Pedestrian and cyclist crashes from 2008–2010 have gray icons. Additionally, any crash from 2010–2012 that has a severity of “moderate injury” or greater has a color-coded narrative.

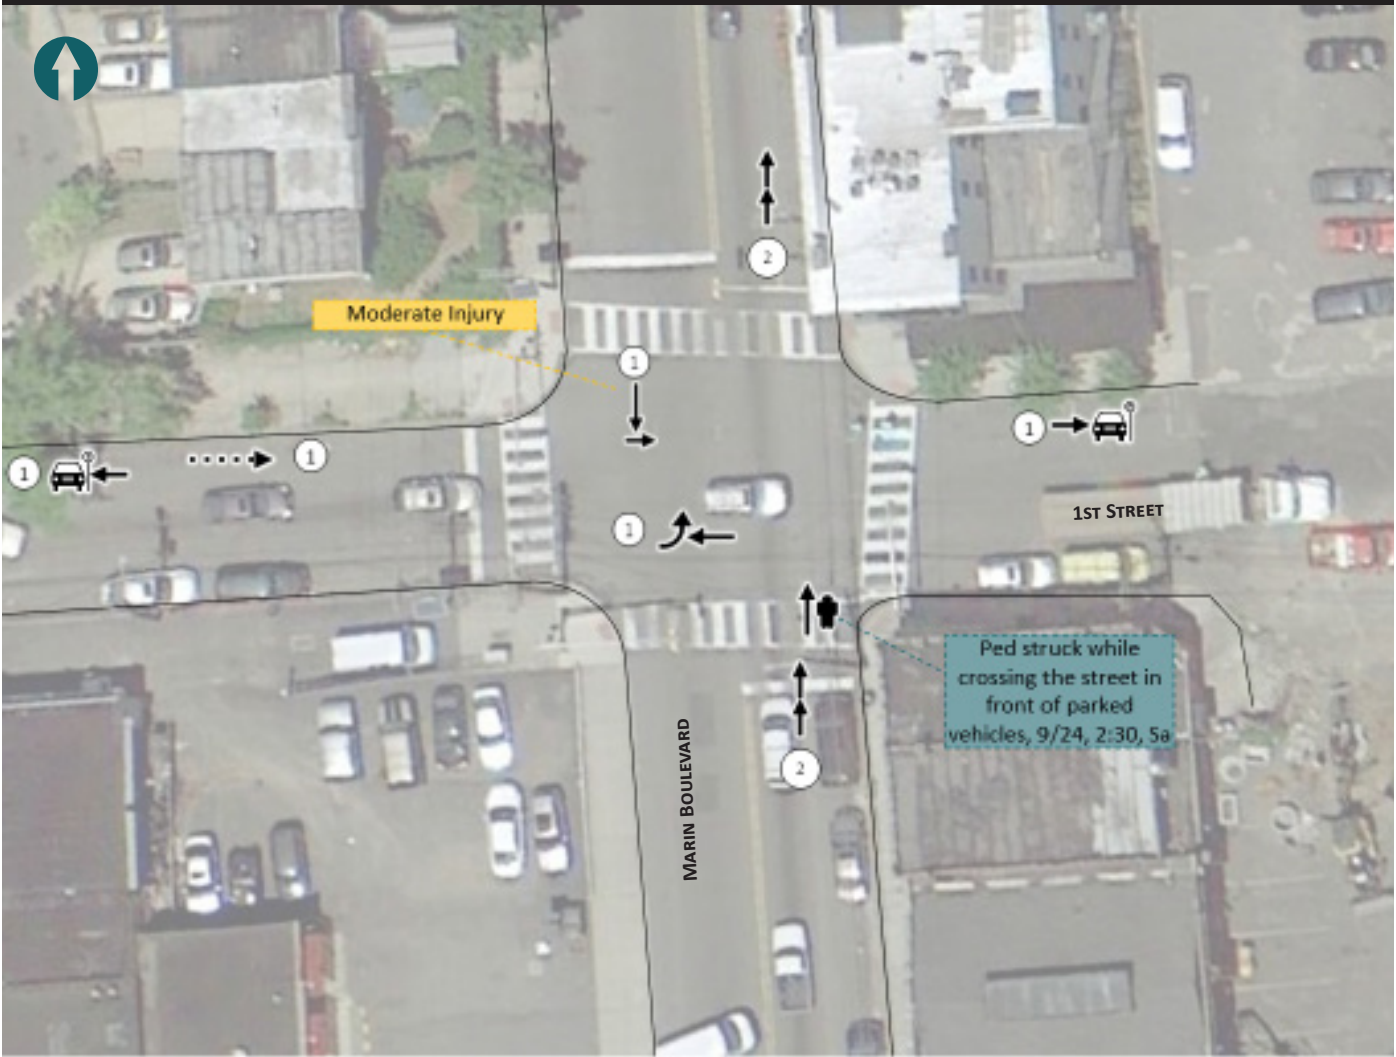
7.5 FIRST STREET AND MARIN BOULEVARD

All pedestrian and cyclist crashes from 2008–2012 have a brief crash narrative included in the diagram and are color-coded by severity. Pedestrian and cyclist crashes from 2008–2010 have gray icons. Additionally, any vehicle crash from 2010–2012 that has a severity of “moderate injury” or greater has a color-coded narrative.

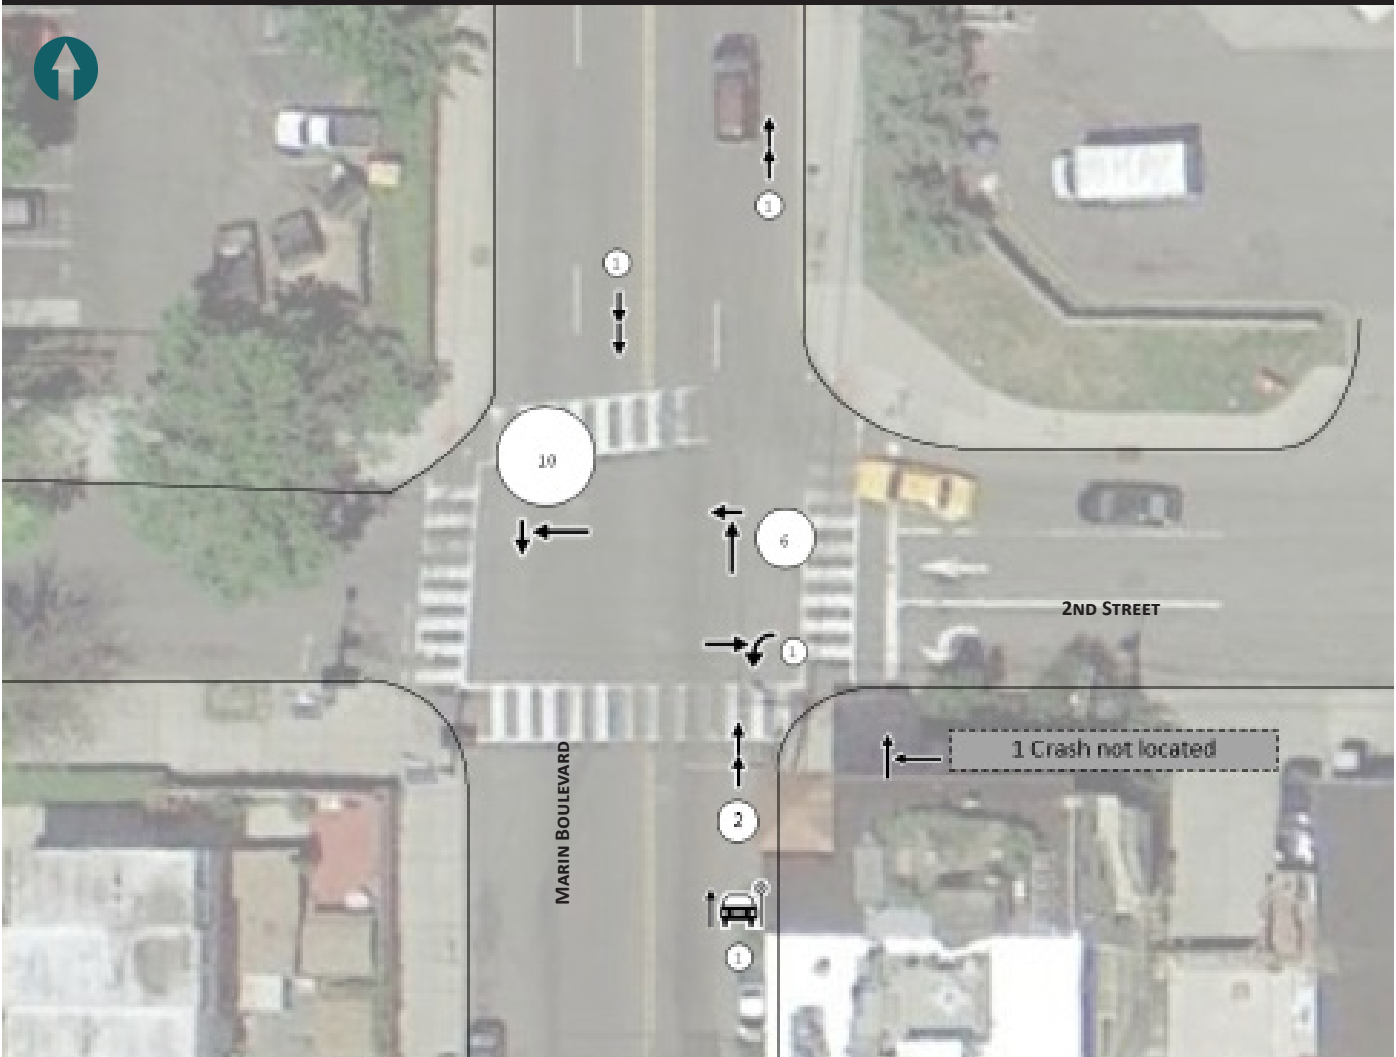
7.6 SECOND STREET AND MARIN BOULEVARD

All pedestrian and cyclist crashes from 2008–2012 have a brief crash narrative included in the diagram and are color-coded by severity. Pedestrian and cyclist crashes from 2008–2010 have gray icons. Additionally, any vehicle crash from 2010–2012 that has a severity of “moderate injury” or greater has a color-coded narrative.

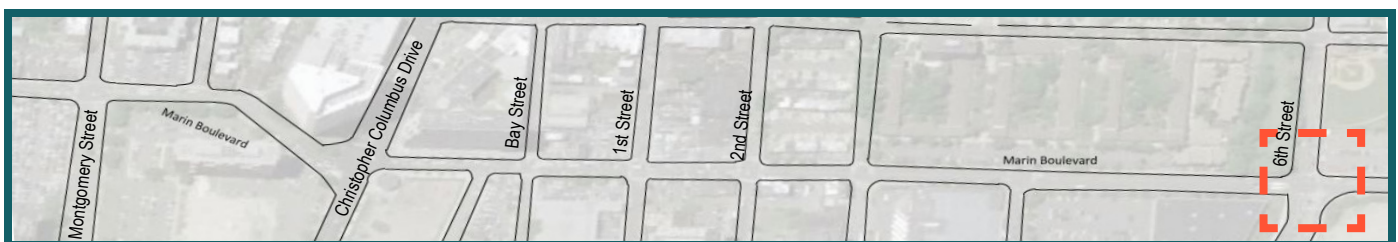
SIXTH STREET/TOMAS GANGEMI DRIVE AND MARIN BOULEVARD – CRASH SUMMARY (2010–2012)

Crash Type	#
Same Direction – Rear End	11
Same Direction – Side Swipe	3
Right Angle	5
Opposite Direction – Head On/Angular	-
Opposite Direction – Side Swipe	-
Struck Parked Vehicle	1
Left Turn / U-Turn	13
Backing	1
Encroachment	-
Overtuned	-
Fixed Object	-
Animal	-
Pedestrian	2
Pedalcyclist	1
Non-fixed Object	-
Rail Car–Vehicle	-
Other	-
Total	37
