CEDAR BRIDGE AVENUE

ROAD SAFETY AUDIT

Lakewood, Ocean County, New Jersey

REPORT

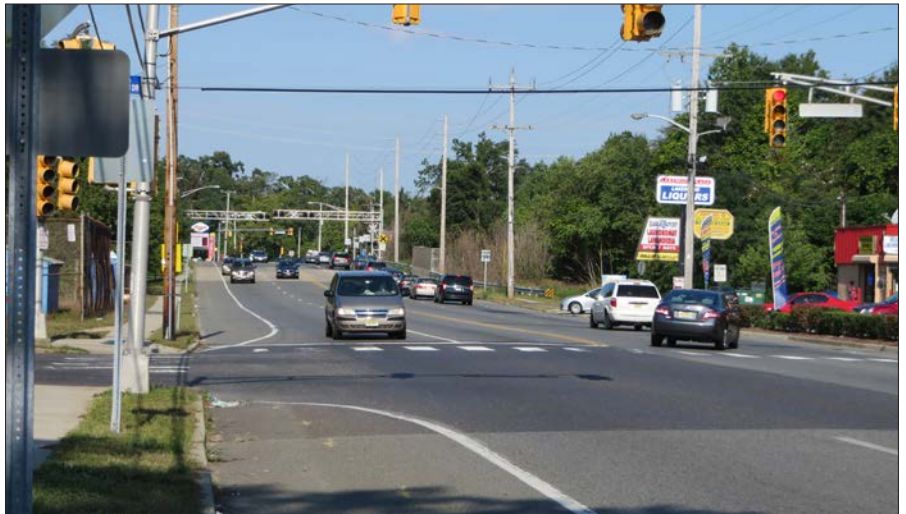
Figure 18 – Cross Section Western Side

The cross section in the area of Dr. Martin Luther King Drive has two lanes in each direction with shoulders. There are sidewalks on both sides of the roadway on Cedar Bridge Avenue.

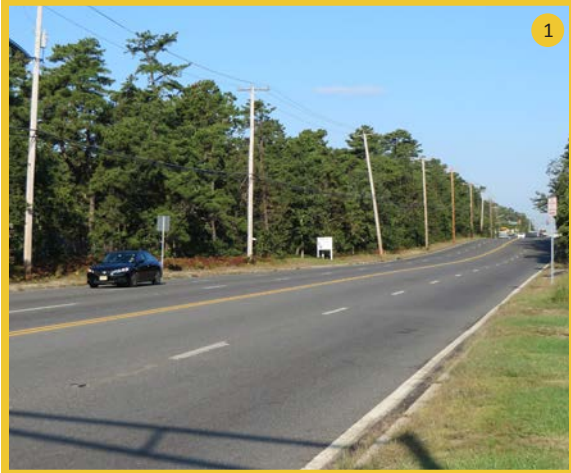
Wide cross section encourages speeding

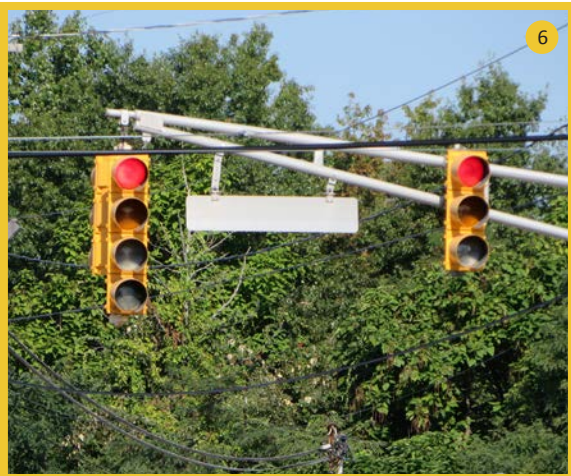
There are no retroreflective back plates

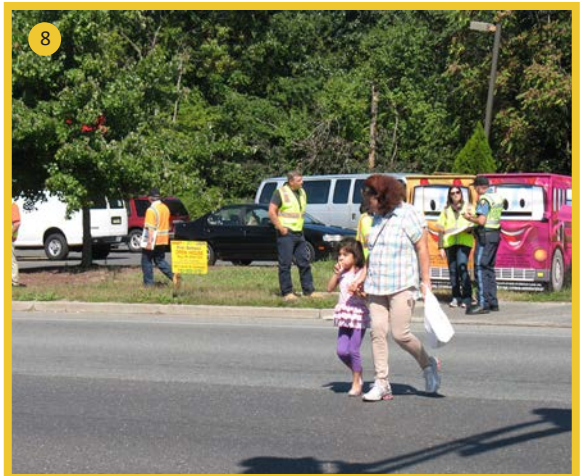
Pedestrians crossing midblock

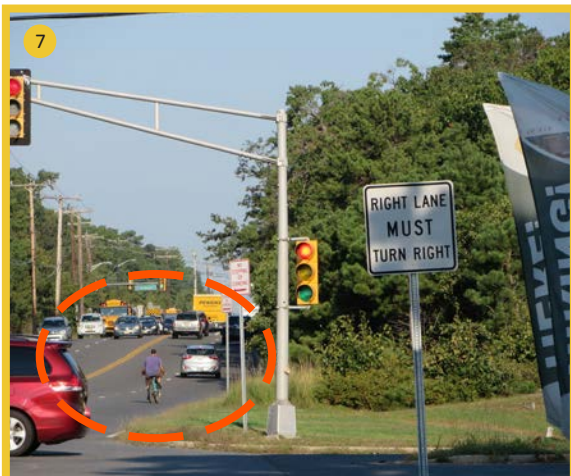
Bicycles in lane of traffic in area with no shoulders

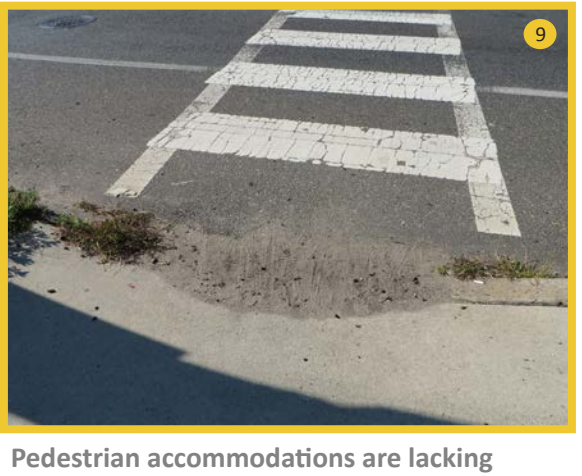
Pedestrian accommodations are lacking

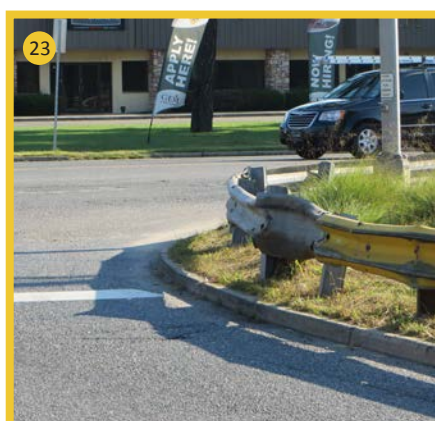
23 Damaged guiderail on southeast corner

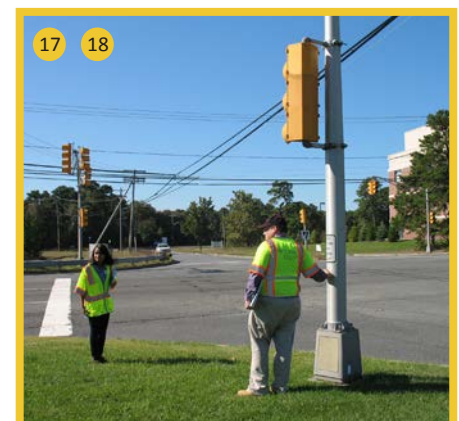
17 18 There are no pedestrian accommodations although there is a push button

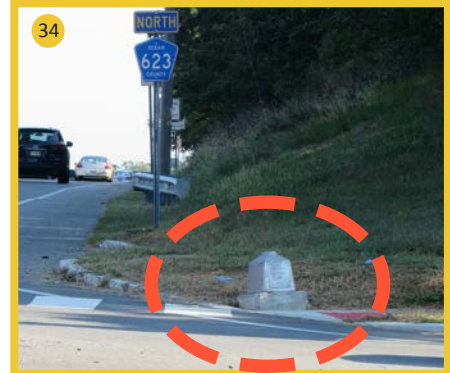
Pedestrian push button broken off from pedestal

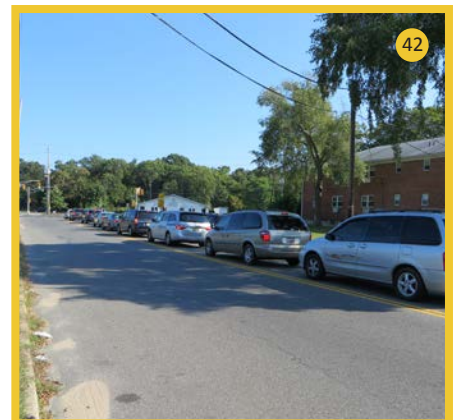
Dr. ML King Drive used as a bypass for regional congestion
