RSA facilitated by the Transportation Safety Resource Center (TSRC) at the Rutgers' Center for Advanced Infrastructure and Transportation (CAIT) in partnership with the North Jersey Transportation Planning Authority (NJTPA) and the City of Paterson with funding provided by FHWA and NJDOT

# WHAT IS A ROAD SAFETY AUDIT (RSA)?

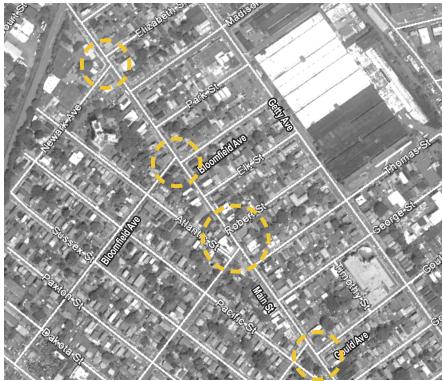
The cross-section on Main Street is primarily two lanes with additional width that is used for parking in many areas and turning lanes in others. According to the Straight Line Diagram, the width of Main Street is 39 feet. There is almost no delineation of the right edge of travel lane and there is minimal signage for parking and no pavement markings delineating approved parking spaces.

According to the Straight Line Diagram, the cross-section on Madison Avenue is 47 feet wide and Getty Avenue is 48 feet wide. There are two lanes in each direction.

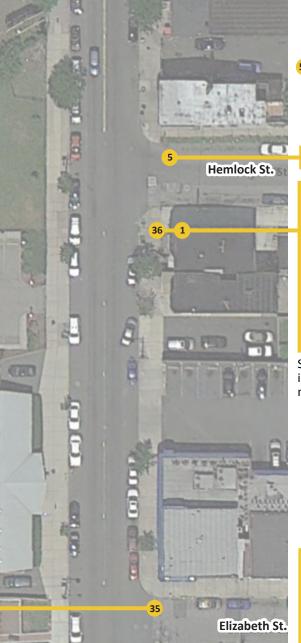
Hemlock Street is alleged to be used as a cut-through alternative to Madison Avenue

Missing stop bar

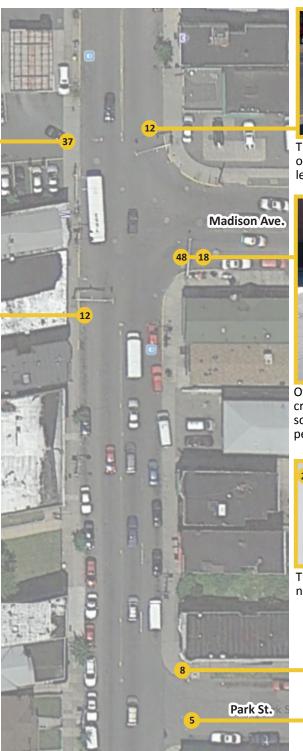
There are no northbound merge signs or pavement markings on the north leg.

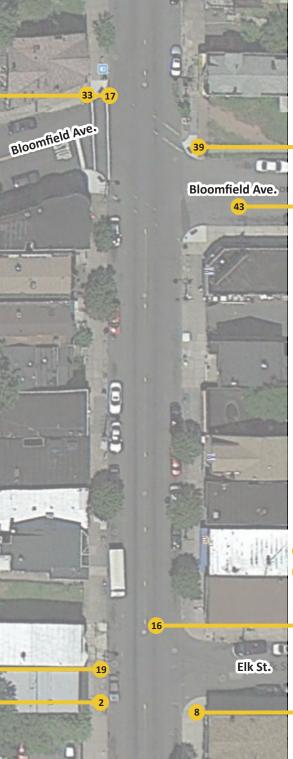
The ADA ramp on the northeast corner of Bloomfield Avenue is being used as a driveway to an illegal parking lot.

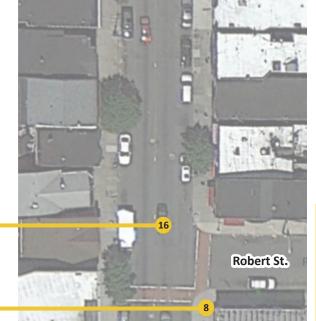
Missing marked crosswalk.

Lacking one-way signage.

Missing marked crosswalk across Main Street on north leg.

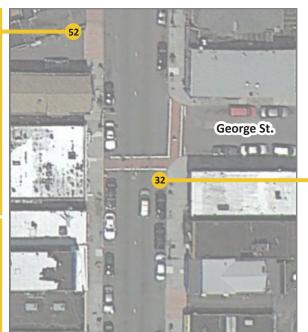
Bus sign is missing arrow that indicates stop location.

Cars were observed to be illegally parked within the skewed intersection of Gould Avenue & Main Street.

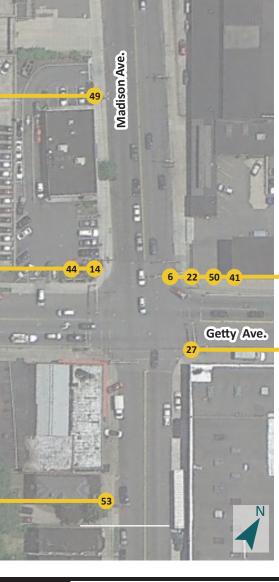
Street signs are not very visible, pavement markings are very worn, 8-inch signal heads have limited visibility and may contribute to Right Angle crashes.

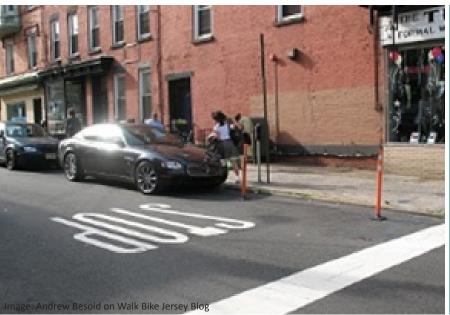
LEFT: Hoboken's use of plastic bollards prevents vehicles from parking at the intersection. The bollards are glued to the pavement with a simple apoxy and can be easily relocated if needed.

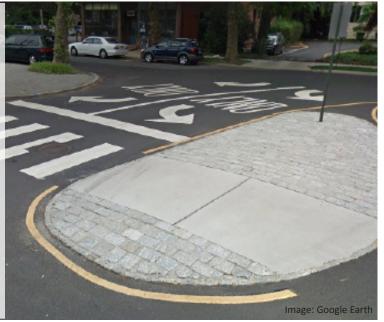
A commonly expressed concern with refuge islands is that they will impede emergency vehicles from full use of the center lane. One way to circumvent this concern is to consider the use of a mountable curb shown in the image at right in Princeton, New Jersey.

Pedestrian refuge islands are recognized by the FHWA as a proven safety countermeasure, reducing pedestrian crashes by 46 percent and motor vehicle crashes by up to 39 percent. They act as a visual barrier to slow traffic and help to alert drivers to the presence of a crosswalk. They may also provide a refuge for pedestrians who are not able to cross the entire length of the intersection in one movement.

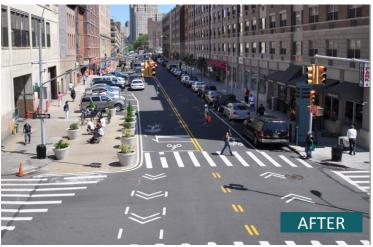
Painted bulb-outs or curb extensions, like those pictured above, are quick, inexpense way to provide safer pedestrian accommadations. They may also be augmented with land-scaping elemnts like planters, benches, bike racks, or garbage recepticles. Notice that the image above also features ergonomic crosswalks that reflect pedestrian desire lines, high visibility crosswalks, and a parking area that doesn't interject onto sidewalk space.

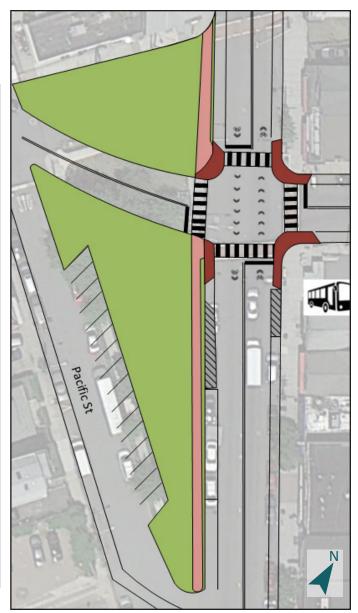
This is a conceptual sketch from the Paterson Department of Engineering. The proposed geometric modification will not only improve the traffic moving capacity and mobility through the intersection on Main Street, but provide safer street crossing for pedestrians, particular for school kids since it is a designated school crossing spot.

L-8	Investiage the feasability of revising the intersection geometry in order to have one four-legged intersection. [GEOMETRY]	High	Long	\$\$\$	Paterson City	33
	Corridor reco	mmenda	ations
