Walkable Community Workshop

Pedestrian Safety and Accessibility in Livingston Township, NJ

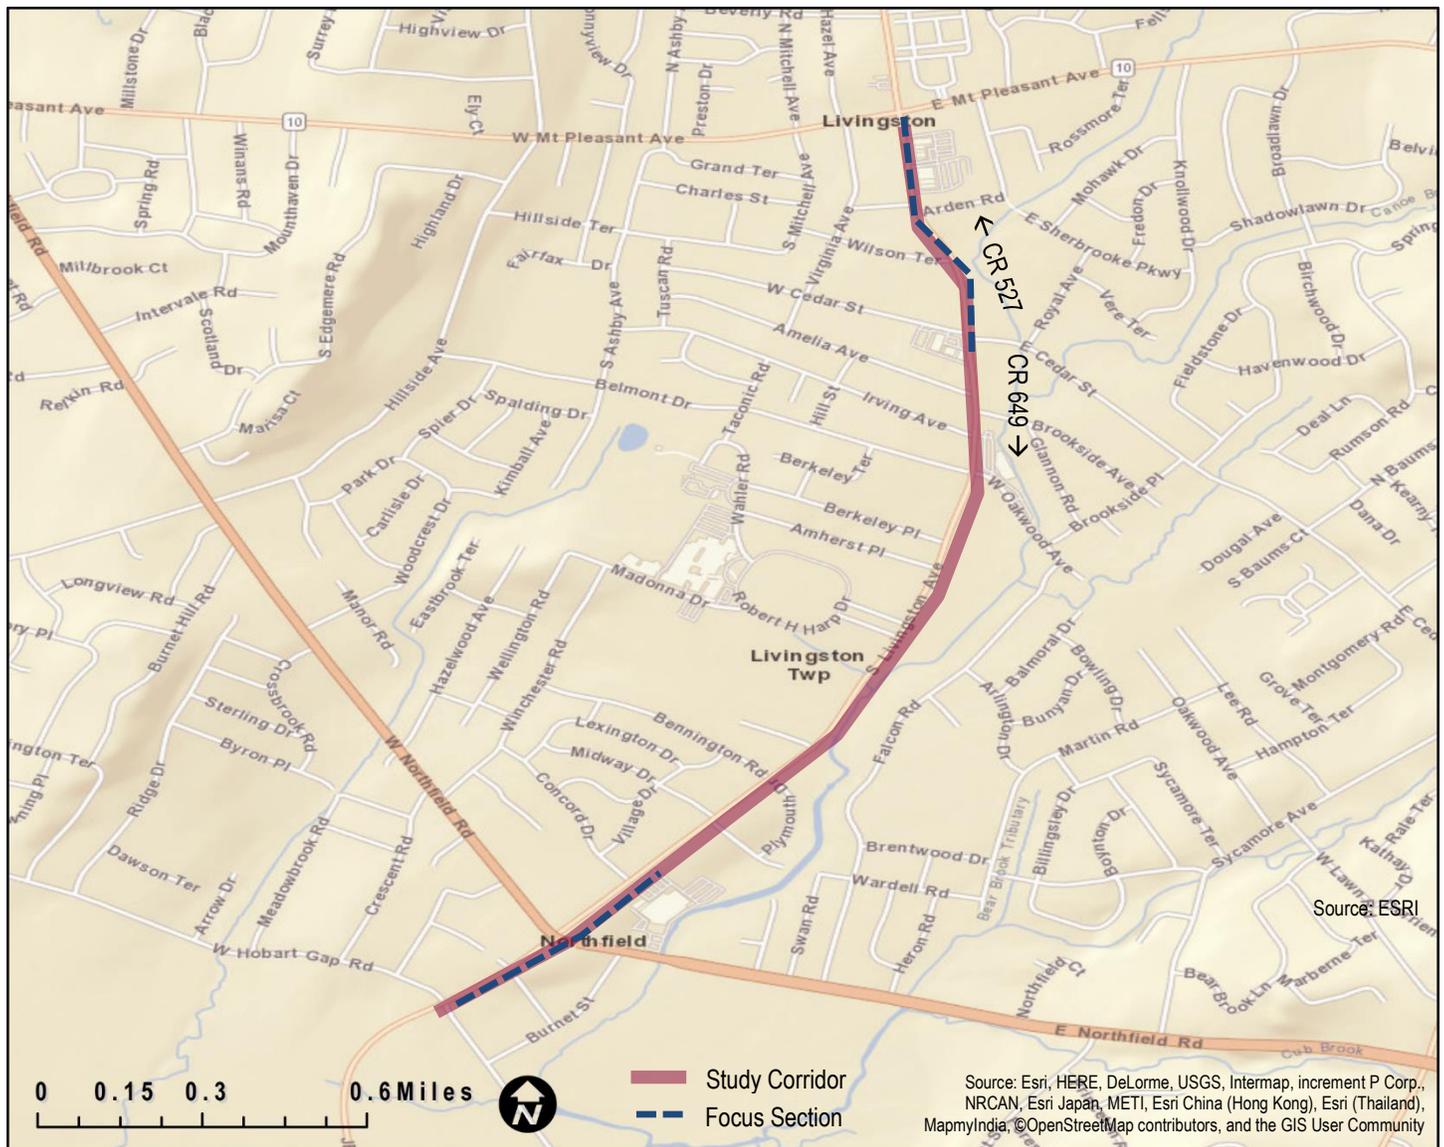
Figure 2: Aerial of the Workshop Neighborhood

The study corridor focused on two sections of Livingston Avenue, as shown in Figure 2. The Livingston Avenue corridor is composed of two county routes—CR 649 south of Cedar Street and CR 527 north of Cedar Street. The northern section of the corridor extended between Route 10/ Mt. Pleasant Avenue and Cedar Street. The southern section ran between a point just north of Concord Drive and West Hobart Gap Road/ CR 608.

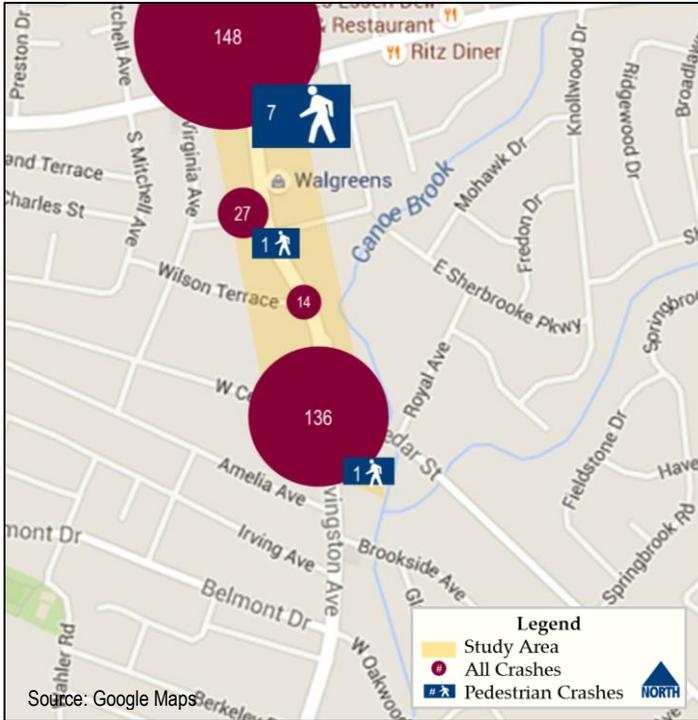
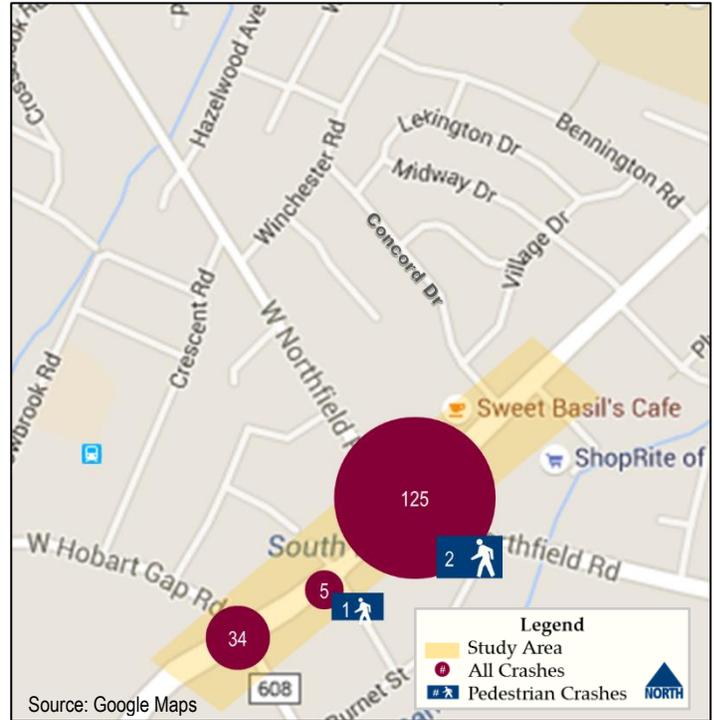
Figure 5: Pedestrian Crash Maps

An analysis of crash data from 2010-2014 using the Plan4Safety data analysis tool found that there were 12 pedestrian crashes resulting in injury within the two workshop focus sections. Figures 5 and 6 below show the location and discuss the characteristics of the pedestrian crashes.

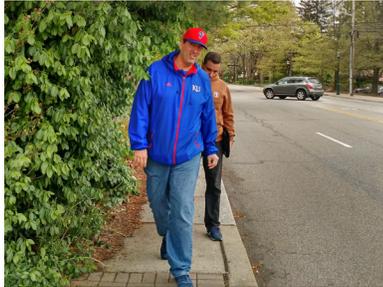
Overgrown foliage, lack of buffer between sidewalk and curb, and lack of shoulder force the pedestrian to walk uncomfortably close to the travel lane.

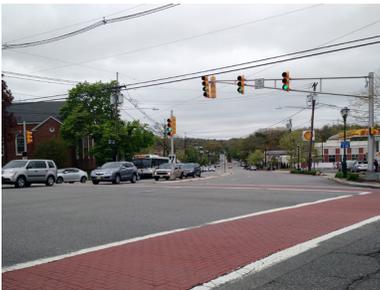
Turning radii on the east and west legs of the Northfield Avenue receiving lanes are exceedingly wide, making the crossing distance quite long for pedestrians.

- **Reduce receiving lane widths of Northfield Avenue's west and east legs via bulb-outs and painted edgelines to mark the parking lane.** A floating parking lane may serve as a traffic calming device to guide and keep drivers at the correct speed limit. These lane marking concepts are drawn in red in the diagram below (Figure 32). On the east leg, shifting the lanes slightly south provides space for a widened median, which can serve as a pedestrian refuge island if pedestrians are unable to cross the entirety of Northfield Avenue.

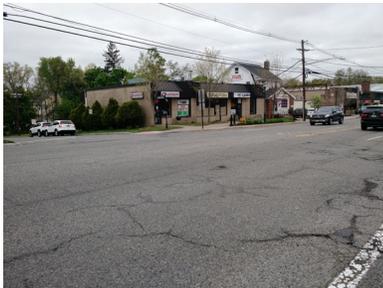
Between Northfield Avenue and Hobart Gap Road is one of several locations where there are few vehicle gaps big enough for pedestrians to cross Livingston Avenue and no marked crosswalks.

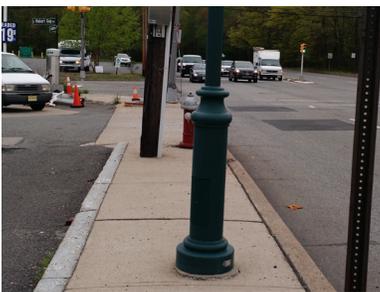
Pole foundations, light posts, and signage pose a potential tripping hazards in crosswalk.

- Remove tripping hazards (light foundations, pipe heads, bollard remains) and trim foliage.
- Remove debris such as sand and dirt from the sidewalks.
- Conduct a sidewalk inventory to identify areas where cross-slopes are too steep and make needed repairs (Figure 11).
- Support traffic calming measures such as road diets where appropriate to make for a more pedestrian-friendly environment (Figures 7 and 8). When properties develop, it may also be appropriate to create a more established buffer zone between the sidewalk and the travel lanes (Figures 15).

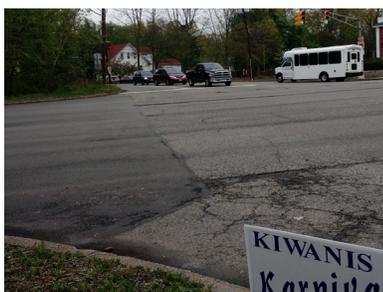
There are no pedestrian heads, and all legs of the Hobart Gap Road intersection (except the north leg) do not have marked crosswalks.

- Resolve maintenance issues and address pedestrian sidewalk obstructions (poles in sidewalk shown in Figure 38) at the northeast corner of CR 608.
- Install crosswalks (shown with red markings in Figure 36) and pedestrian heads at the CR 608 intersection.
- Narrow lane at west receiving lane of CR 608, shown with red markings in Figure 36.

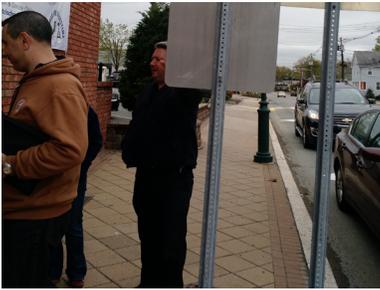
Truncated dome landing pads at the Route 10 intersection were loose or missing.

Vehicular signage is blocking pedestrian right of way on the southeast corner.

- Replace missing or damaged truncated domes.
- Remove vehicular signage located within the pedestrian right of way on the intersection's southeast corner.
- Delineate entry and exit driveways, and prohibit left-turns from the driveway southeast of Route 10.

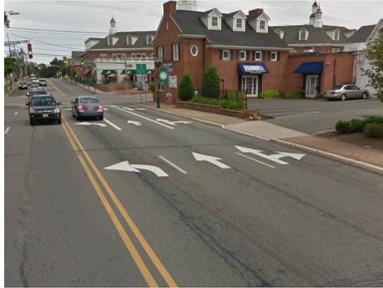
Northbound lanes approaching the Route 10 intersection shift slightly, leading to some driver confusion.

Because of constant turning traffic, it is difficult for drivers to exit the driveway located just southeast of the intersection.

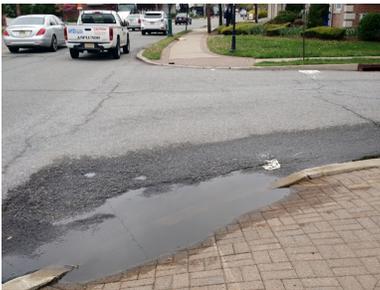
Standing water was observed and a faded crosswalk at Arden Road.

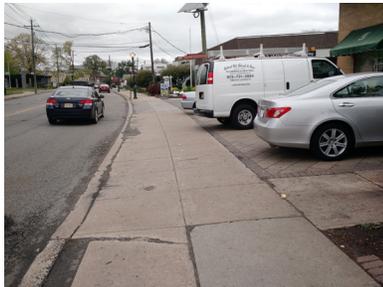
A lengthy depressed curb exposes pedestrians to vehicles backing up for a longer distance than a standard 24-foot driveway. Vehicles backing into the travel lane may also pose a safety concern for drivers.

- **Reduce wide driveway widths and radii to comply with the 24-foot width standard (using texturized paint, planters, bollards etc.).** In the future, ensure developers or property improvements comply with the recognized 24-foot standard and proper aprons. Images in the following pages show how the Seattle DOT resolved similar problems with wide roadways. Workshop participants noticed that some driveways appeared to be unnecessarily wide. For example, one driveway measured at approximately 37 feet wide, despite it being a single lane entrance-only. Another driveway measured 104 feet across and has no striping to identify access or egress points, allowing vehicles to enter and exit at any point along the driveway’s depressed curb. Long areas of depressed curb allow for more areas of potential vehicle-to-vehicle or vehicle-to-pedestrian conflict. A wider turning radii also means that a driver can make the turn at a higher rate of speed, which could lead to a more serious crash, especially if a pedestrian is hit. Reduced driveway widths shorten pedestrian crossing distance and better channelize vehicles entering or exiting.

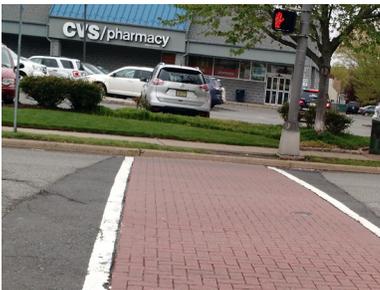
The pedestrian signal head on the northeast corner was located exceedingly high.

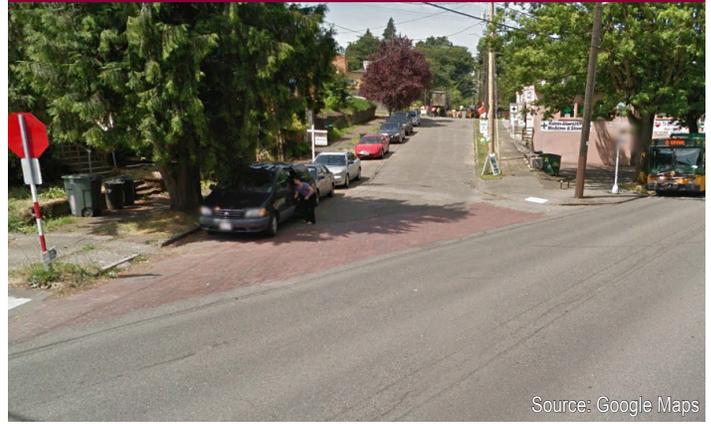
Figure 17: Before

The examples to the right (Figures 17 and 18) show how the city of Seattle has modified similarly wide roadways and reduced the pedestrian crossing distance using paint and bollards.

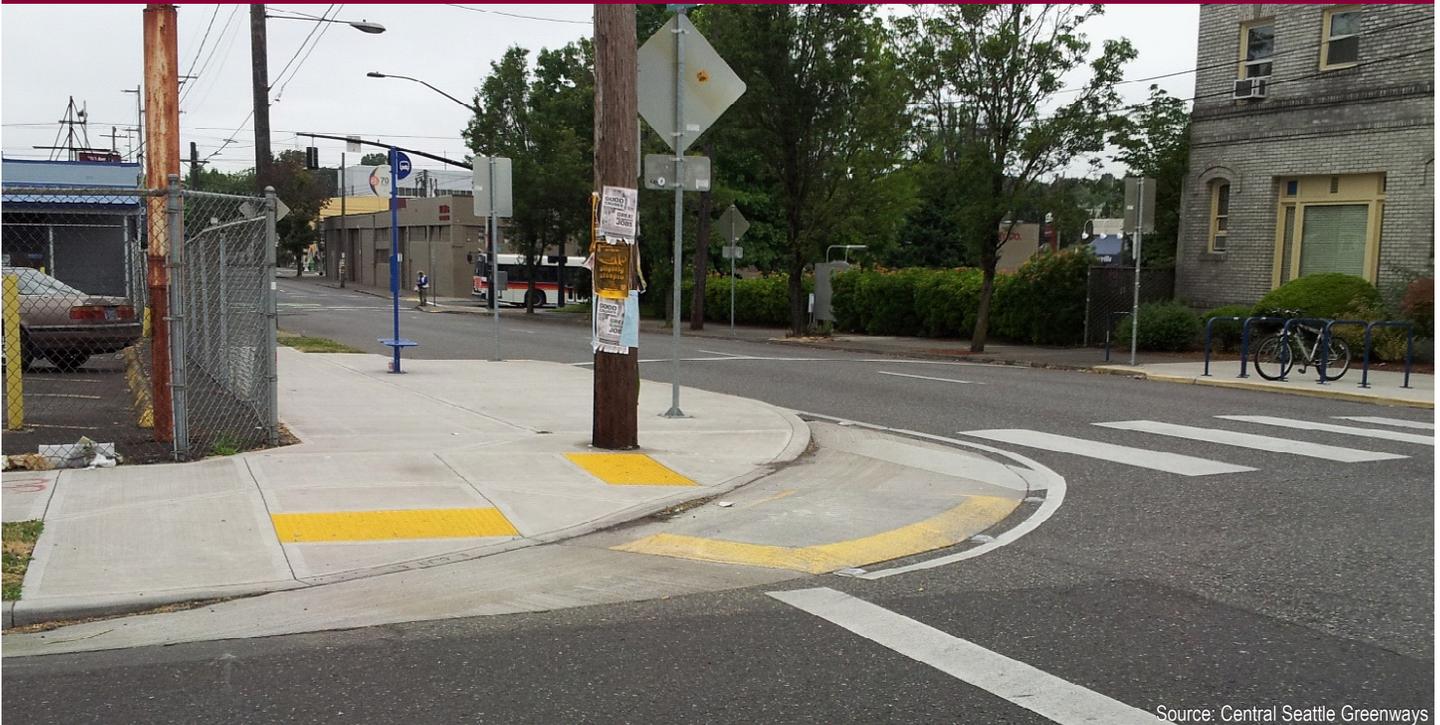
Figure 19: Mountable curb extension

The image below shows an extended mountable curb in Seattle that still allows for vehicles needing wider turning radii to traverse it.

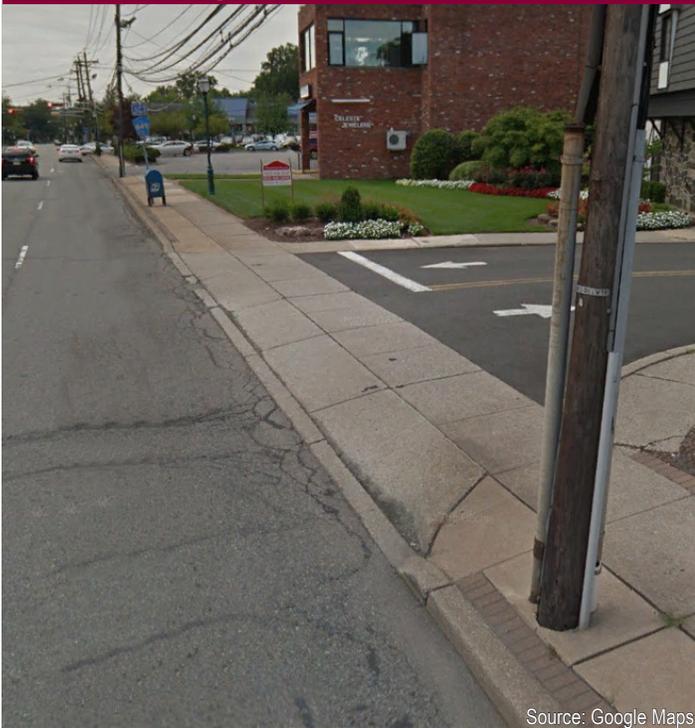
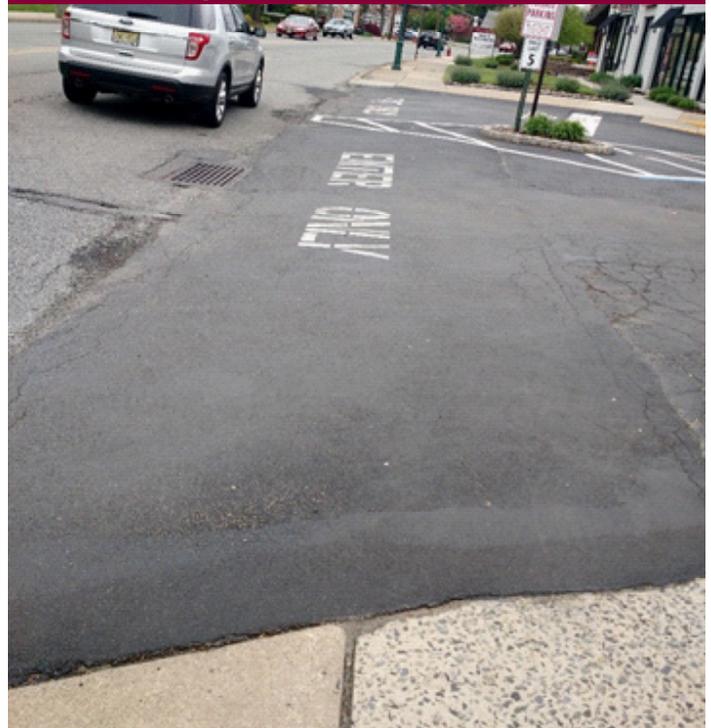
Figure 20: Sidewalk continued

Figure 21: Sidewalk not continued

The driveway on the left provides an example of a level, continuous sidewalk area, whereas the driveway on the right slopes toward the street and gives drivers no indication that they are entering the pedestrian realm.

- **Install sidewalks (or paint distinction) across driveways.** Having a sidewalk continue across a driveway alerts drivers that pedestrians have the right of way. Additionally, the sidewalk should have a maximum cross slope of 2 percent according to the Americans with Disabilities Act Accessibility Guidelines (ADAAG).

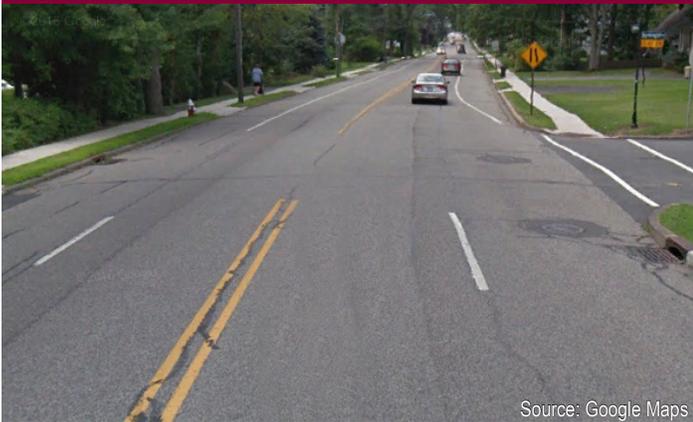
Figure 22: Livingston Avenue at Symington Avenue facing south

This photo depicts Livingston Avenue at Symington Avenue facing south. Though there's another lane merge sign slightly north, workshop participants noted that there are still many instances of aggressive driving at the merge point. Installing in-street pavement markings (such as "MERGE LEFT") may help guide drivers.

- Consider using in-lane markings to designate lane merge areas.

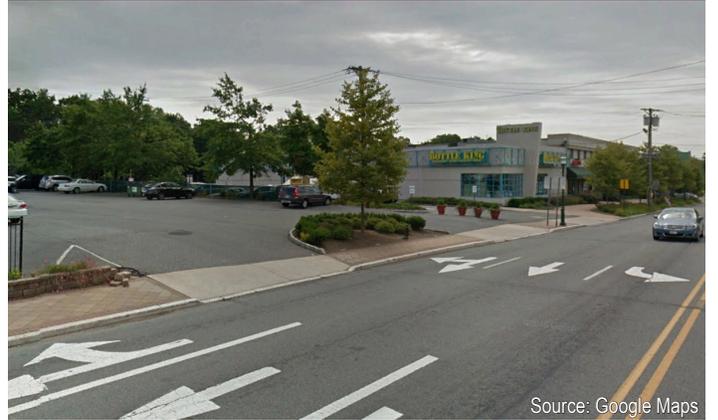
Figure 23: Driveways south of Route 10 and Livingston Avenue intersection

Removing one of the driveway entrances just south of Route 10 may help to limit conflicts with turning vehicles.

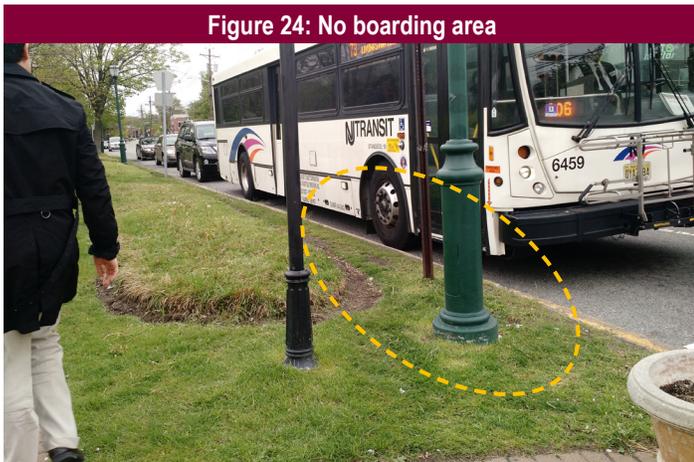
Figure 24: No boarding area

Currently, there is no passenger landing pad for the bus stop at the Cedar Avenue intersection (Figure 24). This is an issue especially important for wheelchair users. The National Association of City Transportation Officials (NACTO) Transit Street Design Guide recommends a passenger landing pad (boarding area) measuring 5 feet long by 8 feet wide (Figure 26). The bus stop located on the southeast corner of Route 10 and Livingston Avenue (Figure 25) illustrates a good-sized boarding area.

- Install missing curb ramp at southwest corner.
- Create a landing area that connects to the sidewalk for the bus stop at southeast corner.
- Lower the pedestrian head on the northeast corner to an appropriate height (Figure 27).

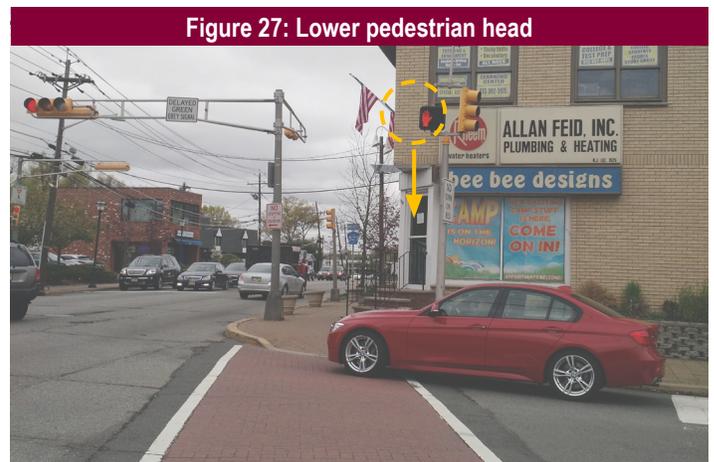
Figure 27: Lower pedestrian head

The pedestrian head at the northeast corner could be vertically lowered.

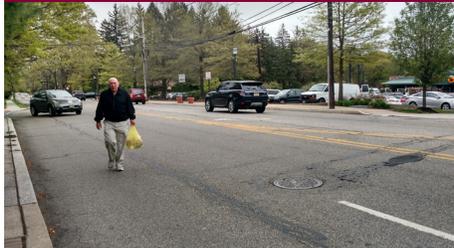
Figure 30: Crossing from ShopRite area

Currently, pedestrians can follow a sidewalk along the south edge of the ShopRite parking lot and cross Livingston Avenue just south of Concord Drive, as shown above. Installing a median refuge allows pedestrians to more safely pause halfway through crossing larger streets.

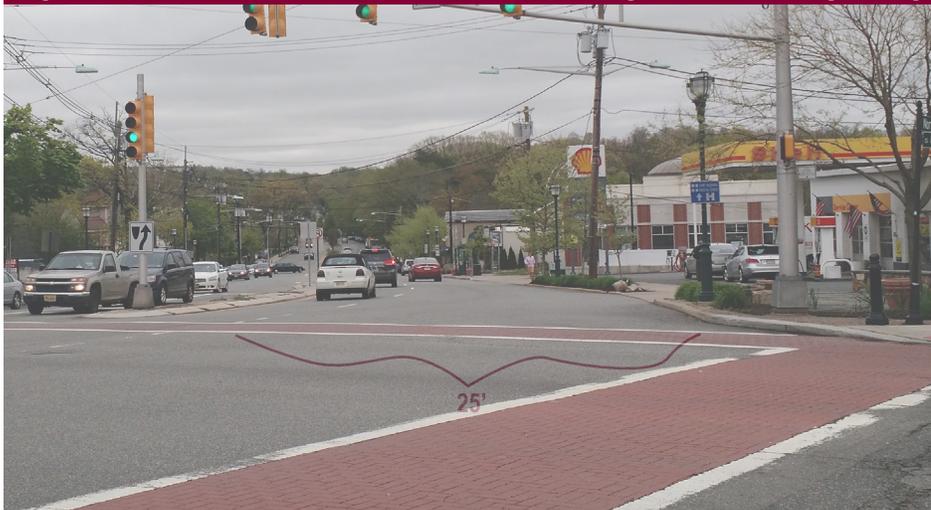
Figure 33: At the intersection of Northfield Avenue and Livingston Avenue, facing east leg

One of the eastbound receiving lanes of Northfield Avenue (Figure 33) is exceedingly wide, at about 25 feet across.

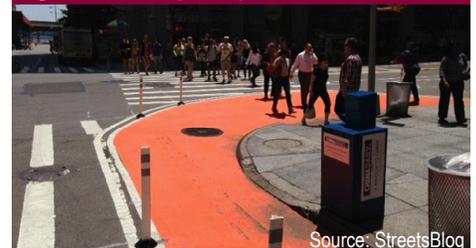
Figure 34: Example of painted curb extension

The image above (Figure 34) shows a low-cost curb extension created with textured paint and plastic bollards.

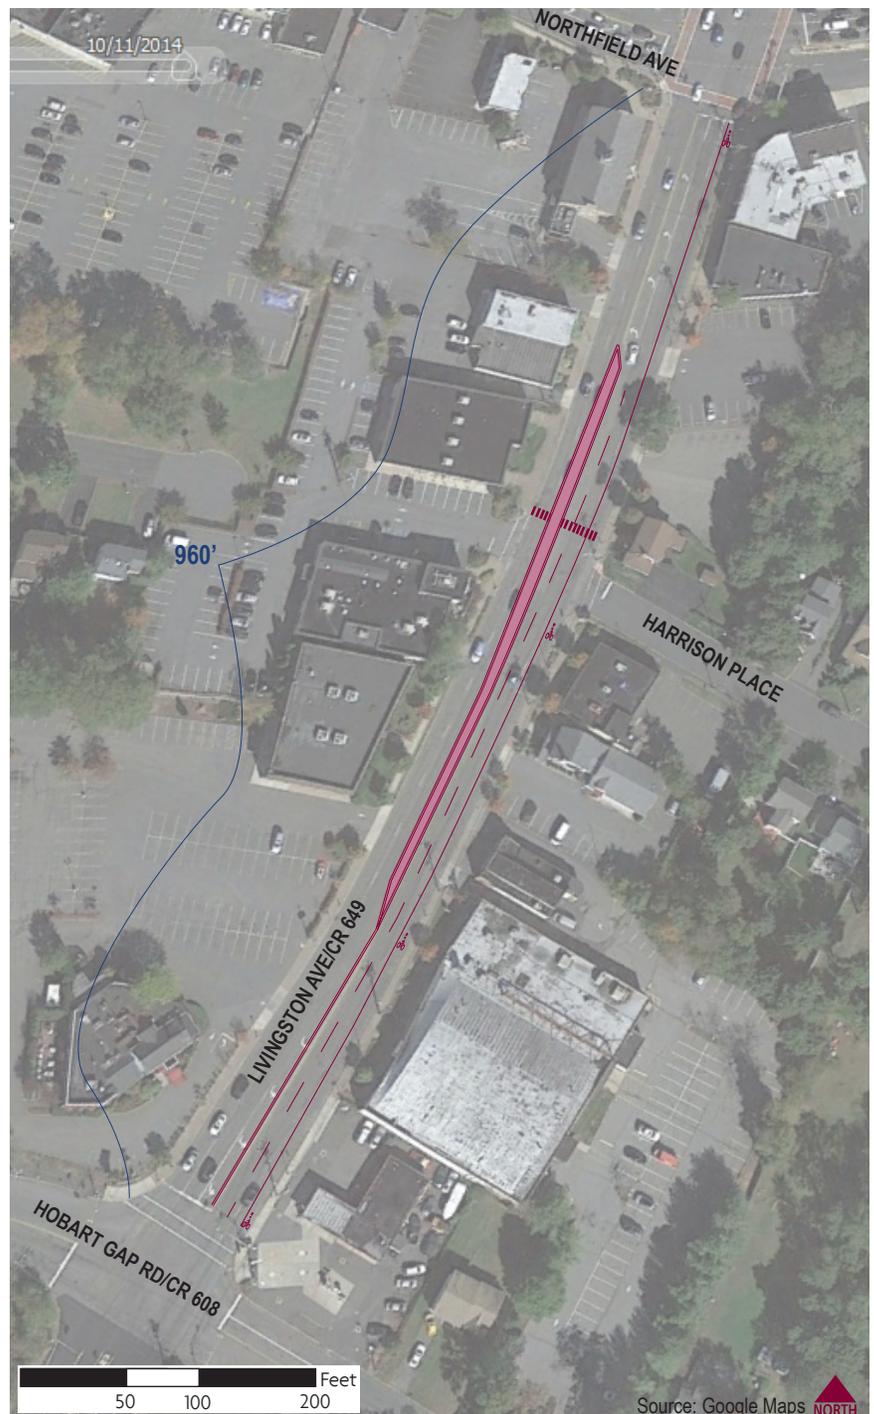
Figure 35: Livingston Avenue in the vicinity of Harrison Place

Closing off Harrison Place will allow for the greater continuation of a median. Using some of the excess pavement width to install a bike lane would be the first step in creating a marked cyclist network.

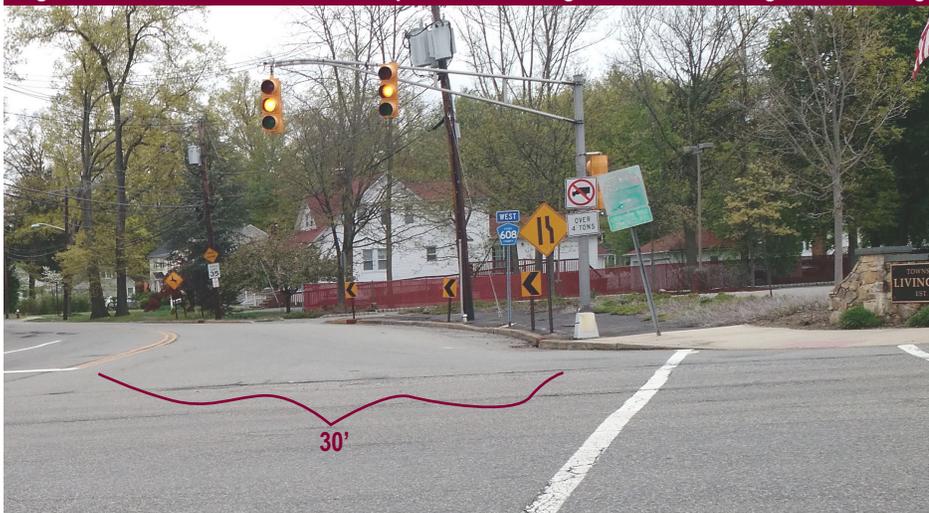
Figure 37: At Intersection of Hobart Gap Road and Livingston Avenue, Facing Northwest Leg

The receiving lane on the northwest side is quite large (30 feet) with no lane markings to indicate separate lanes or a lane drop. A bike lane and painted edgelines would channelize vehicles and calm traffic.
