# Randolph Township Walkable Community Workshop

*Pedestrian Safety and Accessibility at the Intersection of Center Grove Road and Route 10*

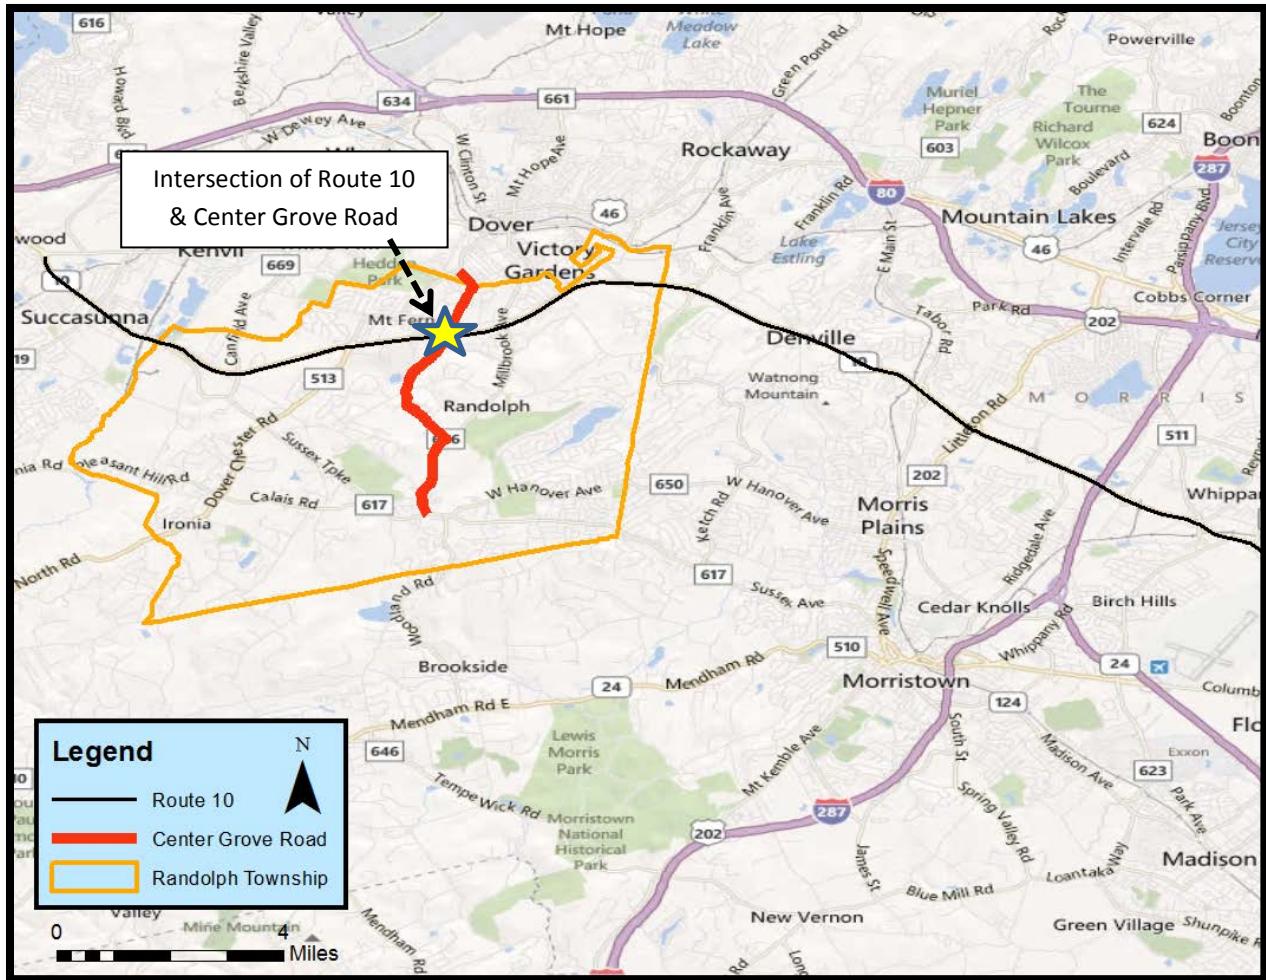
**Figure 1: Randolph Township and Local Roadway Network**

Initiated by the County of Morris and Randolph Township, a Walkable Community Workshop was held in Randolph Township on April 26, 2012, to assess pedestrian safety at the intersection of Center Grove Road and Route 10 (**Figure 1**). Center Grove Road is a county road also identified as County Route 670. Route 10 is a state roadway. This intersection accommodates high speed vehicular movement. Route 10 has a posted speed limit of 50 mph, while Center Grove Road's posted speed limit is 40 mph. Pedestrian safety is a major concern along high speed corridors such as Route 10 since there is a greater probability of pedestrian injury and fatality with higher vehicular speeds. In January 2010, a 17-year-old Randolph High School student was struck and killed at the intersection of Center Grove Road and Route 10 while walking home from her shift at the Randolph Diner. Two additional pedestrian injuries occurred at the intersection between 2006 and 2011. (Additional information on pedestrian crashes at this intersection can be found on page 17.)

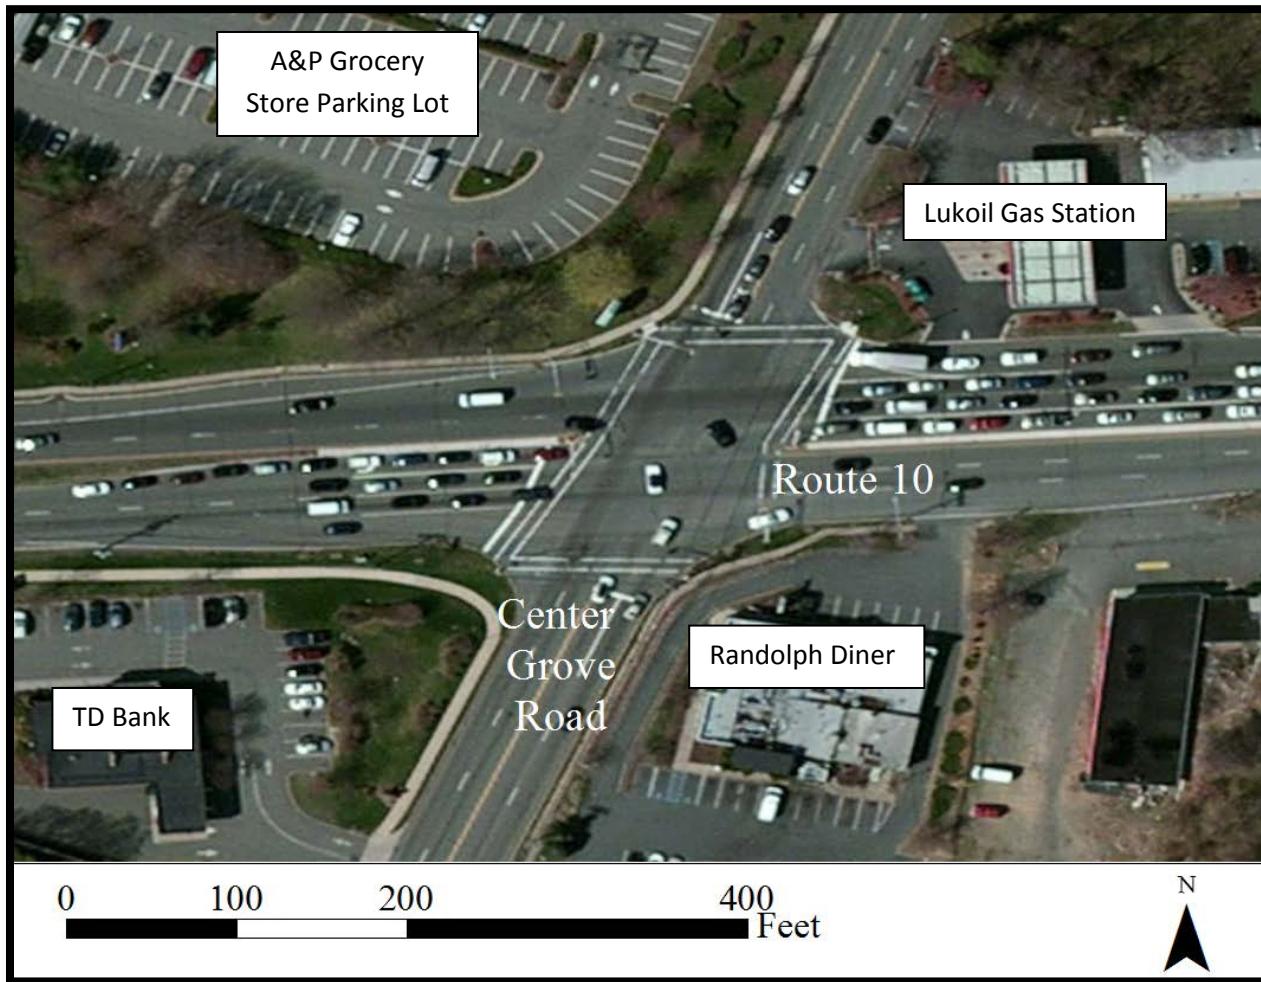
**Figure 2: Aerial View of the Intersection of Center Grove Road and Route 10**

In addition to addressing safety, the Workshop also incorporates the New Jersey Department of Transportation's Complete Streets Policy which seeks to accommodate roadways users of all ages and abilities, including bicyclists, pedestrians, and transit riders. Walkable communities are essential for ensuring the public's health, advancing multi-modal networks, fostering economic development, and improving air quality through a reduction in greenhouse gas emissions produced by vehicles. Within a half mile of the intersection of Center Grove Road and Route 10 there are several apartment complexes, many single-family homes, medical facilities, numerous retail establishments and offices, a "super" A&P grocery store, and the County College of Morris, all of which generate significant motor vehicle traffic. In addition, a gas station, bank, and diner are located at the intersection's corners as shown in **Figure 2**.

Following the presentation, attendees conducted a walking audit of the intersection (**Figure 2**) to identify impediments to pedestrian safety. Particular attention was paid to the ease at which pedestrians were able to cross the intersection, the availability of

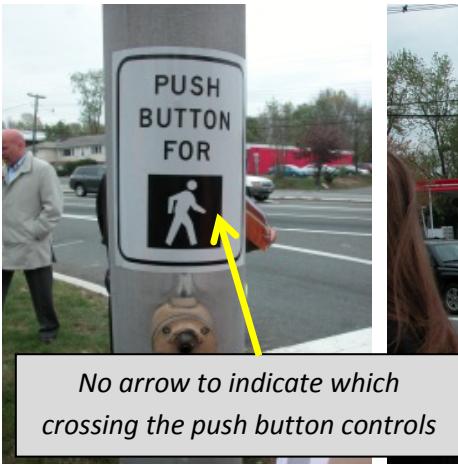
*No arrow to indicate which crossing the push button controls*

- **Install pedestrian countdown signal heads** with fixed signals, LED push button assemblies, and R10-3e plaques with supplemental information (in English and Spanish) that direct the pedestrian, via an arrow, to the push button that controls the crosswalk they are attempting to use. The countdown signal heads let pedestrians know how much time they have to cross and provide a visual cue to drivers making turning movements to stop (as mandated by law) for pedestrians in the crosswalk.

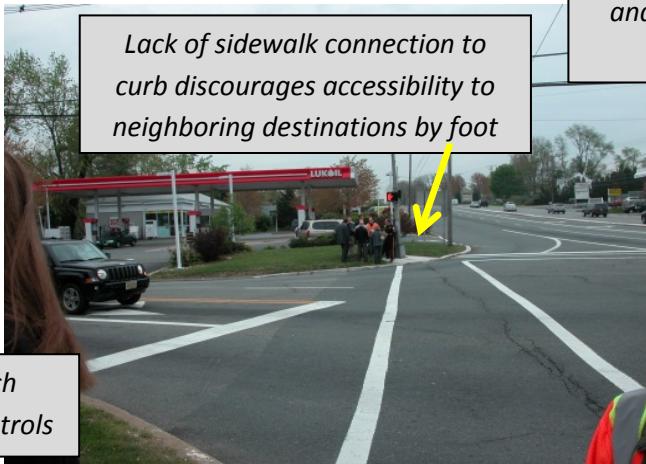
*Lack of sidewalk connection to curb discourages accessibility to neighboring destinations by foot*

*Lack of an ADA compliant truncated dome inhibits easy maneuver into and out of the intersection with a stroller or wheelchair*

- **Install ADA compliant curb ramps** with detectable warning surfaces and a slope of less than 2%. This allows a pedestrian pushing a stroller, toting luggage, or traveling via wheelchair to more easily maneuver into and out of the intersection. *Estimated material cost per curb ramp: \$800-\$1,500*
- **Provide sidewalks** in close proximity to the intersection with a connection to surrounding land uses. There is currently no sidewalk connectivity east of the intersection on both sides of Route 10. The Federal Highway Administration recommends sidewalks that are at least 5-feet wide and not obstructed by trees or sign posts. If there is sufficient space, provide a buffer (i.e., landscaping, trees) between pedestrians and motorists. *Estimated material cost for walkway: \$72/square yard*

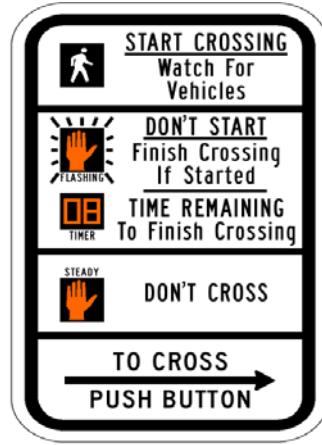
Sign image from the Manual of Traffic Signs <<http://www.trafficsign.us/>>  
This sign image copyright Richard C. Moseur. All rights reserved.

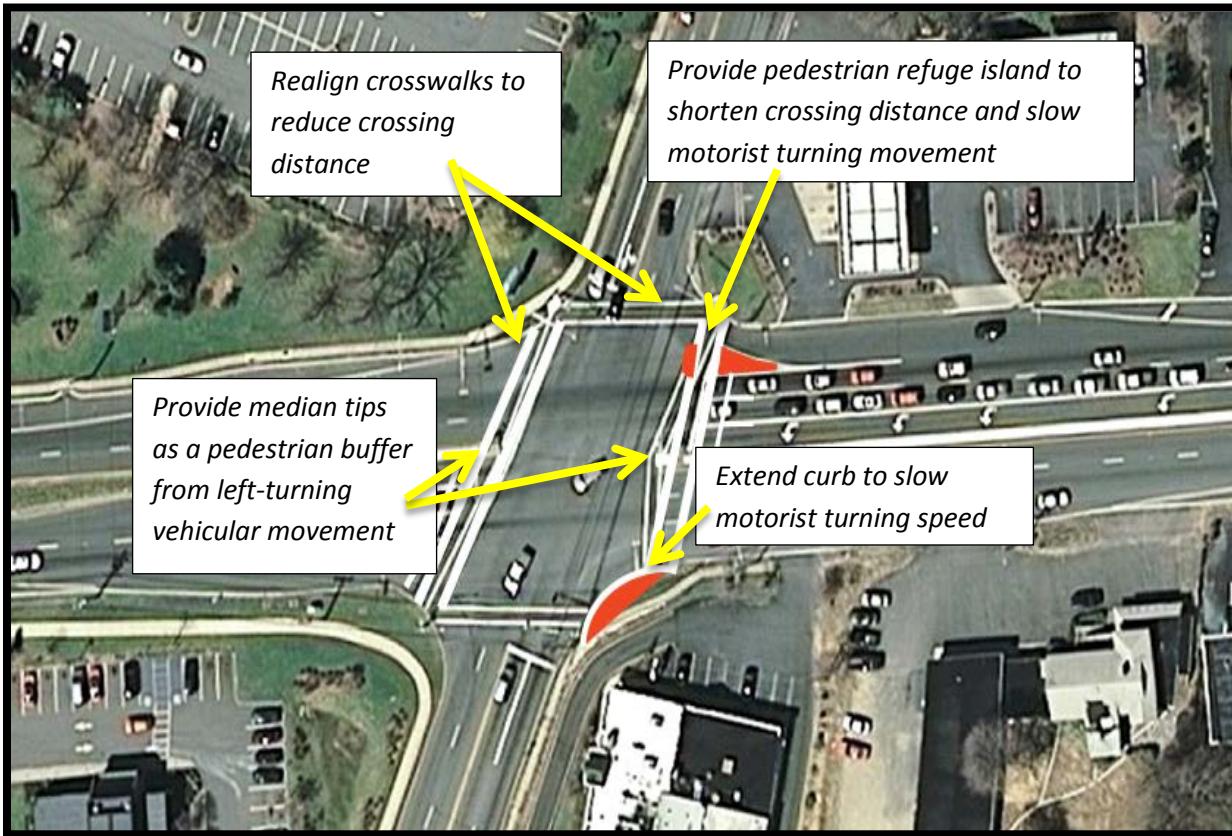
**Figure 3: Reconfiguration of the Intersection of Center Grove Road and Route 10**

- **Extend median tips** to protect pedestrian in the crosswalk and provide a greater sense of “safety” when motorists are making turning movements as shown in **Figure 3** (below).

- **Reconfigure the pedestrian crosswalks** to shorten crossing distance as shown in **Figure 3** (below). *Estimated material cost per crosswalk leg: \$600*

- **Extend the curb and reduce vehicle turning radii** so that motorists are encouraged to reduce the speed of their turning movements as shown in **Figure 3** (below). Extending the intersection curb can help decrease the number of pedestrian crashes by reducing the speed of turning vehicles and allow pedestrians to see and be seen. It also shortens the crosswalk so pedestrians spend less time in the street and minimizes their risk exposure. Typically, in new construction the turning radius is approximately 15 feet for a passenger vehicle where the street has sufficient space to retain the curb lane. For arterial streets, the turning radius increases to 30 feet to accommodate truck volume which require a wider turning radius than cars.<sup>2</sup> *Estimated material cost per corner: \$2,000-\$20,000 depending on design and site conditions*
