FINAL REPORT

Somerset County Roadway Safety Study

December 2021

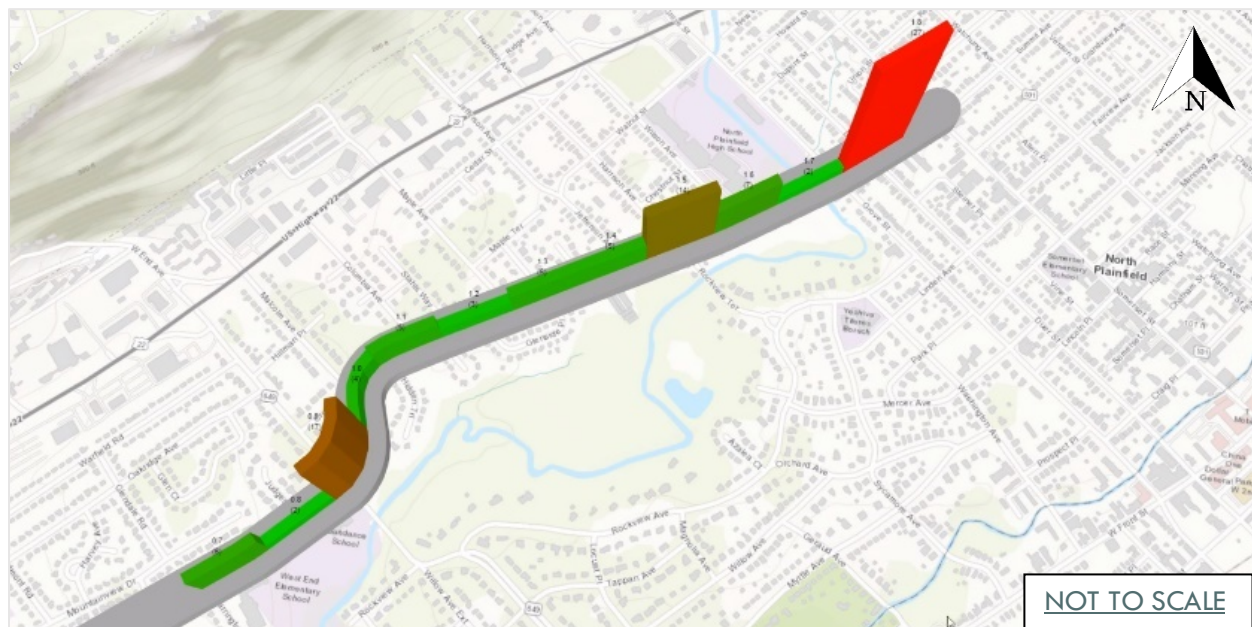
Figure 5 - NJDOT Safety Voyager - Sample Crash Data (Greenbrook Road, North Plainfield Borough)

This analysis evaluated crash attributes such as crash type and severity as a percentage of the total crashes to achieve a more robust understanding of the locations compared to the crash activity on the County roadway system. The project team then mapped all crashes along the segments onto collision diagrams, which can be found in Appendix D, providing a quick spatial overview of crash clustering patterns.

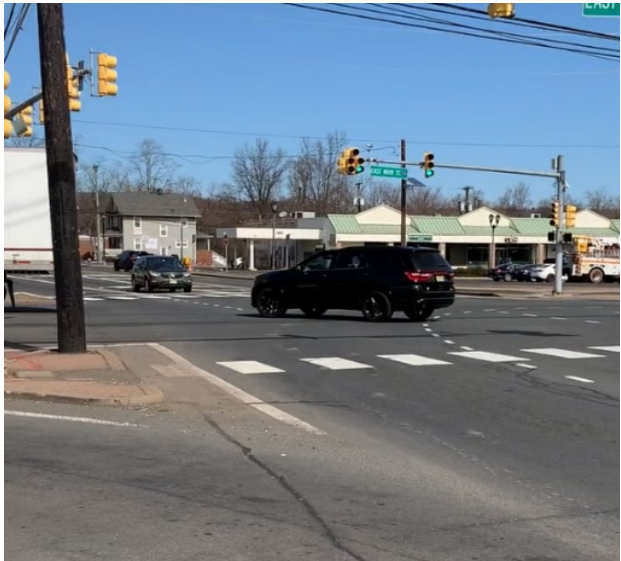
Figure 16 - Field Observations and Identified Needs, Main Street/Finderne Avenue

Close calls between northbound permissive left and southbound through traffic at Finderne Avenue & Main Street intersection

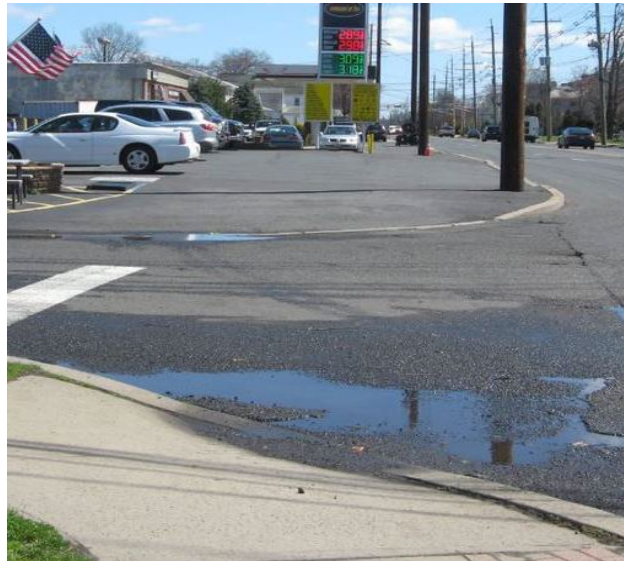
Sidewalk on north side of Main Street often interrupted by wide asphalt curb cuts and parked/standing vehicles

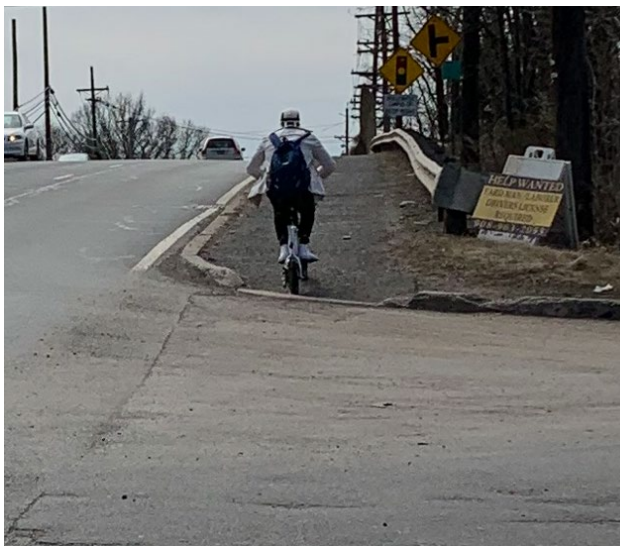
Cycling on Finderne Avenue restricted to narrow multiuse path over bridge with minimal delineation from travel lanes

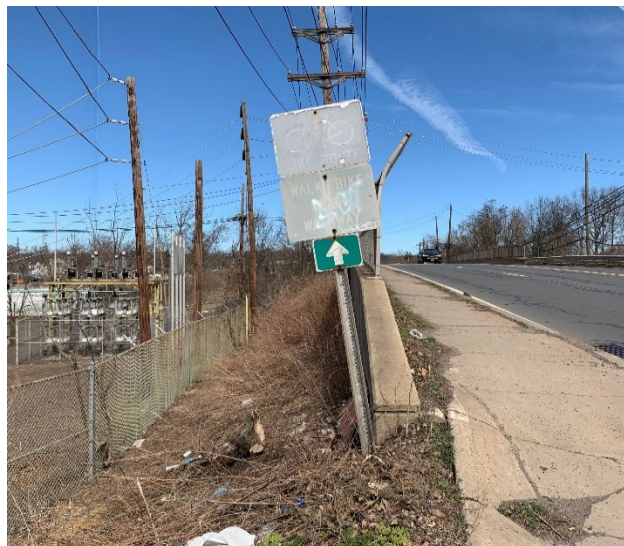
Heavily used cycling route lacking updated wayfinding to connect local communities

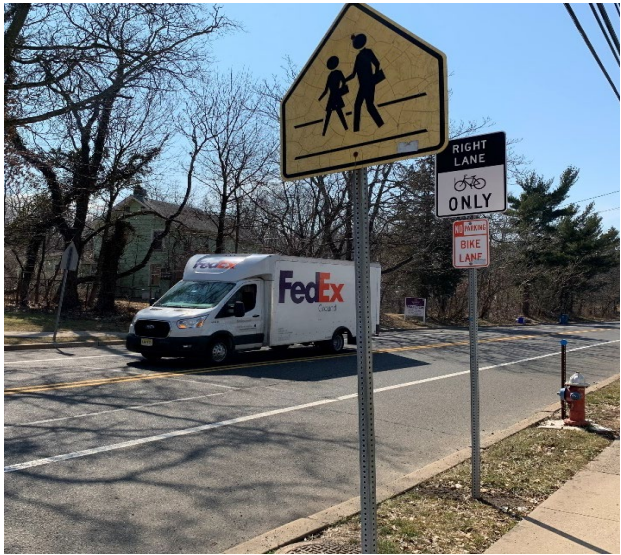
Figure 18 - Field Observations and Identified Needs, Franklin Boulevard

School signage to be upgraded; bike lane not adequately striped

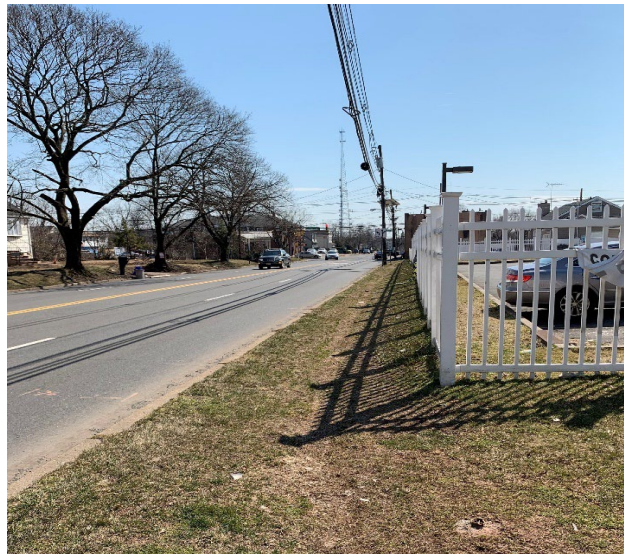
Gap in sidewalk connectivity between Fuller Street and Somerset Street

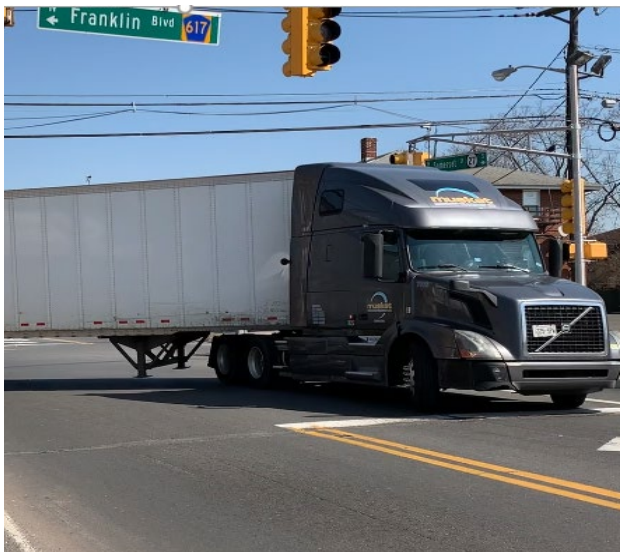
Heavy vehicles encroaching onto Somerset Street left turn lane onto Franklin Boulevard

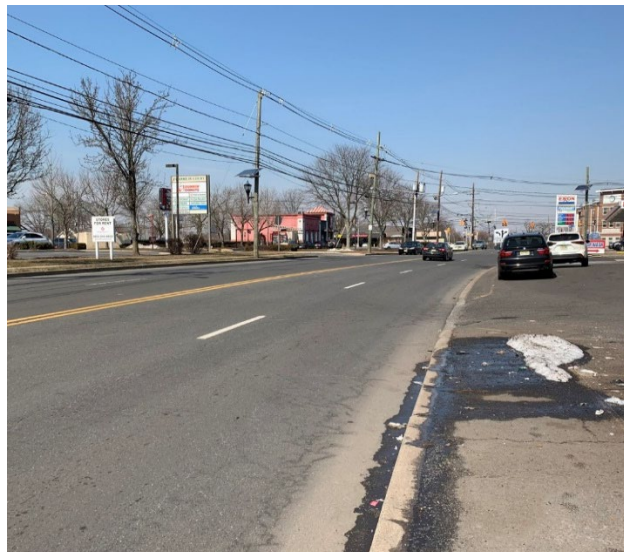
Sidewalk interrupted by wide curb cuts and vehicles encroaching on pedestrian paths

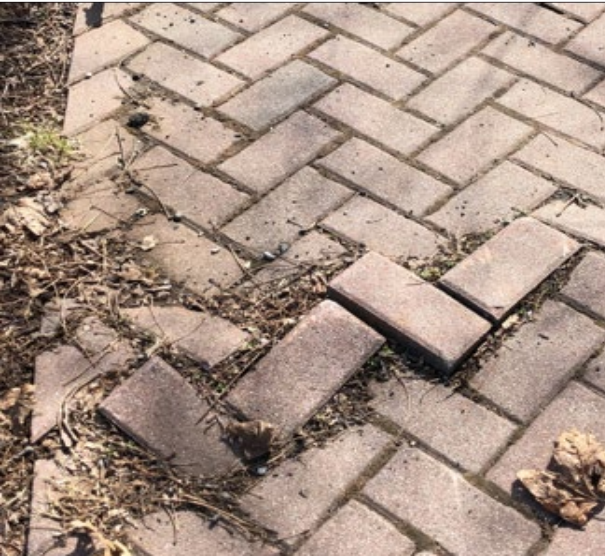
Figure 20 - Field Observations and Identified Needs, Millstone Borough

Brick paver sidewalks need to be reset and repaired along corridor

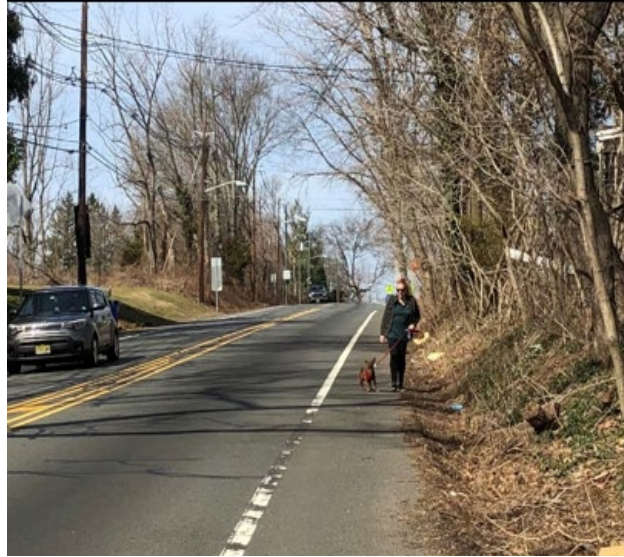
Gaps in pedestrian connectivity and pavement drop-offs on side of road

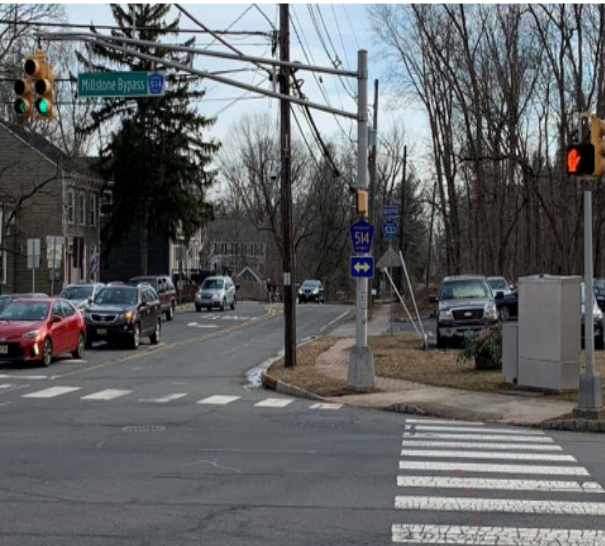
Signal at Amwell Road & Main Street lacks pedestrian countdown signal heads

Recommendations along the Main Street corridor include implementing Leading Pedestrian Intervals (LPI), which stop traffic to give pedestrians a head start, at crossings where no conflicting left-turn phasing exists to improve pedestrian safety. Other improvements include installing wayfinding to increase the visibility of historic sites within the neighborhood, implementing curb extensions at the County Route 650 intersection, and shoring up eroded pavement drop-off areas with a Safety Edge treatment, which shapes the edge of the pavement to 30 degrees instead of a vertical drop-off. Research has shown this is the optimal angle to allow drivers to re-enter the roadway safely,

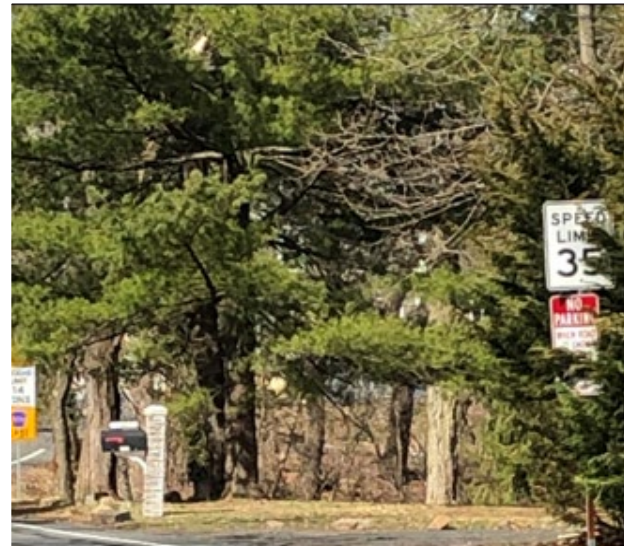
Branches obstructing signage along Main Street

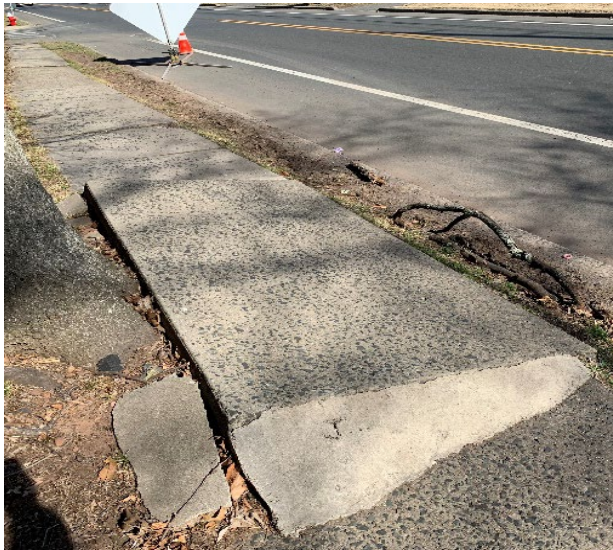
Figure 22 - Field Observations and Identified Needs, Greenbrook Road

Severe sidewalk heaving at locations with mature trees

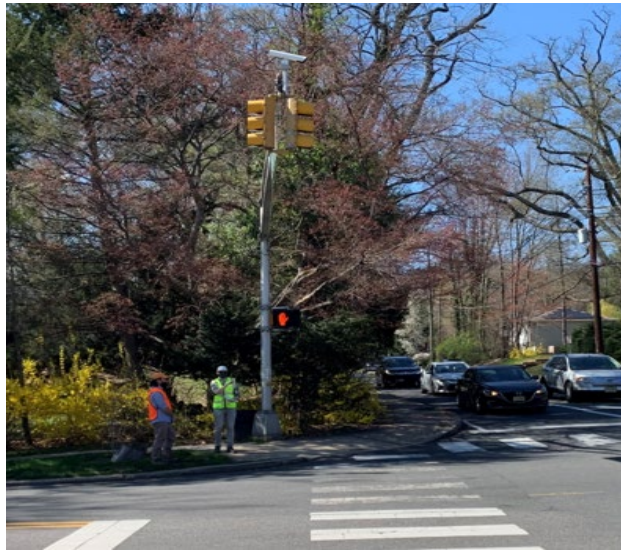
Branches and foliage at the northwest corner of West End Avenue intersection impairing motorists sight distance should be trimmed back

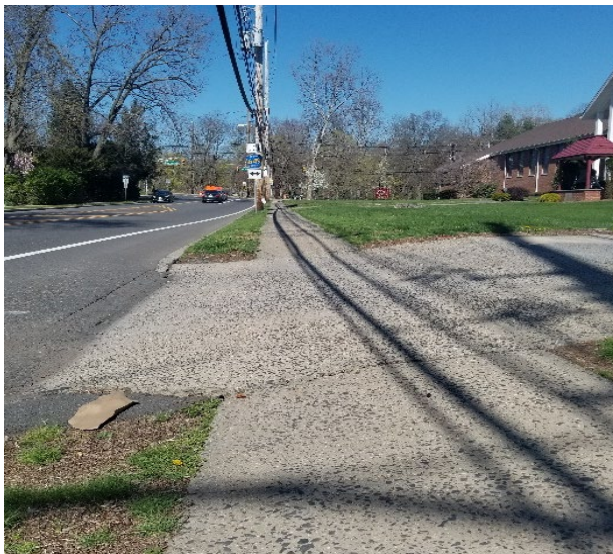
Steep driveway pitch that slopes toward street near Judges Lane

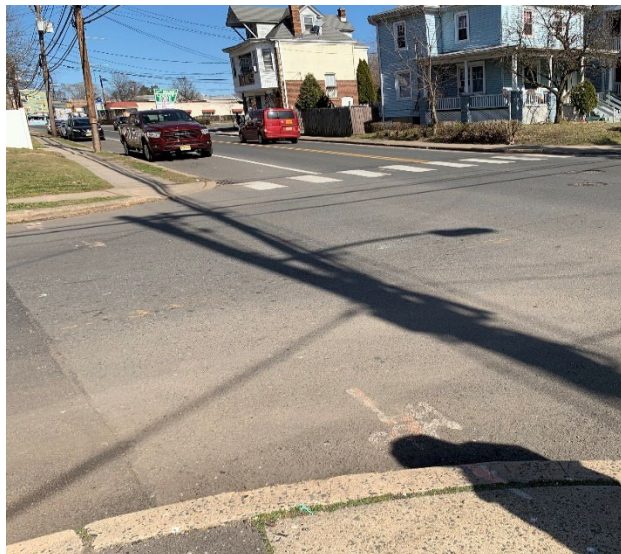
Parked vehicles block motorists' sight line to pedestrians at Duer Street

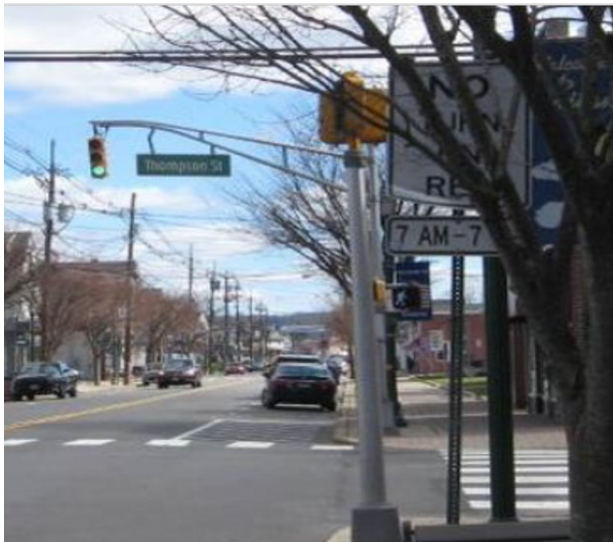
Figure 24 - Field Observations and Identified Needs, Somerset Street

Signs are blocked by roadside tree branches

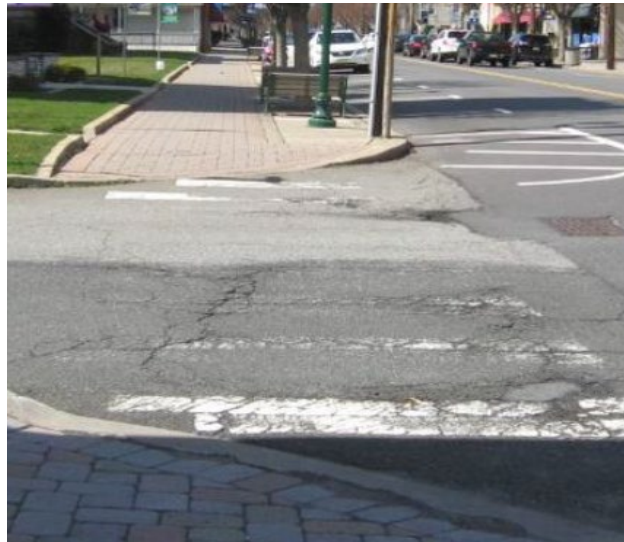
Crosswalk pavement and striping may benefit from updating for better pedestrian/motorist visibility

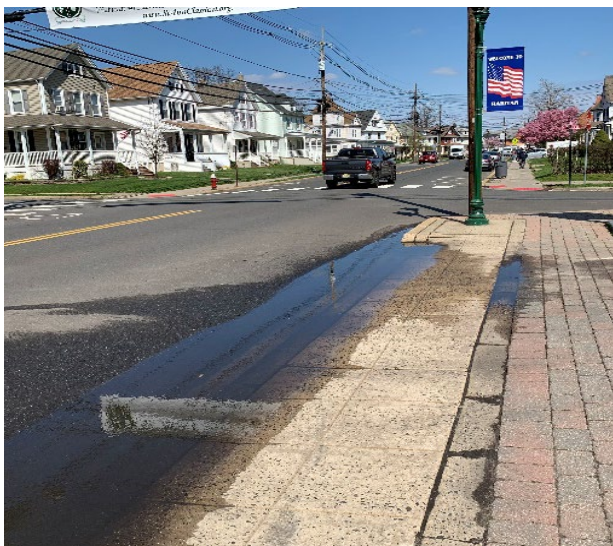
Ponding near crossings indicates drainage problems

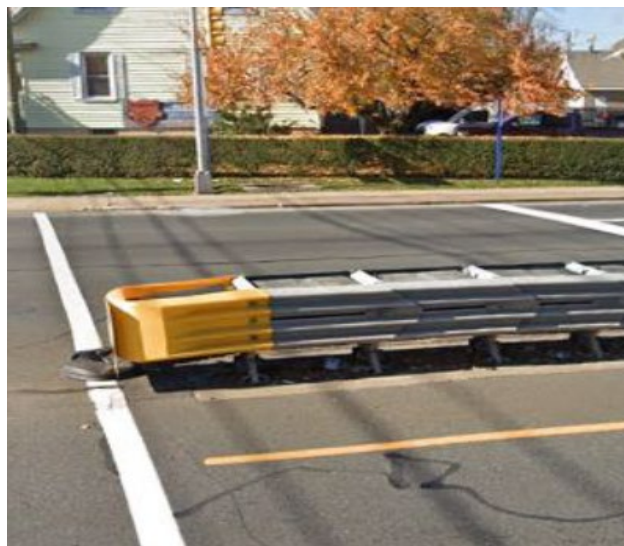
Stop bar on Route 206 South is set too far back

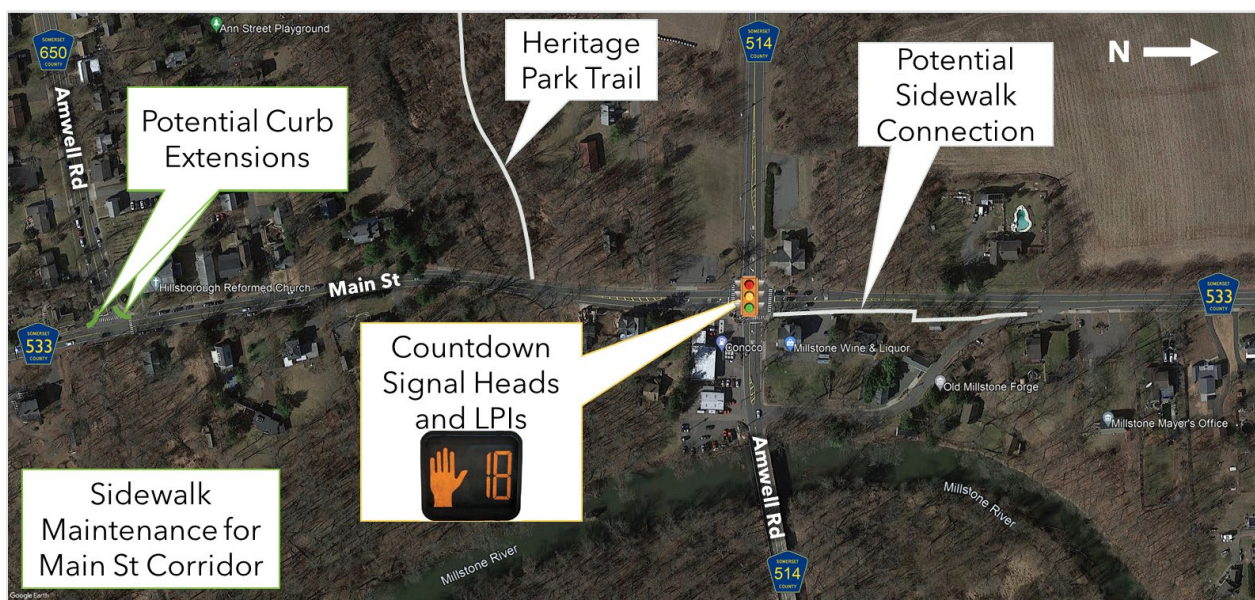
Figure 27 - Pedestrian Infrastructure Improvement Recommendations, Millstone, NJ

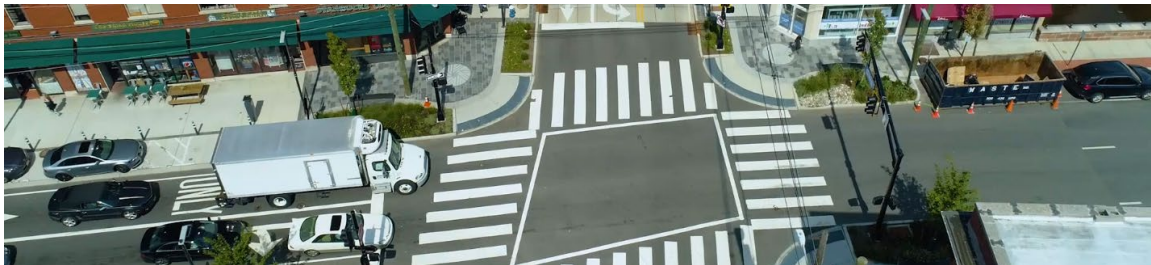
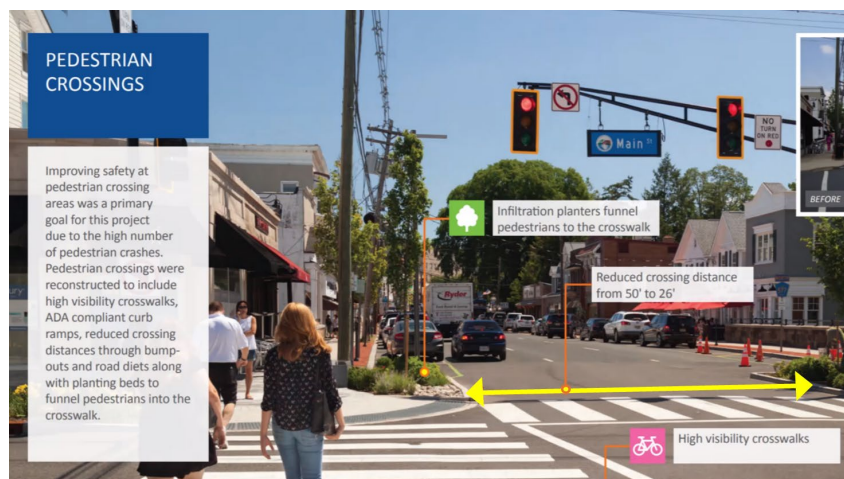
Figure 29 - Aerial Perspective of Daylighting and Curb Extensions, Millburn, NJ

Figure 30 - Street-level Perspective of Daylighting and Curb Extensions, Millburn, NJ¹²

Evidence of daylighting, which increases pedestrian/driver visibility around an intersection, has faded, and vehicles were observed parking in these prohibited areas during the RSA. Continued enforcement and maintenance are needed to make this crash countermeasure effective. Curb extensions can be an effective way to entirely preclude vehicles from parking on top of intersections and provide pedestrians with a space to better establish their presence at a roadway crossing location.

As designs of these improvements on Somerset Street move forward, additional treatments that could be implemented alongside curb extensions should be considered, including ergonomic crosswalks (used to better reflect the more curved paths of pedestrian circulation at an intersection) and infiltration planters (used to act as a receptacle to filter stormwater runoff).
