Somerset County Roadway Safety Study Subregional Project ROAD SAFETY AUDIT REPORT FRANKLIN BOULEVARD IN FRANKLIN TOWNSHIP

November 2021

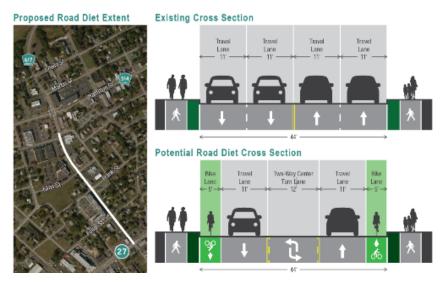
Figure 3 – Franklin Boulevard Road Diet Concept from Phase III Study

The WalkBikeHike (2019) and Supporting Priority Investment in Somerset County Phase III Study (2017) studies recommend implementing a road diet on Franklin Boulevard between Route 27 and Lewis Avenue (**Figure 3**) to reduce vehicle speeds and minimize pedestrian-vehicle conflict exposure. A high-level investigation of the road diet concept was made within the Phase III study with initial capacity analysis showing that existing Levels of service could be maintained with signal timing adjustments. The intersection at Hamilton Street would maintain the existing configuration with a northbound left-turn lane extending approximately to Field Street. At Route 27, the southbound left-turn lane would extend at least 150' to accommodate typical vehicle queues. However, the study recommended that further investigation be performed in coordination with the municipality, local stakeholders, and NJDOT.

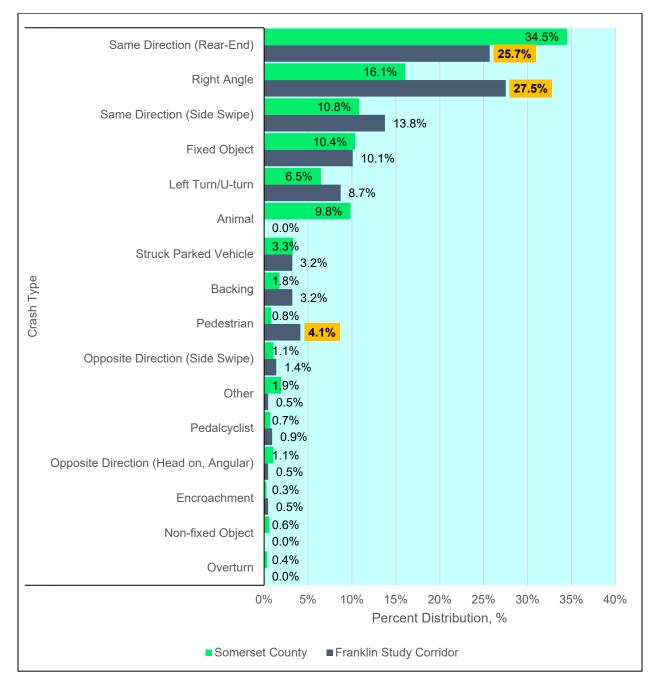
Figure 7 – Vehicular Crashes, Percent Distribution by Crash Type

Fifty-six rear end and 60 right angle crashes make up more than 53% of the crash distribution along the study segment, shown highlighted in yellow in **Figure 7**. Rear end crashes on the corridor occur approximately 10% less frequently than County-wide rear end crashes. Right angle crashes, however, are more frequent within the study segment than the County. Pedestrian-involved crashes on the study segment occur at a considerably higher frequency than the County, almost four times as frequent (0.8% County-wide vs. 4.1% CR 617) highlighted in yellow in **Figure 7**. This is perhaps correlated to the fact that the study segment lies in a more heavily urbanized area. **Figure 7**, and **Table 4**, provide a breakdown of crash types for the study segment.

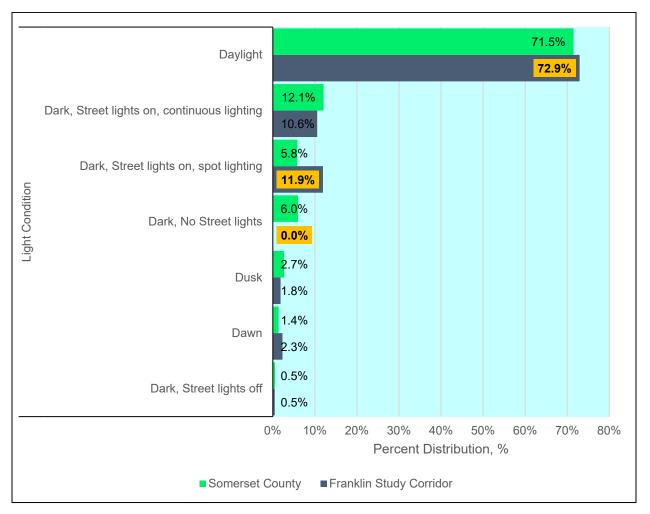
Figure 10 – Vehicular Crashes, Percent Distribution by Light Condition

Approximately 72.9% of crashes on the study segment occurred during daylight conditions. This is slightly higher than the County-wide average of 71.5%. Crashes occurring during "dark, street lights on, spot lighting" is noticeably higher than the County average, occurring more than double the frequency of 11.9% on the study segment corridor versus the 5.8% for the County. This may be due to the relatively-lit/developed nature of the study segment's streetscape, as evidenced by a 0% for "dark, no streetlights" (shown highlighted in yellow in **Figure 10**).

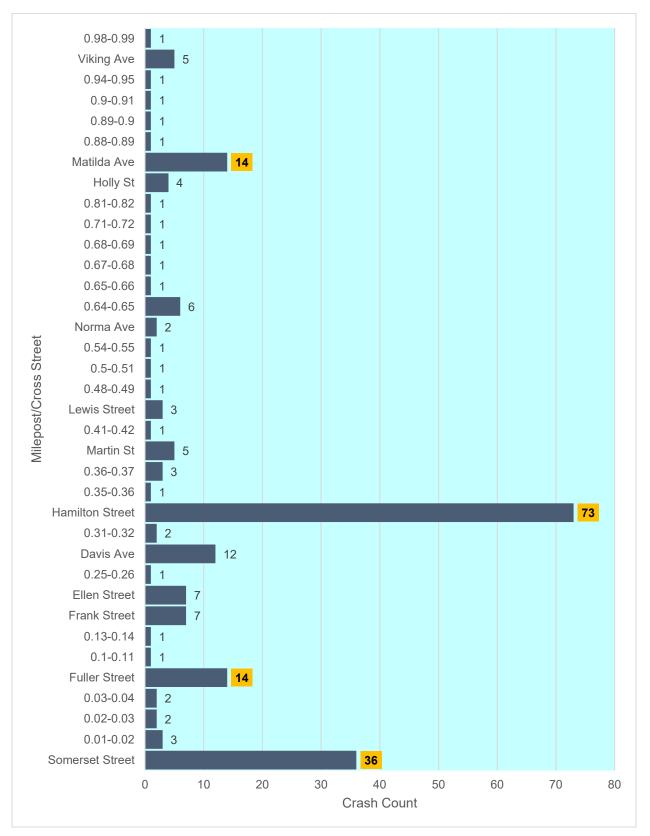
Figure 11 – Vehicular Crashes by Milepost

Crash visualization using the histogram, grouped in 0.01-mile segments, is provided in **Figure 11**. This chart indicates that the signalized intersections of Somerset Street and Hamilton Street experience the highest recurrence rate of crashes along the study segment (as shown highlighted in yellow in **Figure 11**). The crashes at these two locations account for 50% of all crashes. Fuller & Matilda Streets equally present the highest crash totals at unsignalized intersections with fourteen (14) crashes at each location (as shown highlighted in yellow in **Figure 11**). A three-dimensional representation of this crash histogram for the 2016 through 2020 timeframe, imposed onto a map of the study area, is shown on **Figure 12**.

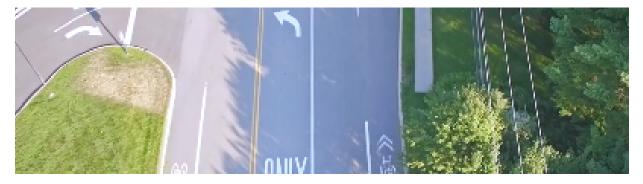
Figure 17 – Alternate Road Diet Option with Shoulders Transitioning to Curb Extensions at Intersections

Since the curb-to-curb cartway width is limited at approximately 44' to 46', bike lanes would not be able to have a buffer and could be of substandard width. An alternate option to dedicating shoulder width available from the road diet to bicycle travel would be to restrict use of shoulders by parked vehicles and to provide curb extensions (in line with shoulder widths) at intersections to reduce pedestrian crossing distance, as depicted in **Figure 17**.

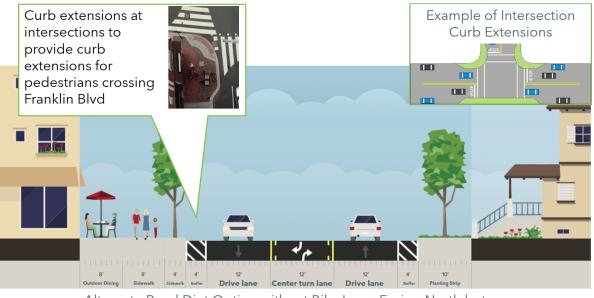
Alternate Road Diet Option without Bike Lane, Facing North between Frank Street and Fuller Street

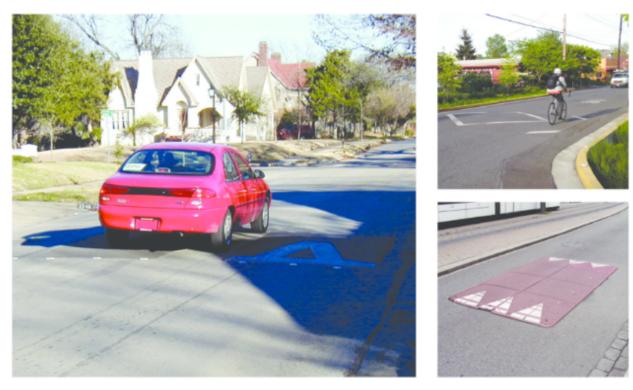
Figure 23 – Sample Speed Humps from NACTO²⁸

Cut-through traffic was observed to occur on Berry Street and Ellen Street, with vehicles bypassing peak hour congestion at the intersection with Hamilton Street to the southwest. Speed humps (

Figure 23), combined with turning restrictions could help to discourage this cut-through traffic activity. Speed humps can be designed to slow an average vehicle's wheelbase width yet can also allow for bicyclists and larger emergency vehicles, such as firetrucks, to move along the street unimpeded.
