Somerset County Roadway Safety Study  
Subregional Project

# ROAD SAFETY AUDIT REPORT

MAIN STREET IN MILLSTONE BOROUGH

November 2021

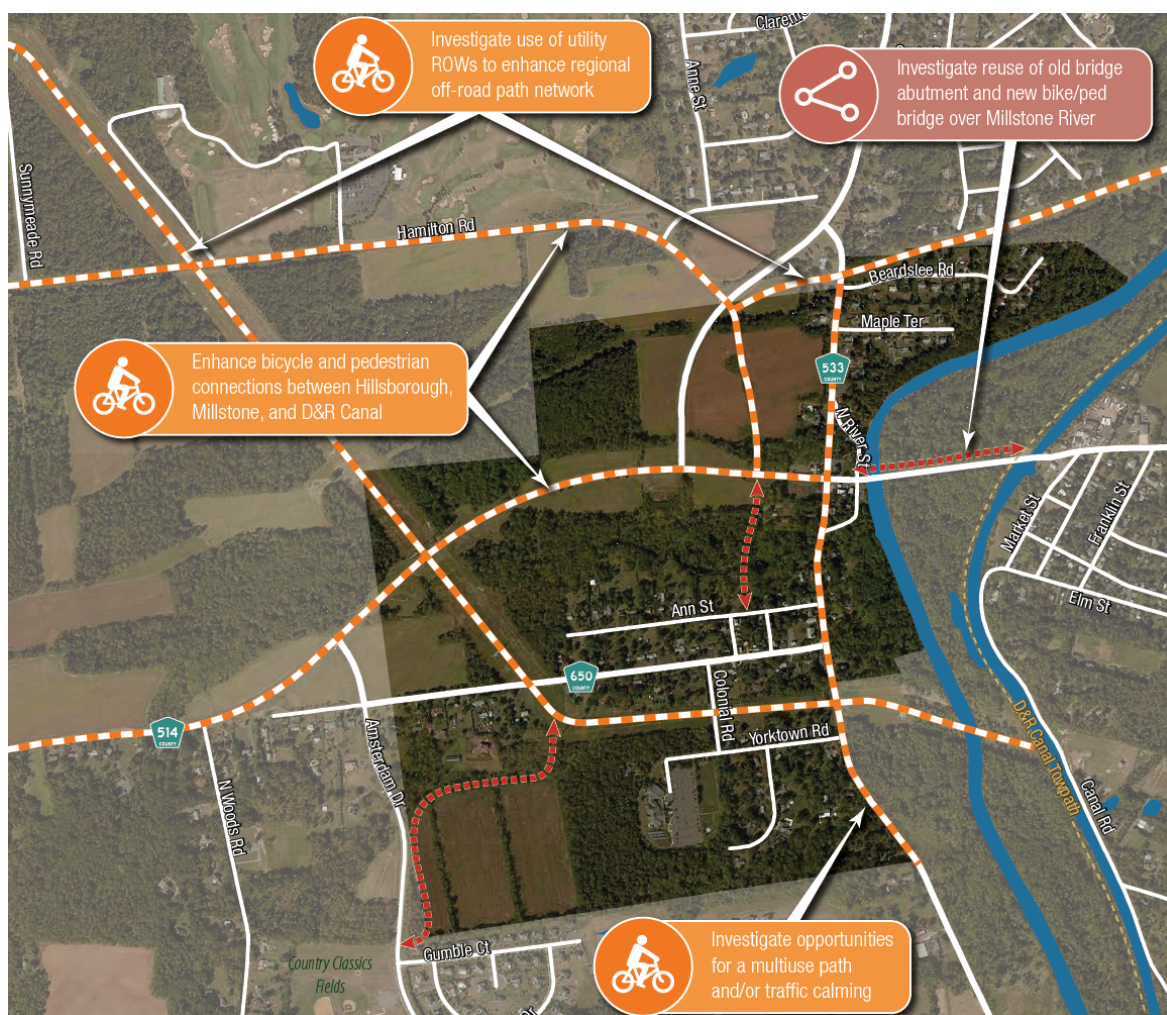
Figure 3 – Multimodal Recommendations from Phase III Study

The area surrounding the corridor segment has been designated as a Local Priority Area (LPA) by the County in its 2017 *Supporting Priority Investment in Somerset County, Phase III* study. The Phase III study noted that this area is a very auto-centric environment and that multimodal mobility improvements can help to support tourism and recreation opportunities in the Borough. An overview of mobility improvements from the Phase III study is shown in **Figure 3**.

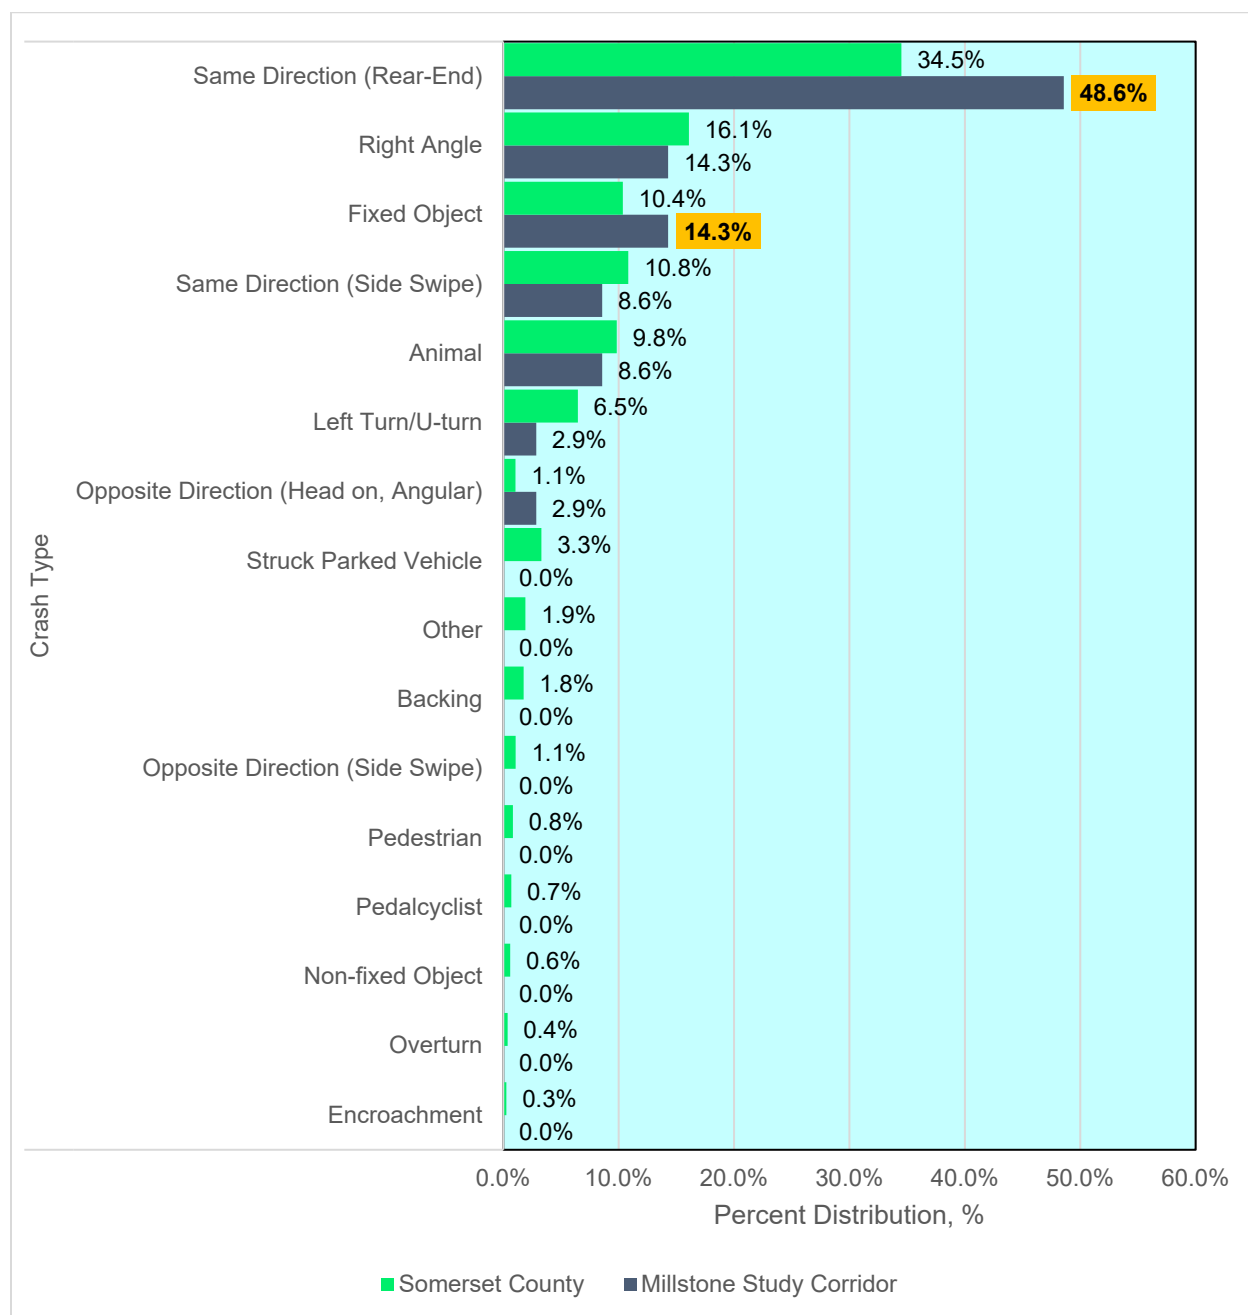
Figure 7 – Vehicular Crashes, Percent Distribution by Crash Type

Seventeen rear end crashes make up approximately 49 percent of the crash distribution along the study segment, shown highlighted in yellow in **Figure 7**. Most rear end crashes are occurring at the intersection of Main Street and Amwell Road. These crashes can possibly be attributed to congestion approaching the signal or glare issues. Rear end crashes on the corridor occur approximately 11 percent more frequently than County-wide rear end crashes. The frequency of fixed object crashes is higher on the corridor than the County, representing 14.3 percent of crashes (highlighted in yellow in **Figure 7**). Number of crashes by type are shown in **Table 4**.

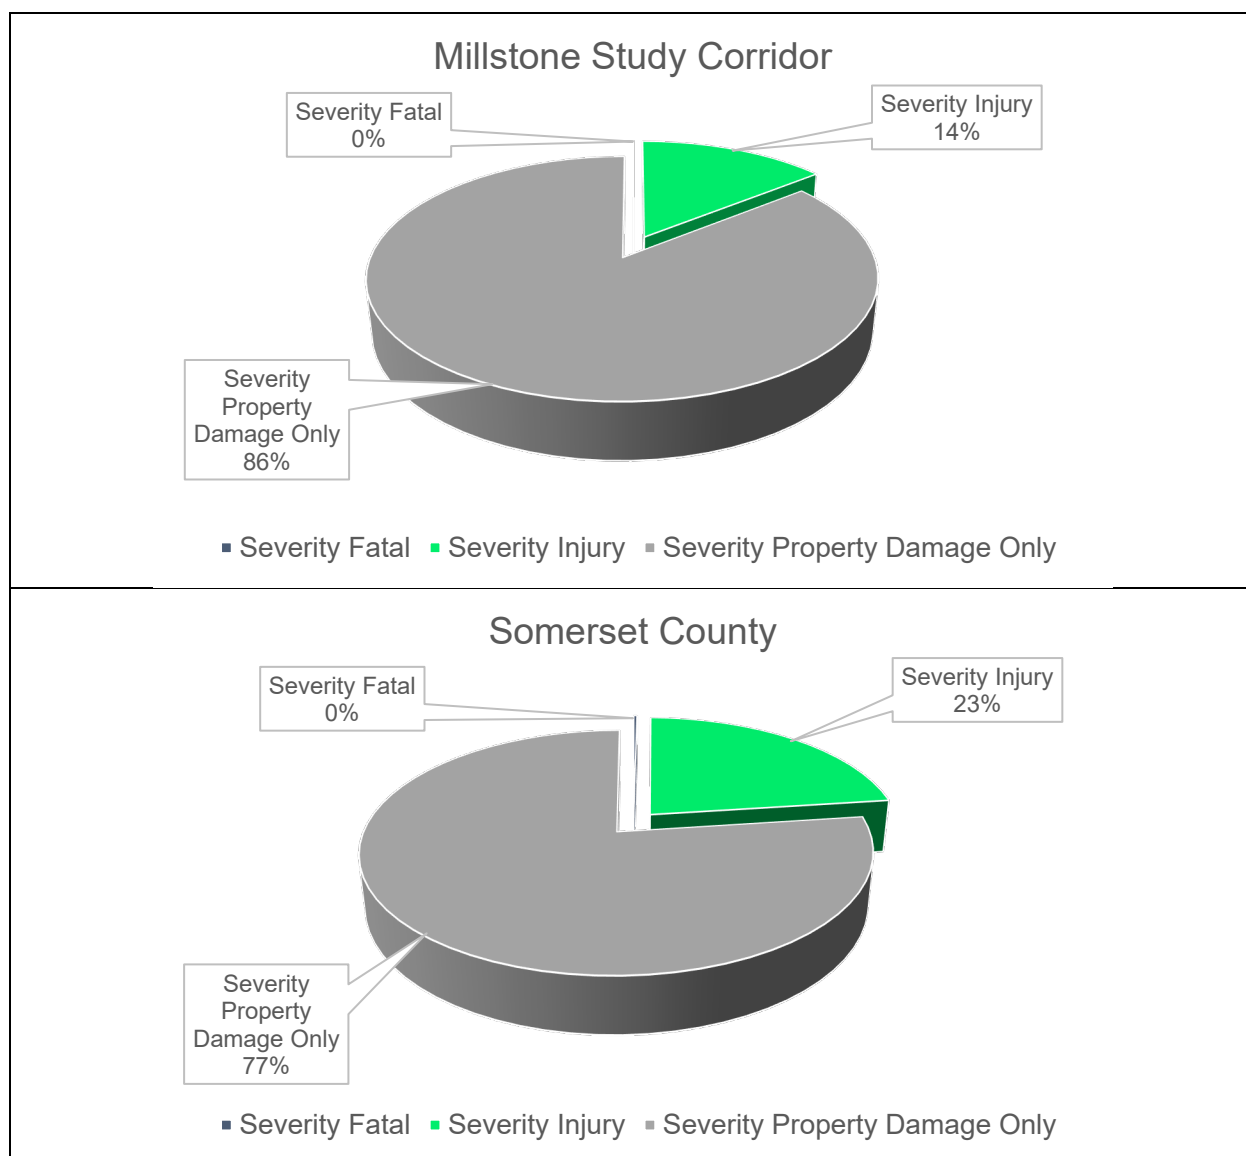
Figure 8 – Vehicular Crashes, Percent Distribution by Severity

Data in **Figure 8** shows a slight decrease in crashes resulting in injuries rather than property damage only when compared to the County. The analysis period saw no fatalities along the selected roadway segment.

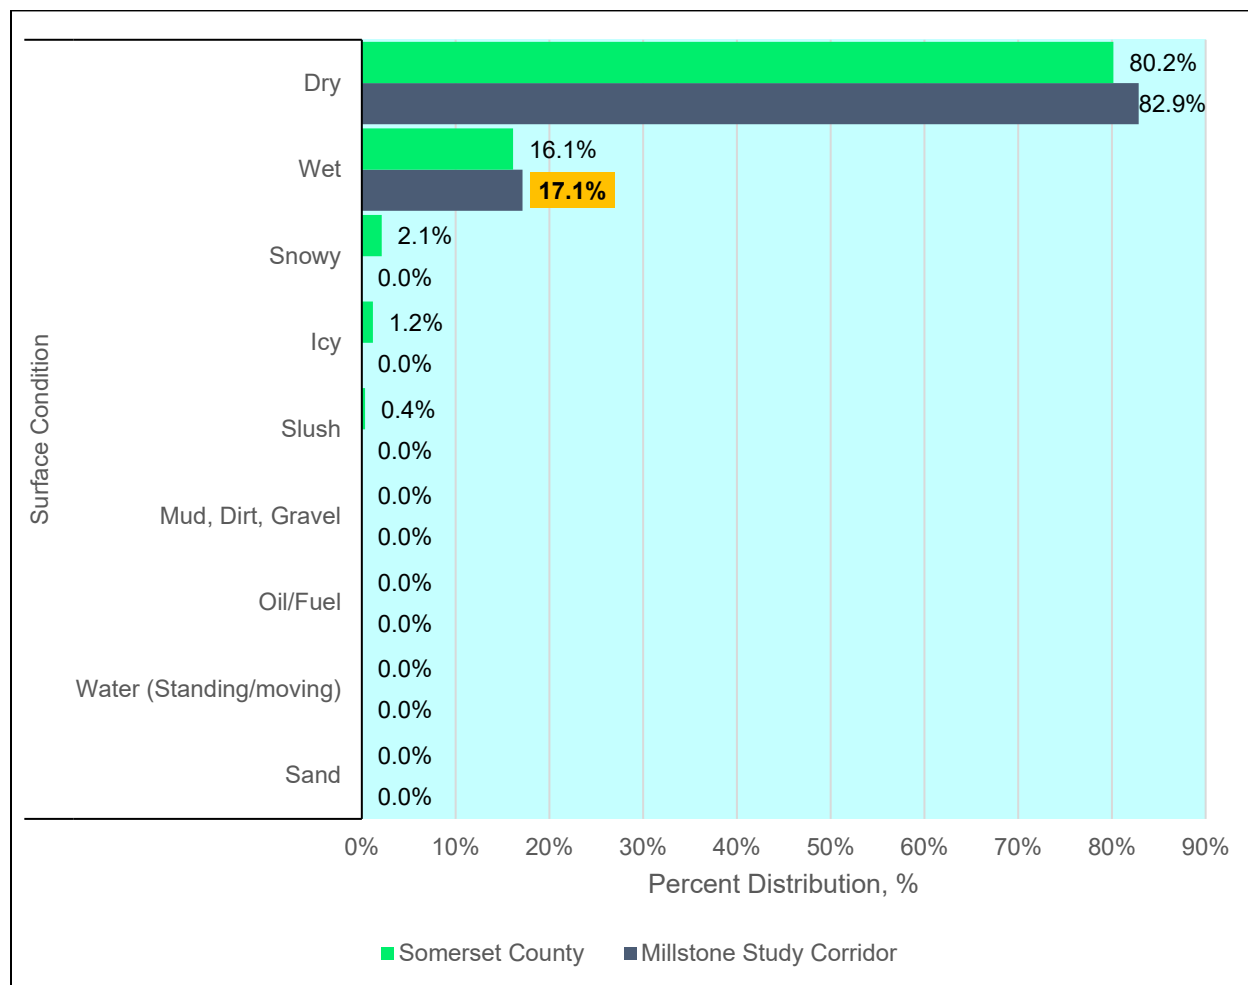
Figure 9 – Vehicular Crashes, Percent Distribution by Surface Condition

Crashes occurred more frequently during wet and dry driving conditions on the study corridor than County-wide. Wet road-related crashes are the second most overrepresented roadway surface condition during crashes at 17.2 percent, which is approximately 1 percent more frequent than the County-wide average at 16.1 percent (highlighted in yellow in **Figure 9**).

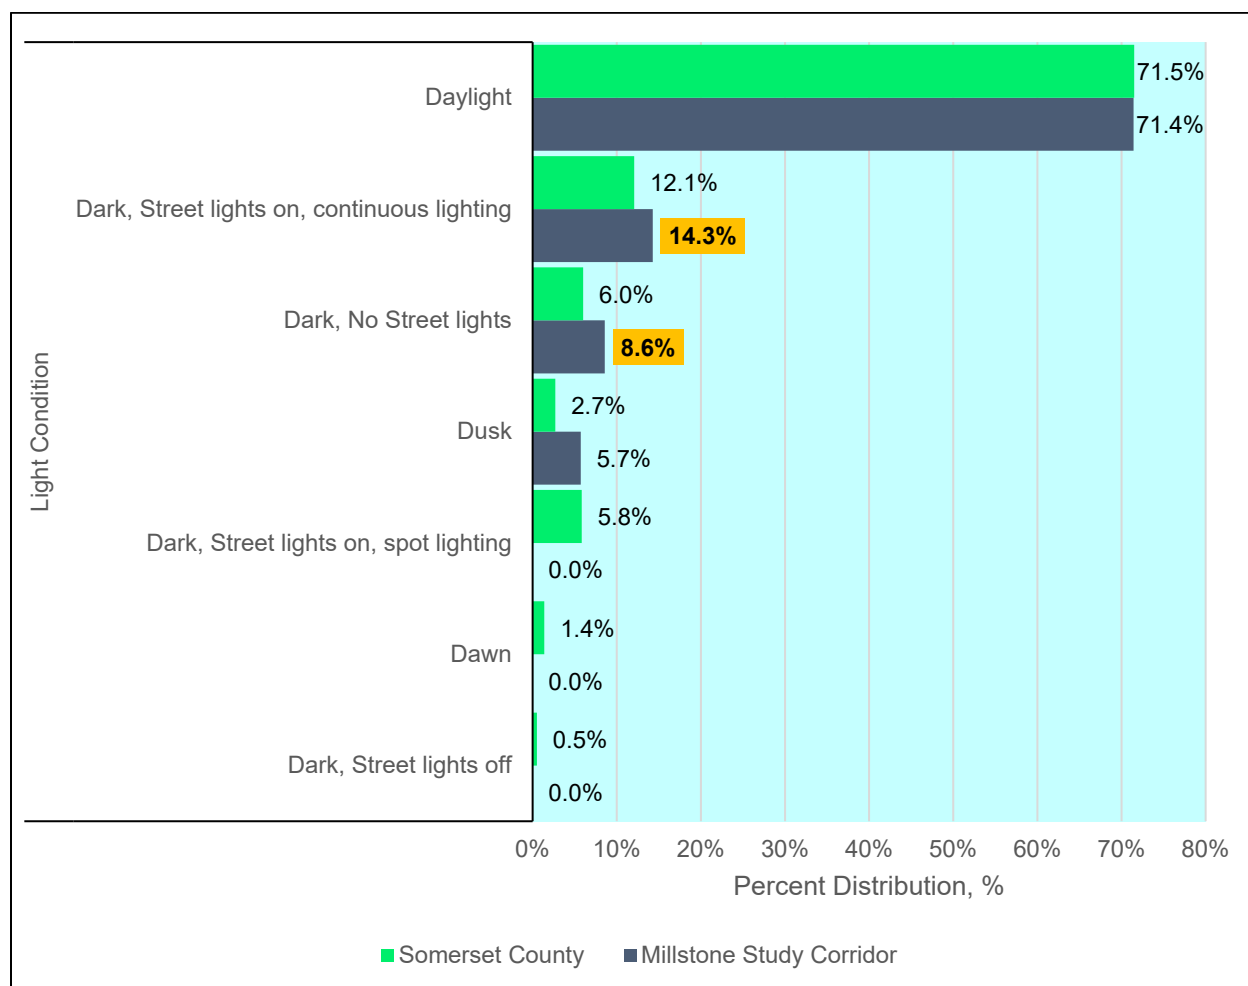
Figure 10 – Vehicular Crashes, Percent Distribution by Light Condition

Approximately 71.4 percent of crashes on the study segment occurred during daylight conditions, similar to the County-wide average of 71.5 percent. Crashes occurring during “Dark, Street lights on, continuous lighting” and “Dark, No Street lights” are higher than the County averages (highlighted in yellow in **Figure 10**). Dusk crashes were also over twice the share of County-wide crashes, suggest an issue with sun glare for vehicles on the westbound and eastbound Amwell Road (CR 514) approaches to Main Street.

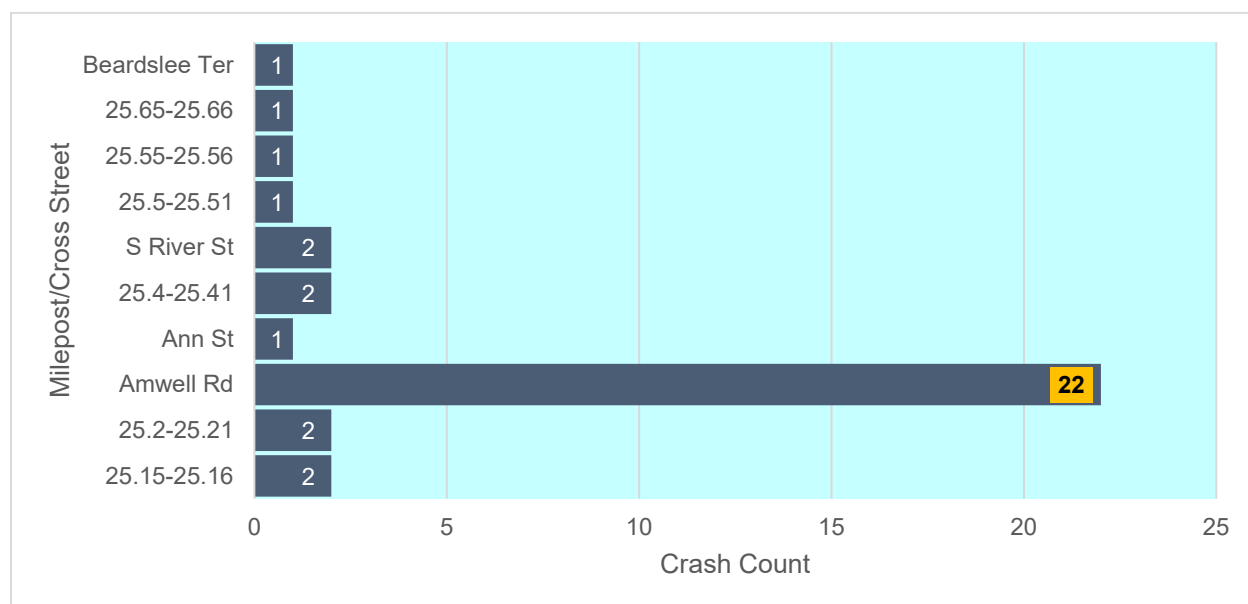
Figure 11 – Vehicular Crash Totals by Milepost

Crash visualization using the histogram, grouped in 0.01-mile segments indicates that the signalized intersection of Amwell Road (CR 514), highlighted in yellow, experienced the highest occurrence rate of crashes along the study segment corridor (**Figure 11**). These crashes at this location account for 63 percent of all crashes. A three-dimensional representation of this crash histogram for the 2016 through 2020 timeframe, imposed onto a map of the study area, is shown on **Figure 12**.

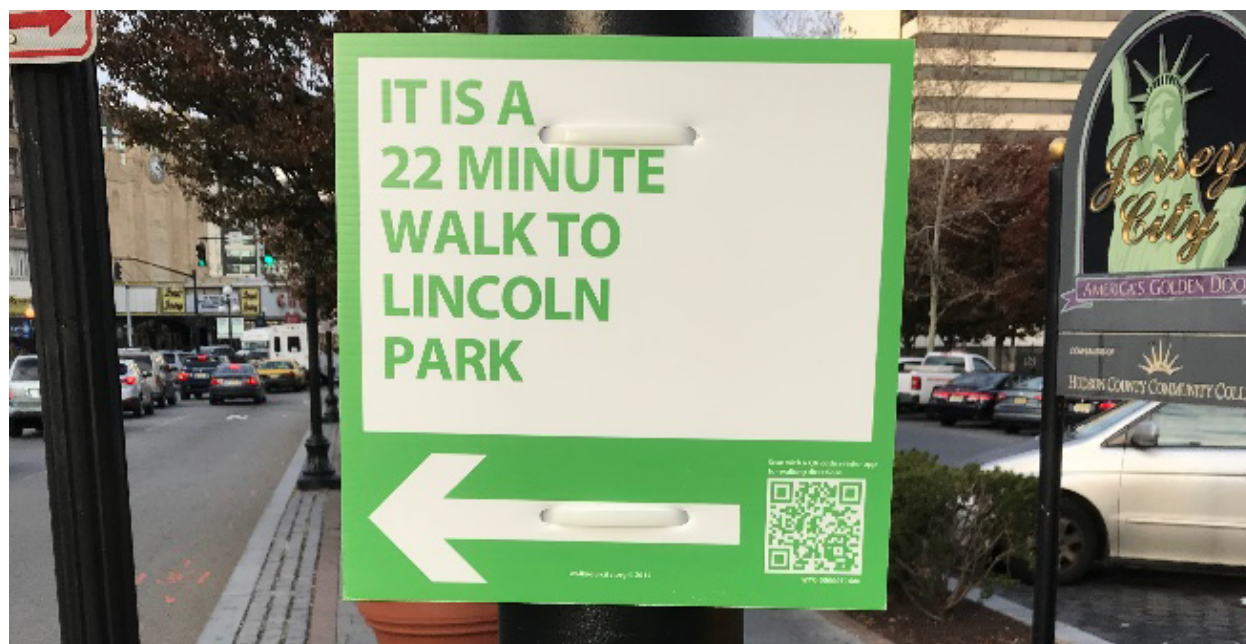
Figure 14 – Temporary Wayfinding Signing in Jersey City

A potential demonstration project in this corridor could work to improve the pedestrian wayfinding. As a historic community with several noteworthy destinations, wayfinding could help visitors find these historic buildings. Moreover, historical information signage could help educate passersby about the Revolutionary War events in Millstone and build an even stronger sense of place. **(Figure 14).**

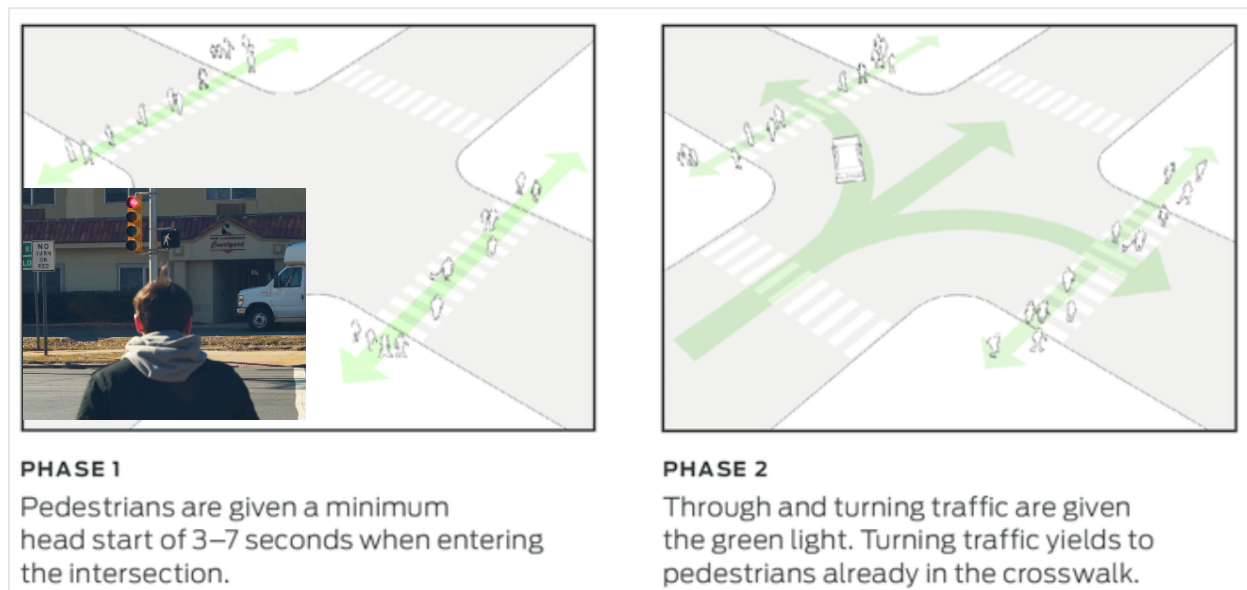
Figure 15 – Leading Pedestrian Interval (from NACTO and Lakewood Township)<sup>21</sup>

By changing lead left to lag left phasing<sup>22</sup>, however, LPIs could be implemented for all crosswalks at the signalized intersection. However, lag left phasing may result in driver confusion and additional congestion. In addition to LPIs, No Turn on Red (NTOR) restrictions can be enacted at this intersection to mitigate the occurrence of right-hook pedestrian collisions. The County should perform a capacity analysis of the intersection to see if lag left phasing and LPIs could be accommodated within existing intersection capacity.

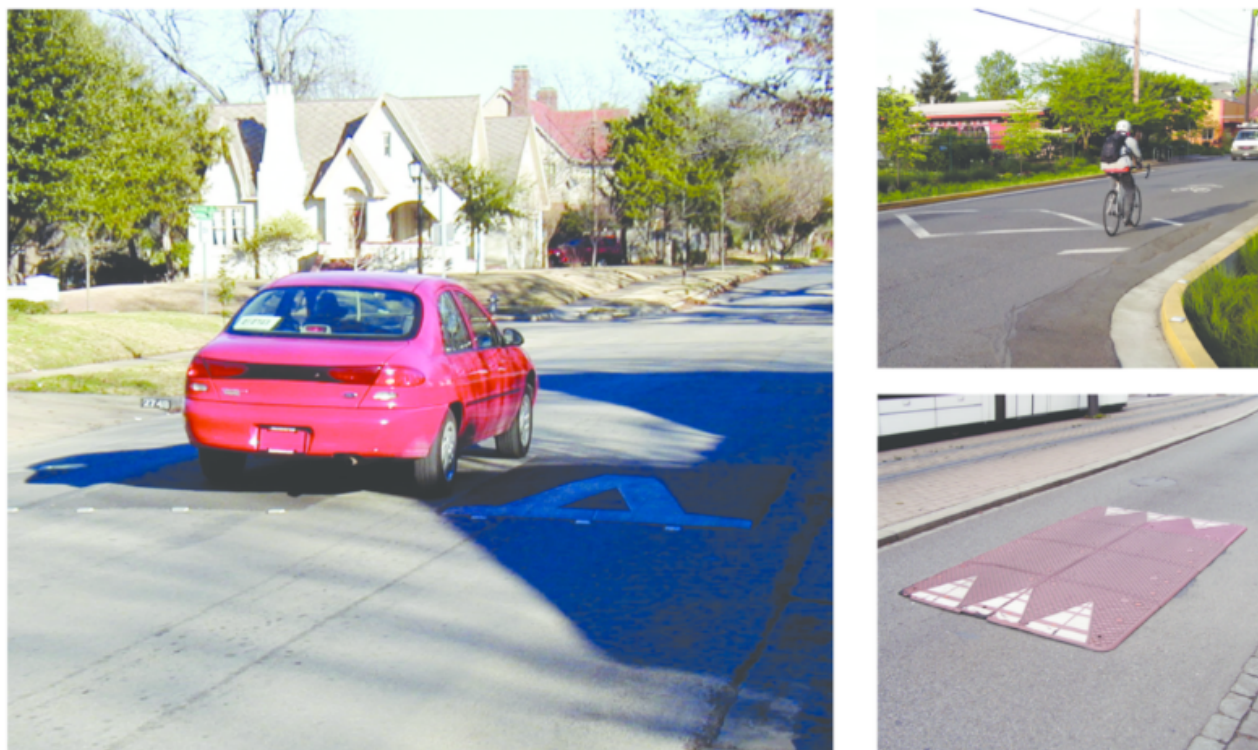
Figure 17 – Sample Speed Humps from NACTO<sup>24</sup>

At the Township's discretion, either paved or raised speed humps could be installed on North and South River Street to discourage cut-through traffic looking to bypass brief periods of congestion at the Amwell Road (CR 514) intersection. Speed humps can be designed to slow an average vehicle's wheelbase width yet can also allow for bicyclists and larger emergency vehicles, such as firetrucks, to move along the street unimpeded (**Figure 17**).
