UNION COUNTY ROUTE 1&9 CORRIDOR STUDY FINAL REPORT

JUNE 2011

ROUTE 1&9 CORRIDOR STUDY

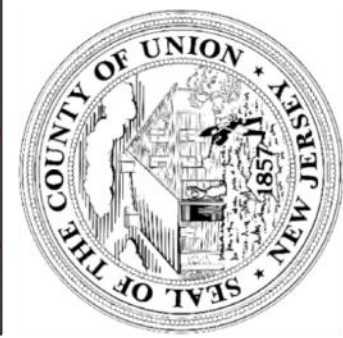
Study Area
Corridor of US Routes 1 & 9
Union County, New Jersey

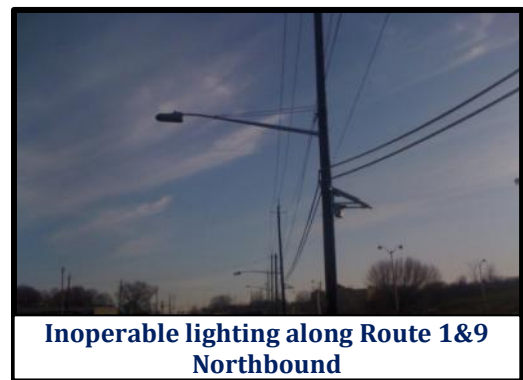
Inoperable lighting along Route 1&9 Northbound

- A review of existing lighting conditions within the corridor should be completed. This should include the identification of damaged or non-operating fixtures, measuring luminance levels for the roadway (including vertical luminance levels) and an assessment of levels for pedestrian-scale lighting.

- Lighting should be repaired, upgraded, or replaced as needed based on a lighting conditions assessment.
- A detailed review of crashes occurring at night should be undertaken at numerous locations within the study area identified as having an overrepresented number of crashes occurring during dawn, dusk, or night. Locations within the corridor that should be reviewed to identify any similar cause of crashes occurring during dawn, dusk, or night include:

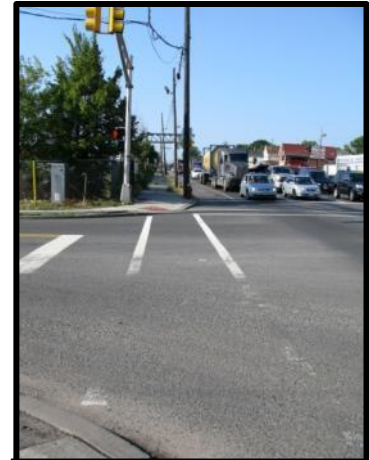
Worn striping typical of entire Route 1&9 Corridor

- To address the nearly 7-mile segment of poor pavement, the resurfacing of the corridor within Linden and Elizabeth is recommended using modern pavement design or concrete to handle the high volumes of traffic, including heavy vehicles.
- NJDOT should replace existing striping and pavement markings with thermoplastic markings to extend the lifespan of markings and reduce maintenance needs.
- A review of MUTCD compliance for stop bar/crosswalk spacing should be completed.

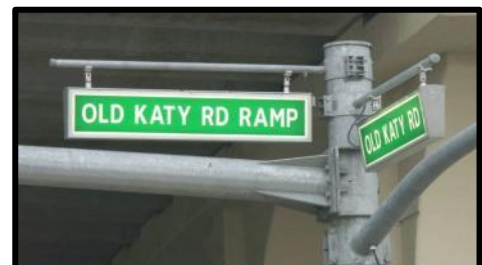
Backlit street sign increases visibility

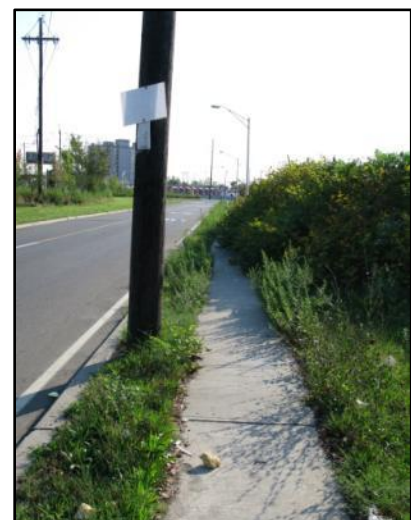
Poor Maintenance along sidewalk at North Avenue

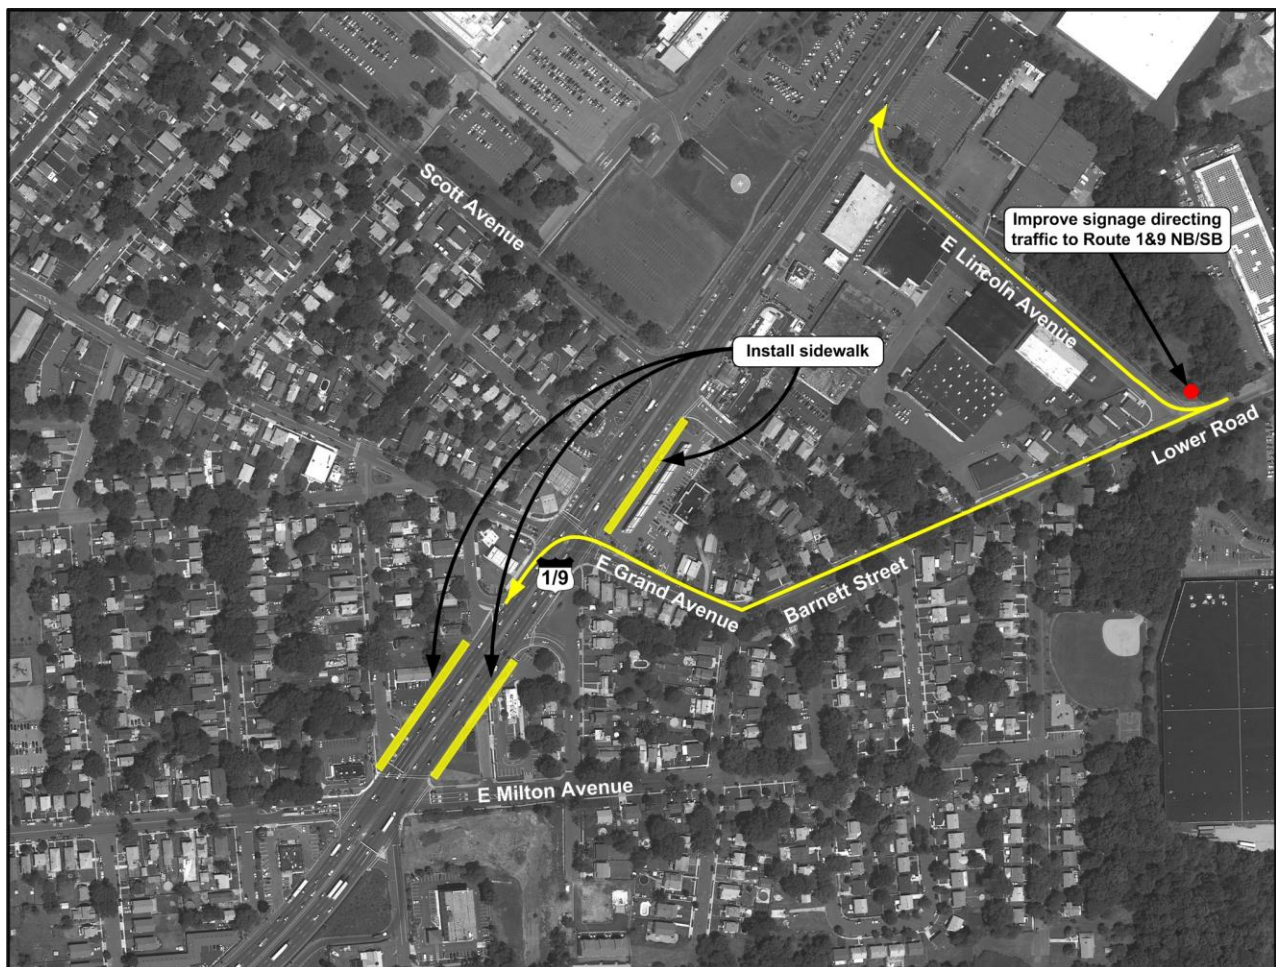
Figure 7 – Route 1&9 at Grand Avenue Improvements

The Union County Engineer suggests the investigation of an additional signal at E. Lincoln and Route 1&9 to relieve traffic on E. Grand, a residential neighborhood, and divert traffic from E. Grand to E. Lincoln. This recommendation needs further analysis for signal warrants and NJDOT standards as it would be within 1300 feet of an existing signal, and the NJDOT minimum spacing for new signals is generally 1500 feet.

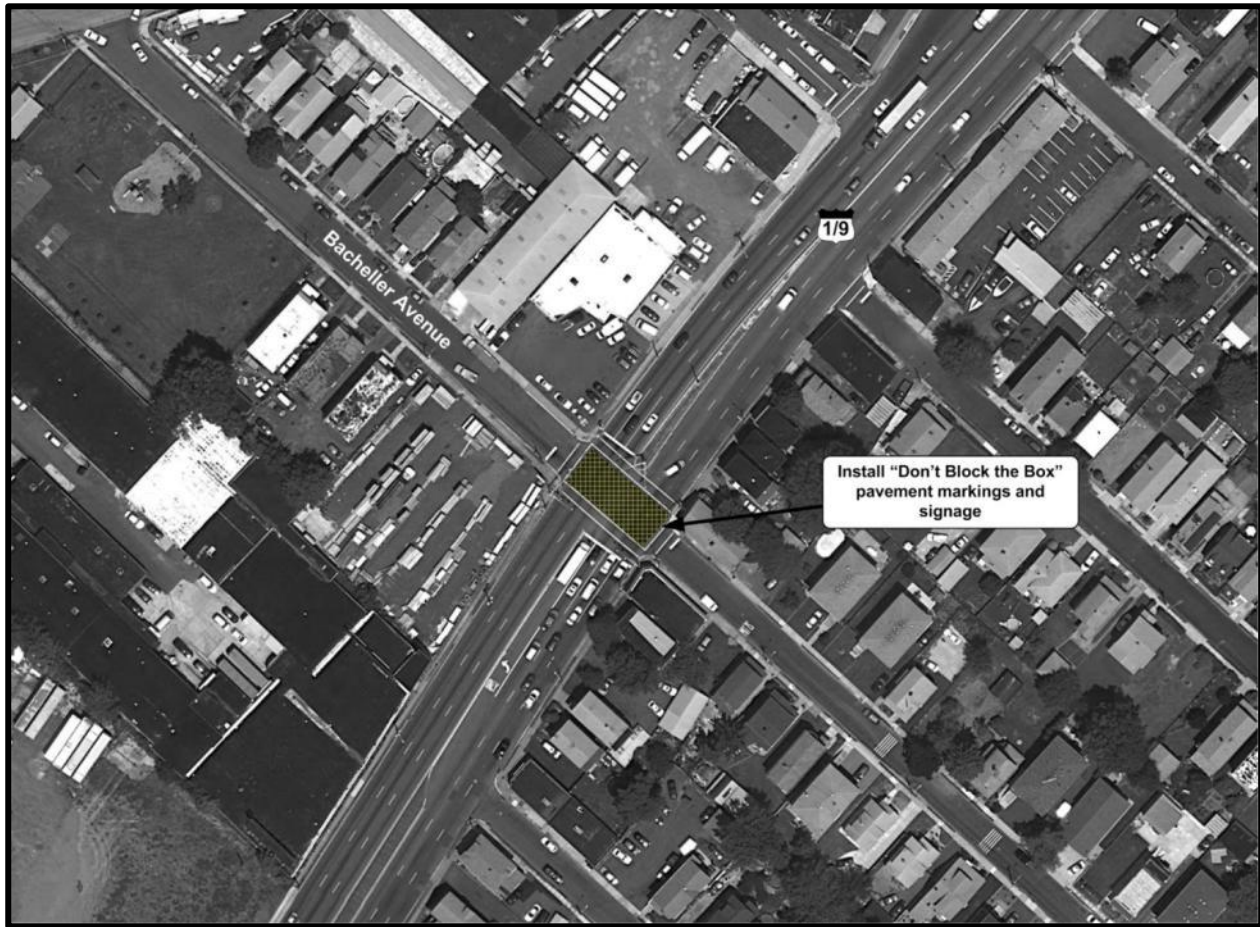
Figure 14 – Route 1&9 at Bachelor Avenue Improvements

“Don’t block the box” pavement markings and signage should be installed at the intersection, as backups at this location often extend through the intersection.

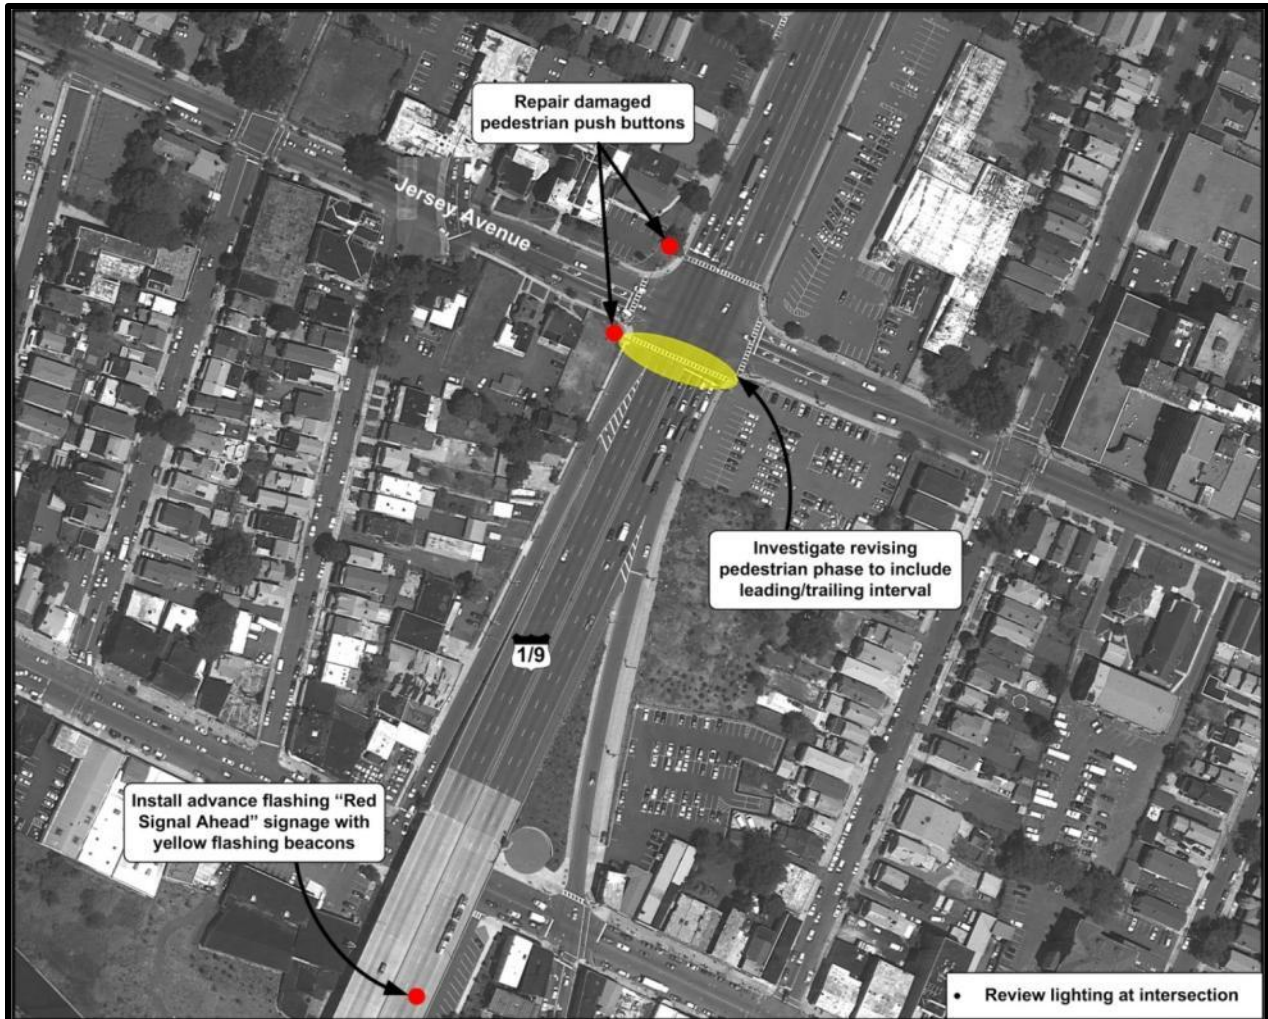
Figure 19 – Route 1&9 at Jersey Avenue Improvements

The signalized intersection of Route 1&9 and Jersey Avenue was recently improved as part of the Elizabeth River Viaduct improvement. However, the intersection remains challenging for pedestrians who must cross the approximately 130-foot crosswalk on the northbound approach of Route 1&9. Crash data further indicates the problems pedestrians have at this intersection, as six crashes (including one fatality) involving pedestrians were reported during the three year analysis period. Further intensifying the pedestrian concerns at this intersection is the fact that pedestrian push buttons on the northwest and southwest corners of the intersection were not functioning during a field visit. Like Route 1&9 southbound traffic approaching Maple Avenue, northbound Route 1&9 traffic approaching Jersey Avenue can travel at higher rates of speed due to the recent improvements to the Elizabeth River Viaduct, and drivers unfamiliar with the area may not expect a signalized intersection at the foot of the bridge.

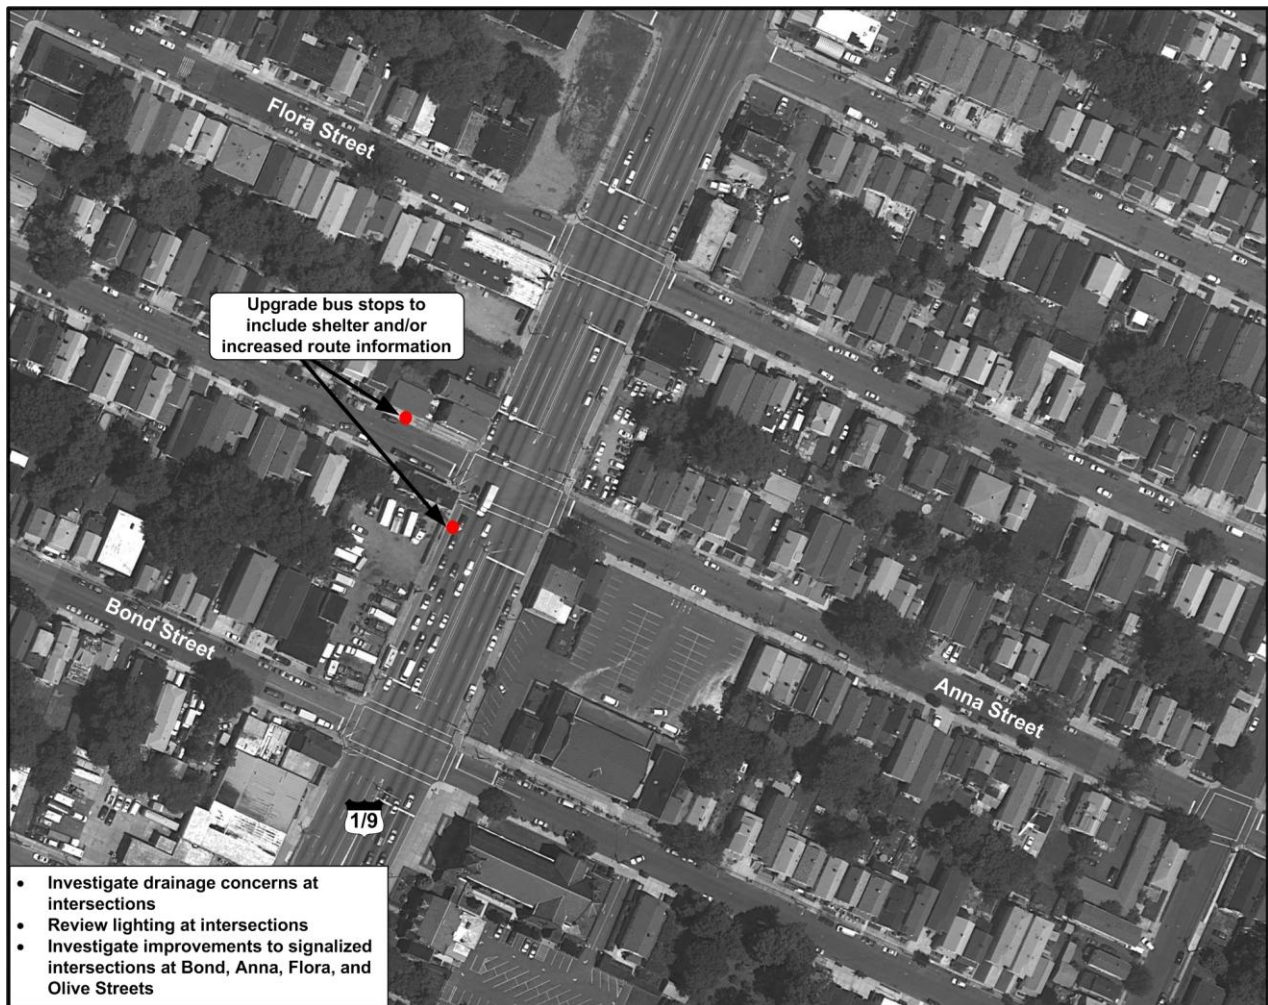
Figure 21 – Route 1&9 at Bond/Anna/Flora Street Improvements

Finally, bus stops located near the intersections should be upgraded to include a shelter and/or seating, as well as increased route and connections information.

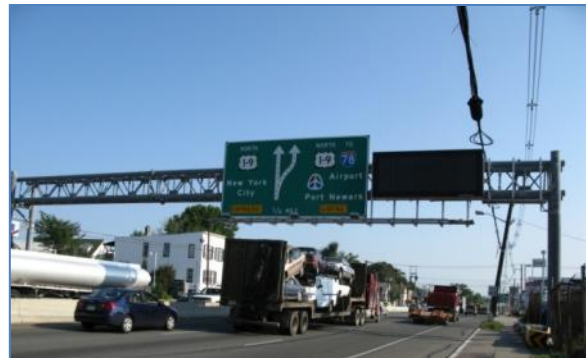
Route 1&9 Northbound north of Fairmount Avenue, approaching the transition to the freeway portion of Route 1&9

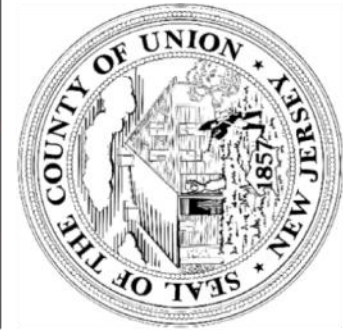
Figure 24- Traffic Count Locations, Route 1&9 Corridor

Traffic Count Locations Corridor of US Routes 1 & 9 Union County, New Jersey

Source: NJDEP NJDOT, Union County, NJ Transit, ESRI
 Note: Numbers of traffic count locations correspond with Data Assessment Technical Memorandum.
 Note: This map was developed using NJDEP GIS data, but this secondary product has not been verified by the NJDEP and is not State-authorized.

The project team reviewed existing traffic counts from readily available sources including NJDOT’s traffic count repository and counts related to previously completed traffic studies within the corridor. Figure 24 depicts the locations of traffic data available throughout the corridor. In total, 11 count locations have been collected and reviewed from various sources, from a four year period between 2007 and 2010. Five of these locations provide average AADT volumes, summarized in Table 1, while six provide turning movement counts (TMC), summarized in Table 2 (morning), Table 3(midday), Table 4(evening), and Table 5 (midday Saturday).

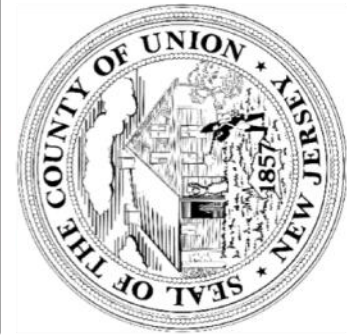
Figure 26 - Crash Locations, Route 1&9 Corridor

Crash Locations Corridor of US Routes 1 & 9 Union County, New Jersey

Source: NJDEP, NJDOT, Union County, NJ Transit, ESRI
Note: This map was prepared with NJDOT Crash Records for 2007-2009
Note: This map was developed using NJDEP GIS data, but this secondary product has not been verified by the NJDEP and is not State-authorized.

Study area crash locations (Figure 26), truck crash locations (Figure 27), and pedestrian crash locations (Figure 28) are shown on their respective maps. These figures highlight crashes along Routes 1&9 as well as along surrounding roadways with parcels located within one-half mile of Route 1&9, as well as associated rights-of-way.

Figure 26, Figure 27, and Figure 28 provide a detailed overview of the intersections that are shown in Table 8.

In addition to the locations noted in Table 8, there are several locations with multiple crashes that are not located directly at a signalized intersection. A more detailed analysis of these locations may reveal specific issues where safety improvements are necessary. These locations are detailed in Table 9 and Figure 26, Figure 27, and Figure 28.

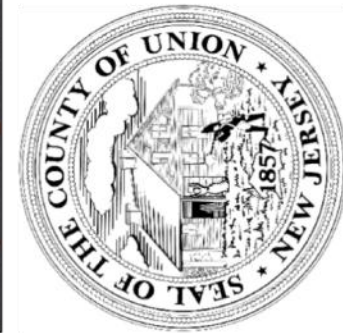
Figure 27 - Crashes Involving Trucks, Route 1&9 Corridor

Truck Crash Locations Corridor of US Routes 1 & 9 Union County, New Jersey

Source: NJDEP, NJDOT, Union County, NJ Transit, ESRI
 Note: This map was prepared with NJDOT Crash Records for 2007-2009
 Note: This map was developed using NJDEP GIS data, but this secondary product has not been verified by the NJDEP and is not State-authorized.

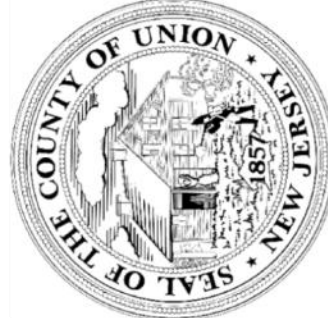
Pedestrian and Pedicyle Crashes Corridor of US Routes 1 & 9 Union County, New Jersey

Source: NJDEP, NJDOT, Union County, NJ Transit, ESRI
 Note: This map was prepared with NJDOT Crash Records for 2007-2009
 Note: This map was developed using NJDEP GIS data, but this secondary product has not been verified by the NJDEP and is not State-authorized.

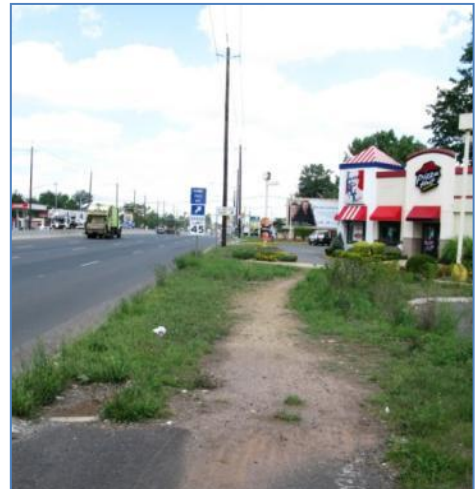
Route 1&9 Northbound between Milton Avenue and Patterson Street. The heavily worn path indicates significant pedestrian traffic along this gap in the sidewalk network.

Review of the existing conditions inventory for bicyclists and pedestrians revealed numerous existing deficiencies which restrict the circulation of non-motorized traffic along and more importantly, across Route 1&9. Pedestrian crossings of Route 1&9 are challenging throughout the corridor not only due to the number of travel lanes along the highway but also due to the many skewed crossings which make the already lengthy crosswalks even longer. Pedestrian signals vary throughout the corridor and in many cases are not compliant with the current MUTCD, because it requires countdown pedestrian signals for all crossings within the study corridor. There are numerous crossings within the corridor that include pedestrian signal heads that do not meet this current standard. While pedestrian activity is greatest in the section of the corridor within Elizabeth, pedestrians were observed throughout the corridor in Linden and Rahway.

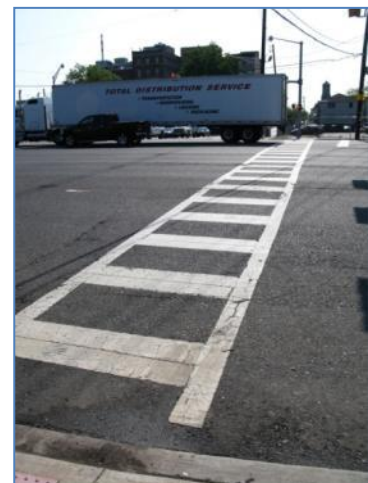
This intersection is located directly north of the recently reconstructed Elizabeth River Viaduct. The vertical curve of the structure traveling northbound limits advance warning of the signalized intersection. Also, the width of the structure exhibits characteristics of a freeway, as opposed to the actual context of the roadway through densely populated areas within this portion of the corridor. Pedestrian conditions at the intersection are made challenging due to the extreme length of the crossings, most notably on the Route 1&9 northbound approach. Ladder style crosswalks are striped on all four approaches

at this intersection, as opposed to the longitudinal markings generally found along Route 1&9 within Elizabeth. During an initial field investigation, push buttons installed on the northwest and southwest corners of the intersection were not functioning properly as pedestrians were unable to actuate the signal to provide sufficient crossing time. This intersection is critical for pedestrian circulation as it provides a key link to the Elizabeth Central Business District.

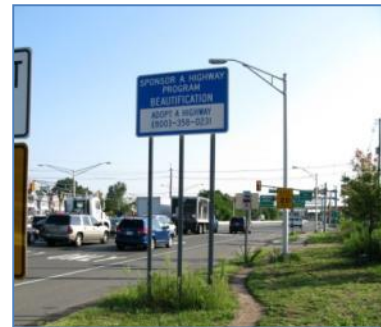
Route 1&9 Northbound approaching North Avenue looking north. The heavily worn path indicates a gap in the sidewalk network approaching an existing bus stop

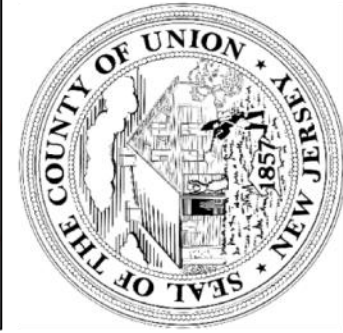
Figure 29 - Local Property Tax Land Use Classification, Route 1&9 Corridor

Property Tax Classification Corridor of US Routes 1 & 9 Union County, New Jersey

Source: NJDEP, NJDOT, Union County, NJ Transit, ESRI, MOD-IV
Note: Property tax classifications are obtained from MOD-IV assessment records dated 09/30/10. They provide a general indicator of land use.
Note: This map was developed using NJDEP GIS data, but this secondary product has not been verified by the NJDEP and is not State-authorized.

The study team reviewed and mapped the existing land use patterns using local property tax classification data (Figure 29). The tax classification data provides insight into the current uses along the study area by their tax code.

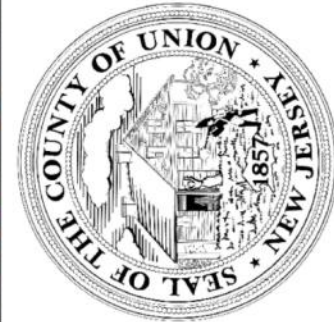
Figure 30 - Environmental Constraints, Route 1&9 Corridor

Source: NJDEP, NJDOT, Union County, NJ Transit, ESRI
Note: This map was developed using NJDEP GIS data, but this secondary product has not been verified by the NJDEP and is not State-authorized.

An environmental screening was performed based on existing GIS mapping to identify potential sensitive areas within the study area. This analysis indicated several potential environmental constraints located along the project corridor. Specific environmental sensitivities are outlined by type below and are illustrated in Figure 30.
