# Long Beach Boulevard Road Safety Audit

OCEAN COUNTY

## FINAL REPORT

December 2013

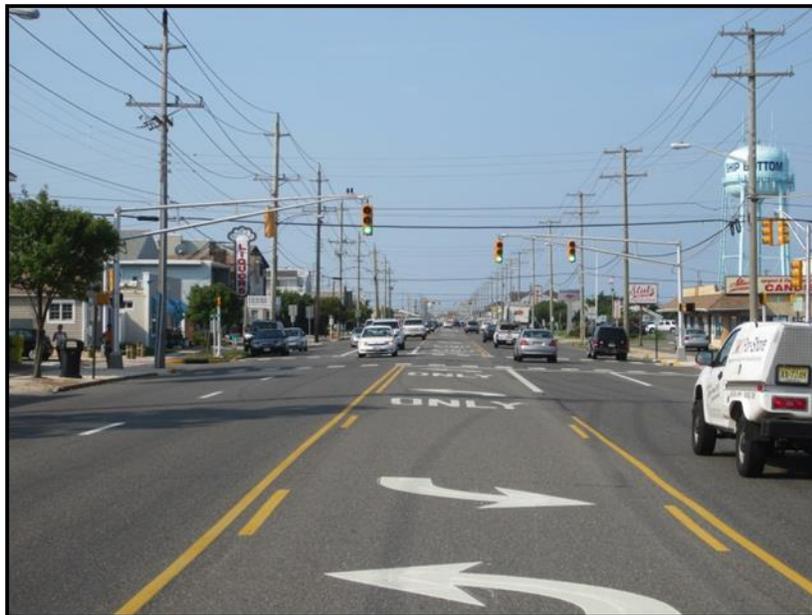
Figure 2 – Typical view along Long Beach Boulevard

signs instruct the public with the change in speed limits. The land use throughout the corridor is predominantly focused on tourism, primarily during the warmer weather, and includes commercial and residential properties, as observed in Figure 2 above. There is one bus route that operates only one day a week.

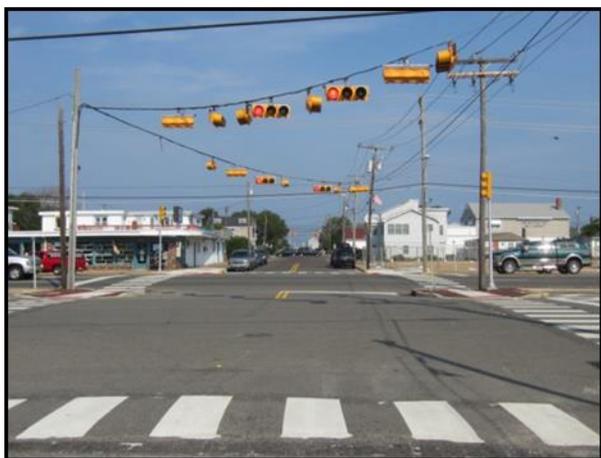
Figure 3a – Horizontal signal on span wire

Primarily during the tourist season, and especially during the weekends, there is heavy vehicular volume as well as significant pedestrian activity. There is confusion to both drivers and pedestrians due to the lack of uniformity of traffic signals (see Figures 3a and 3b), signage, and crosswalks. In addition, pedestrians take a lot of liberties with their roadway crossings.

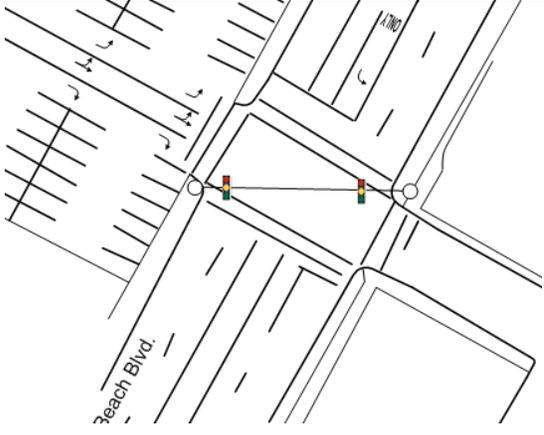
<p>6b)</p>	<p>48th Street (MP 7.60): The western part of the intersection is a one-way exit (only) from a church parking lot. The roadway section includes two lanes in each direction with a southbound left-turn lane. The pavement width is 69 feet, with wide outside lanes to accommodate parking. There are no shoulders. There are marked crosswalks at all crossings. The traffic signal heads are vertical on a span wire.</p> <p><b>Note:</b> See crash diagram in Appendix D.</p>

<p>The diagram shows an intersection of 48th Street and Beach Blvd. Two vertical traffic signal heads are mounted on a horizontal span wire across the intersection. The roadway has two lanes in each direction, with a dedicated left-turn lane on the southbound side. A church parking lot is located to the west of the intersection.</p>
<p>7)</p>	<p><b>Five-Lane Roadway with Horizontal Signals on Span Wire</b></p> <p>24th Street (MP 8.56): The roadway section includes two lanes in each direction with a left-turn lane in both directions. The pavement width is 69 feet, with wide outside lanes to accommodate parking. There are no shoulders. The crosswalks are marked at all the crossings and the horizontal traffic signal heads are on a span wire. There is mini-golf on the northwest side of the intersection that generates pedestrian traffic.</p>

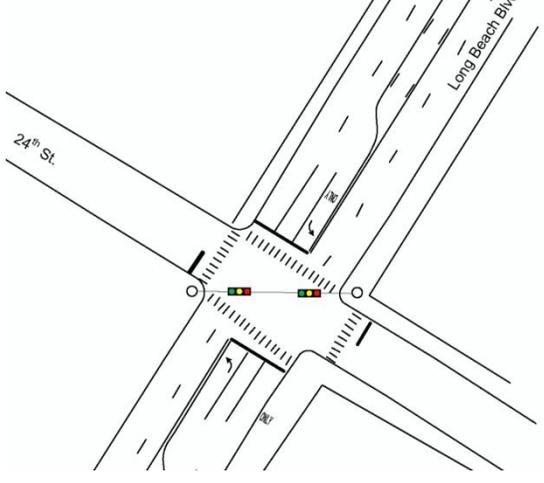
<p>The diagram shows an intersection of 24th Street and Long Beach Blvd. Two horizontal traffic signal heads are mounted on a horizontal span wire across the intersection. The roadway has two lanes in each direction with left-turn lanes in both directions. A mini-golf course is located on the northwest side of the intersection.</p>

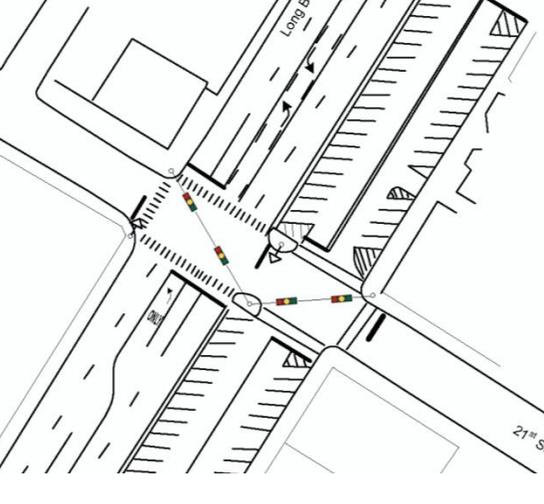
<p>8)</p>	<p><b>Five-Lane Roadway with Horizontal Signals on Span Wire and Adjacent Angled Parking</b></p> <p>21st Street (MP 8.70): The roadway section includes two lanes in each direction with a two-way-left-turn lane. The pavement width is 69 feet, with wide outside lanes to accommodate parking; there are no shoulders. The crosswalks are marked. There is an adjacent roadway to the east with angled parking in both directions; access is from 21st Street. The traffic signals are horizontal signal heads on a span wire.</p>

<p>The diagram shows an intersection of 21st Street and Long Beach Blvd. Two horizontal traffic signal heads are mounted on a horizontal span wire across the intersection. The roadway has two lanes in each direction with two-way left-turn lanes. An adjacent roadway to the east features angled parking with access from 21st Street.</p>

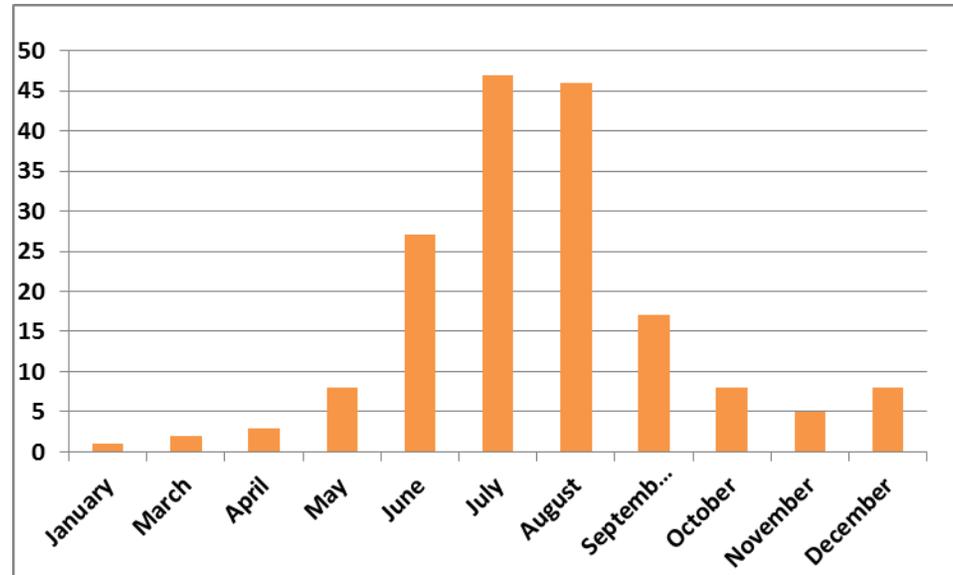
Figure 5 – Crashes by month 2009 to 2011

The table below makes it very clear that the majority of the crashes occurred during the summer tourist season.

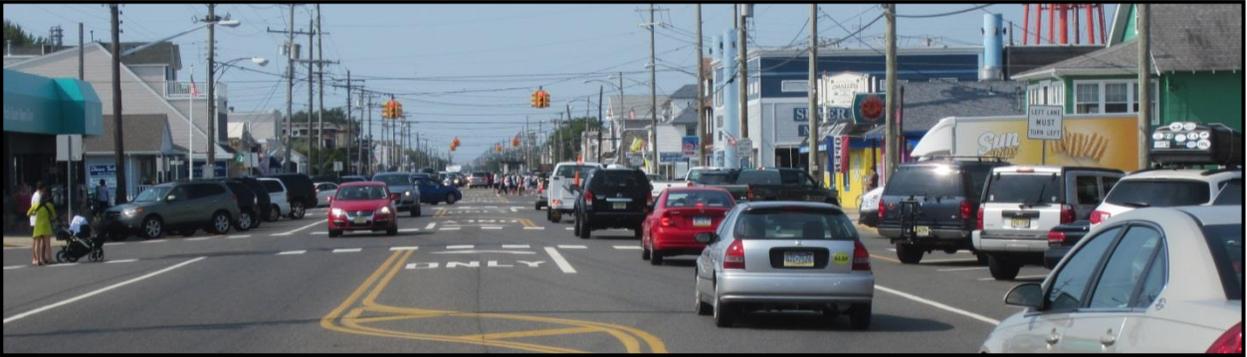
Issue: Visibility	Safety Risk	
<b>Description:</b> Visibility at intersections is limited by parked vehicles and high speed of traffic.	Medium/High

RSA Team's Recommendation	Cost	Potential Safety Benefit
Consider the installation of (mountable or painted) bulb-outs at intersections. (1)	Low (Painted), High (Mountable)	Medium/High

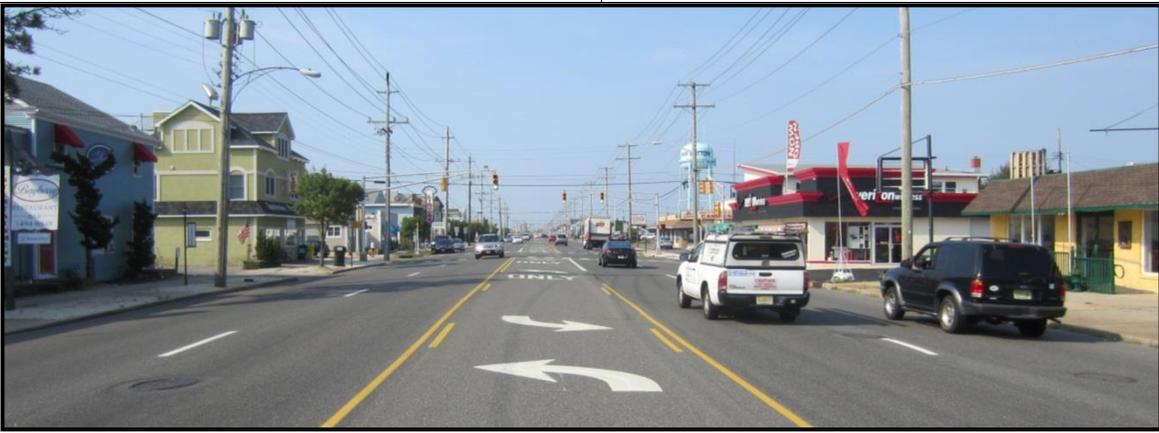
Issue: Excessive Speed	Safety Risk	
<b>Description:</b> The current roadway cross section is experiencing high vehicle operating speed.	High

RSA Team's Recommendation	Cost	Potential Safety Benefit
Speed reduction may be encouraged by narrowing lanes from 12 to 11 feet. (2)	Low	High
Consider the delineation of the edge of the outer travel lane with shoulder markings. (3)	Low	High

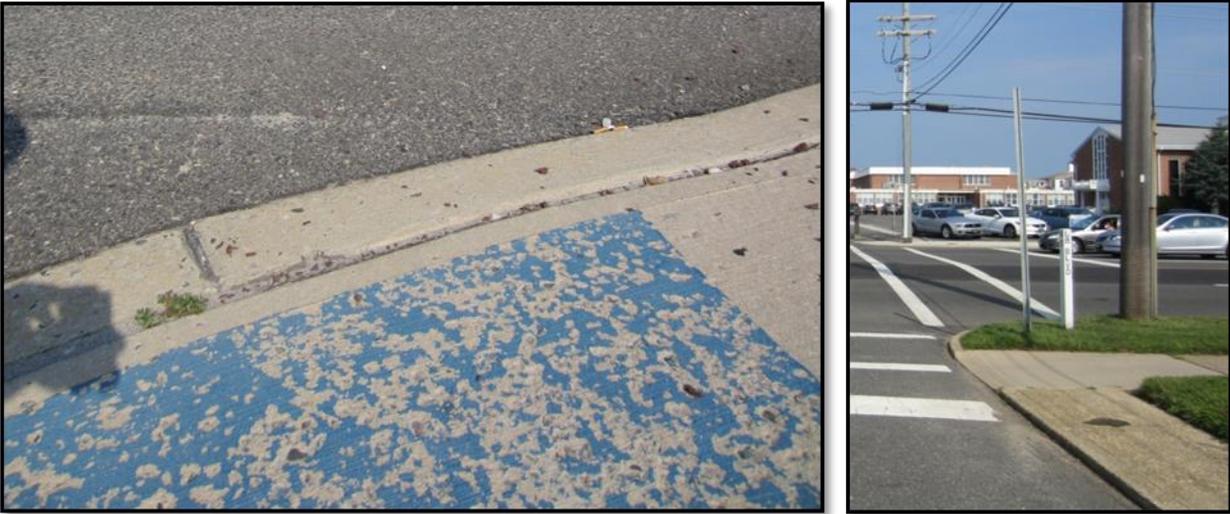
Issue: ADA	Safety Risk	
<b>Description:</b> ADA accommodations are not uniformly fully compliant.	Medium

RSA Team's Recommendation	Cost	Potential Safety Benefit
Plan for full ADA compliance by scheduling upgrades of existing curbs and sidewalks. (6)	Medium	Medium

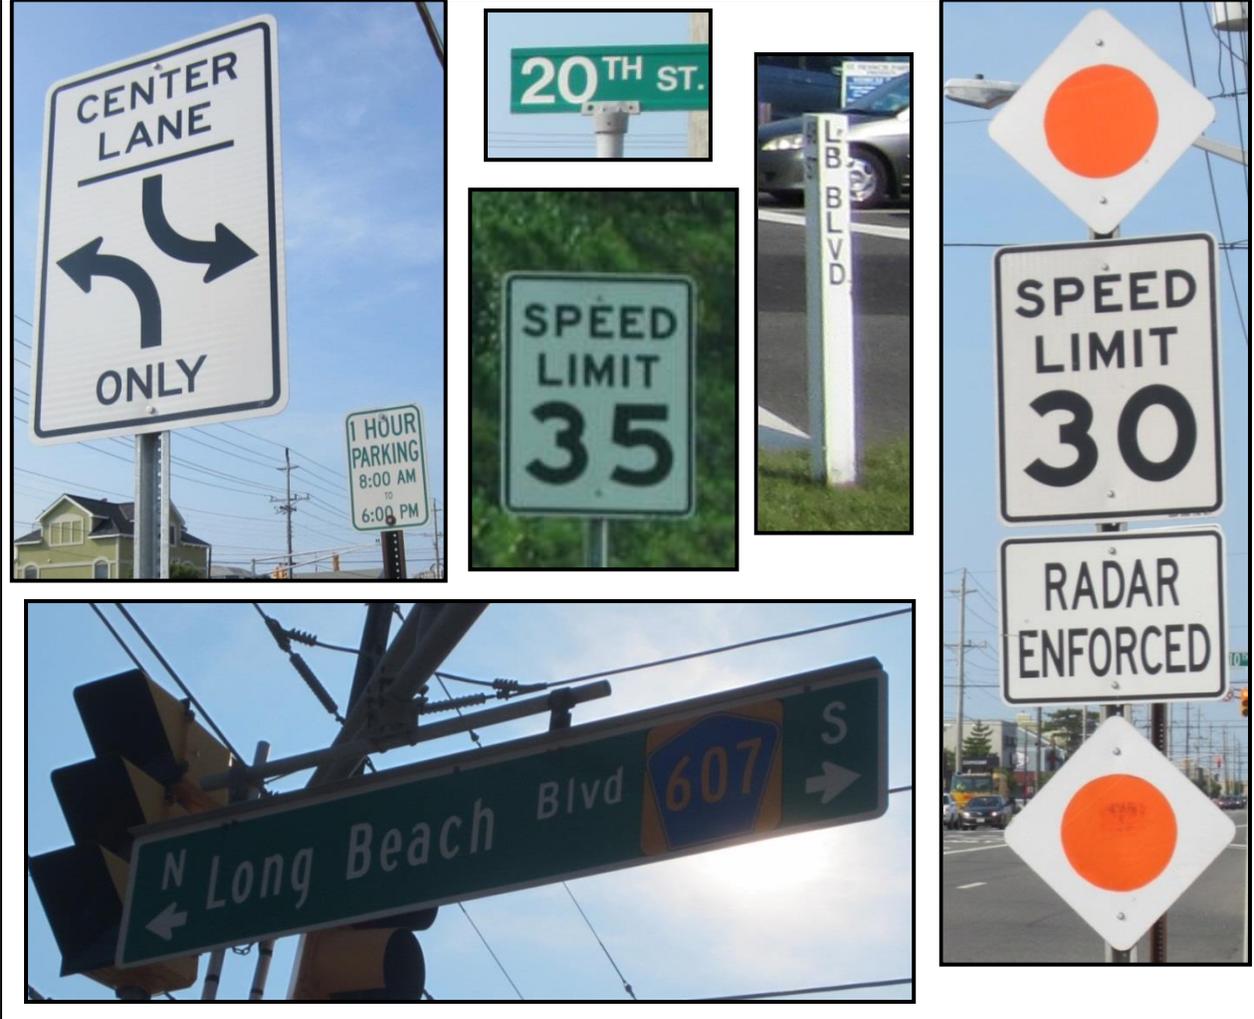
Issue: Signs Not Uniform	Safety Risk	
<p><b>Description:</b> Signage use and application is not uniform throughout the corridor.</p>	<p>Medium/High</p>

RSA Team's Recommendation	Cost	Potential Safety Benefit
<p>Professional engineering staff should review the use and application of signage to ensure standardized application throughout the corridor.(7)</p>	<p>Low</p>	<p>Medium/High</p>
<p>Professional engineering staff should conduct a thorough evaluation of existing and required signage to reduce the amount of signage along the corridor and decrease sign clutter. (8)</p>	<p>Low</p>	<p>Medium/High</p>

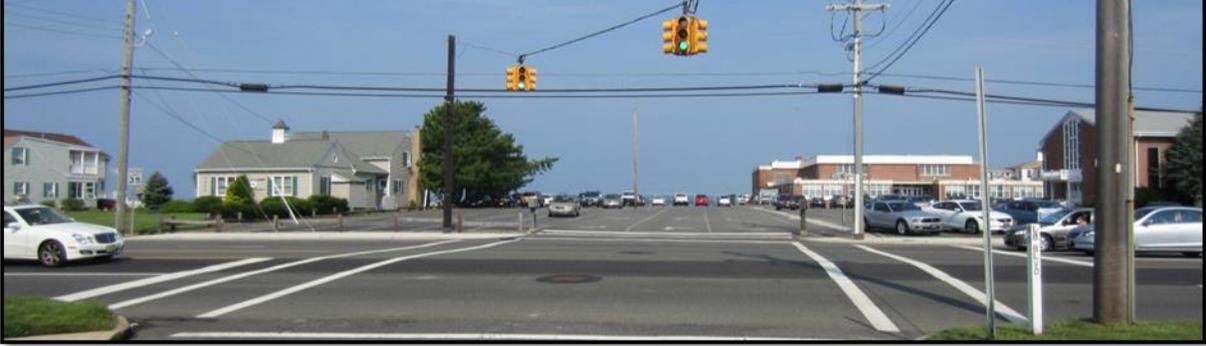
Issue: Pedestrian Heads	Safety Risk	
<b>Description:</b> Traffic signals lack pedestrian heads or have older, non-countdown pedestrian signal heads or no pedestrian heads.	Medium/High	
<b>Description:</b> Pedestrians appear to have difficulty crossing at signalized intersections.	Medium

RSA Team’s Recommendation	Cost	Potential Safety Benefit
Consider installation or upgrade of countdown pedestrian heads at signalized intersections.(9)	Medium	Medium/High

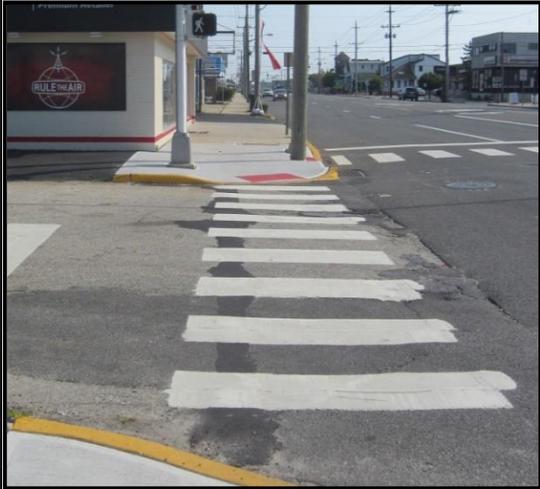
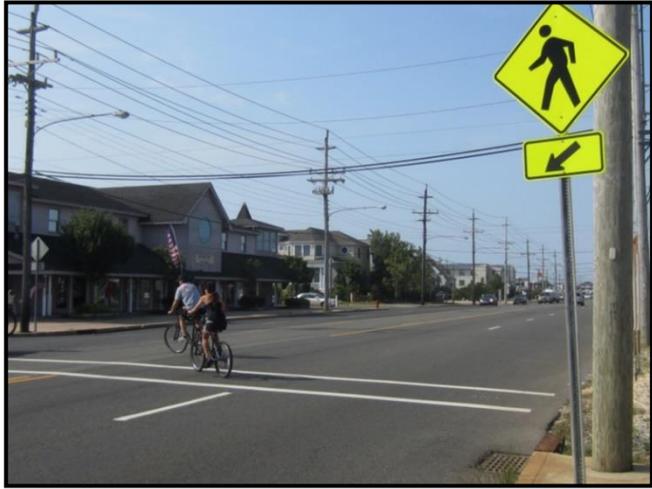
Issue: Uniformity of Crosswalks	Safety Risk	
<p><b>Description:</b> There is a lack of consistency in the overall marking, signage, and locations of unsignalized crosswalks.</p>	<p>Medium/High</p>

RSA Team's Recommendation	Cost	Potential Safety Benefit
<p>Review the corridor to identify crosswalks with inconsistent marking styles and promote uniformity with crosswalks.(10)</p>	<p>Low</p>	<p>Medium/High</p>
<p>Consider providing an unsignalized crossing location periodically between signals, at consistent intervals. (Every block, every other block, every third block, etc.) (11)</p>	<p>Low</p>	<p>Medium/High</p>

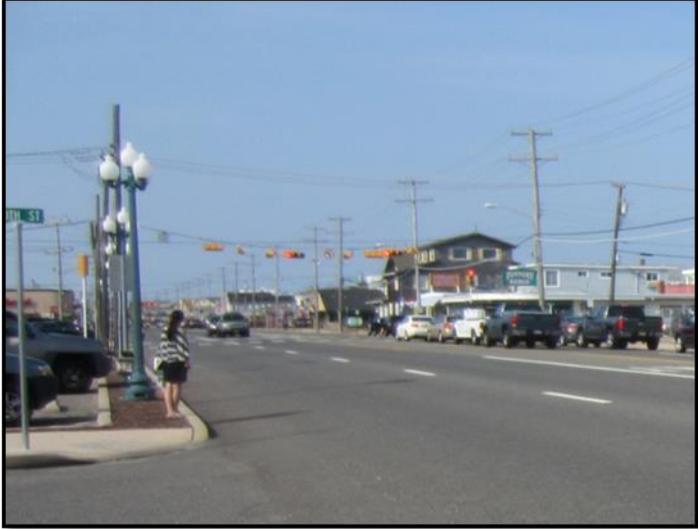
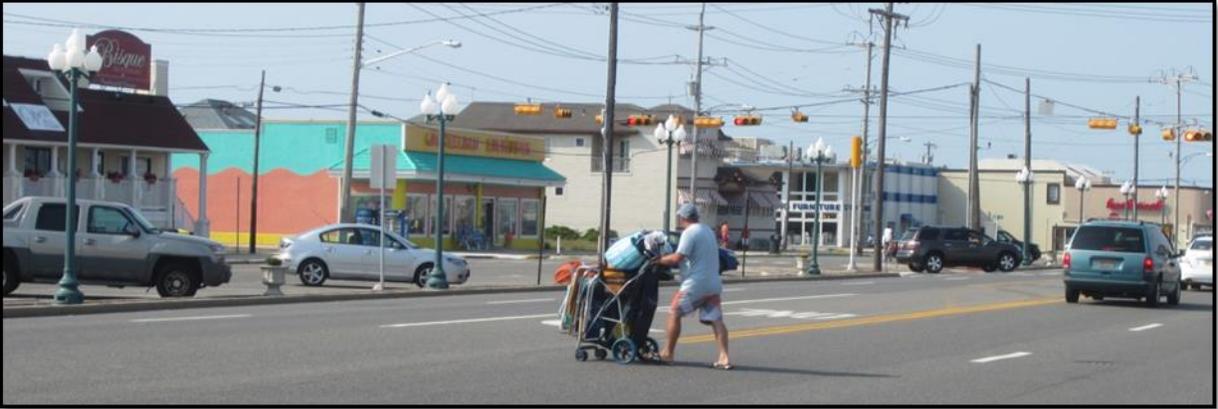
Issue: Crosswalk Design	Safety Risk	
<p><b>Description:</b> Pedestrians did not feel comfortable crossing at unsignalized designated pedestrian crossing locations, due to driver behavior.</p>	Medium/High	
<p><b>Description:</b> Pedestrians were observed not using pedestrian facilities such as sidewalks and marked crosswalks.</p>	High

RSA Team's Recommendation	Cost	Potential Safety Benefit
<p>Additional active lighted crosswalk signage should be considered at marked crosswalks where additional visibility is needed.(18)</p>	Medium	Medium/High
<p>Consider the use of treatments to enhance visibility of crosswalks, potentially including stamped concrete, bump-outs, bollards, stanchions, and refuges where additional visibility is needed. (19)</p>	Medium	Medium/High

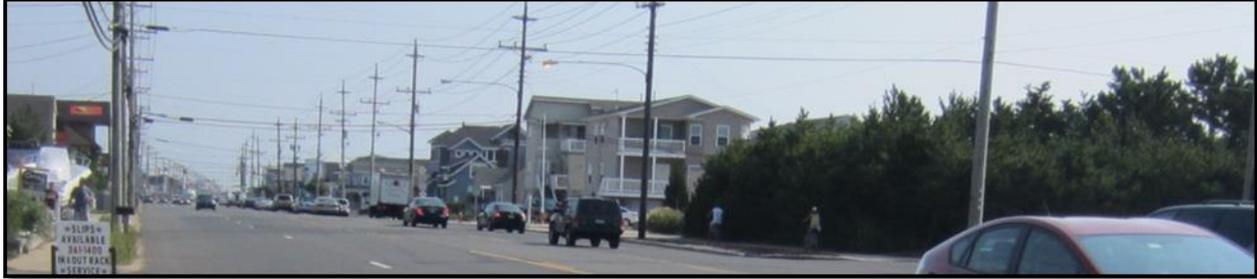
Issue: Signal Locations	Safety Risk	
<b>Description:</b> Left turns are difficult to make; the signal locations are not optimally located and the network of intersections does not operate efficiently.	Medium

RSA Team's Recommendation	Cost	Potential Safety Benefit
Professional staff should conduct a study to determine the optimal locations and intervals of signalized intersections. (28)	High	High

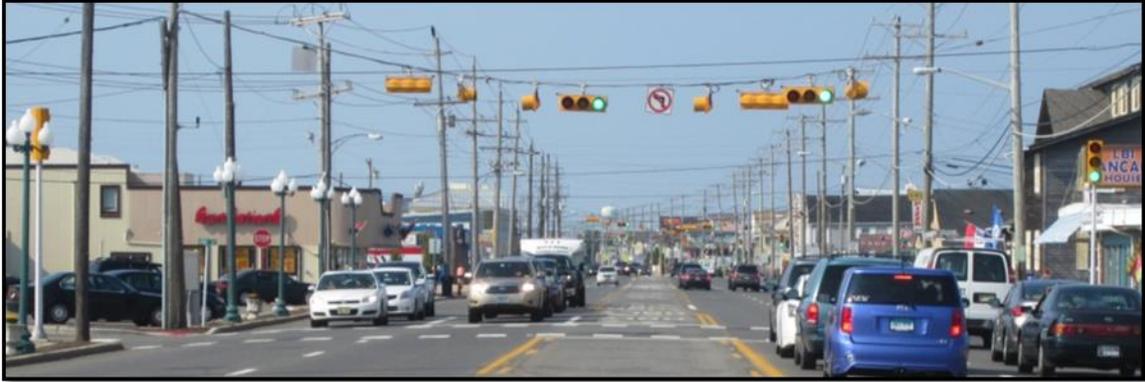
Issue: Horizontal Signal Heads	Safety Risk	
<b>Description:</b> Some of the signals are horizontal and because this type of signal head is uncommon, and drivers are not familiar with it, enhanced visibility would be helpful.	Medium

RSA Team's Recommendation	Cost	Potential Safety Benefit
Increased visibility of signal heads would be enhanced by installing retroreflective back plates. (29)	Low	Medium

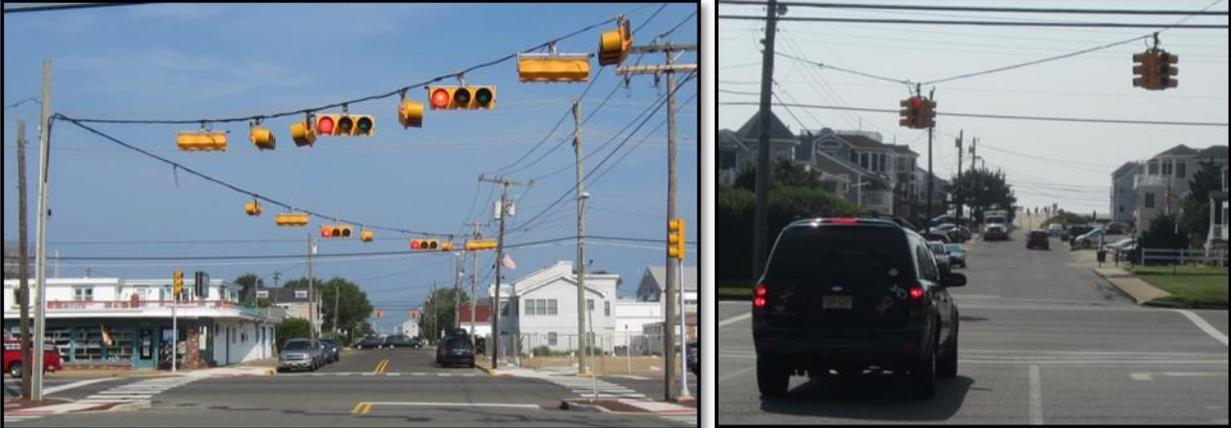
Issue: Signal Heads	Safety Risk	
<p><b>Description:</b> There are a number of different combinations of signal head configurations at traffic signals: vertical, horizontal, on span wires, and on poles. The inconsistency can be confusing to drivers.</p>	<p>Medium</p>

RSA Team's Recommendation	Cost	Potential Safety Benefit
<p>A standard signal configuration should be developed and implemented as signal equipment is upgraded in conformance with the MUTCD. (30)</p>	<p>High</p>	<p>Medium/High</p>
<p>Consider installation of 12-inch lenses for vehicle signal heads as per MUTCD. (31)</p>	<p>Medium</p>	<p>Medium</p>

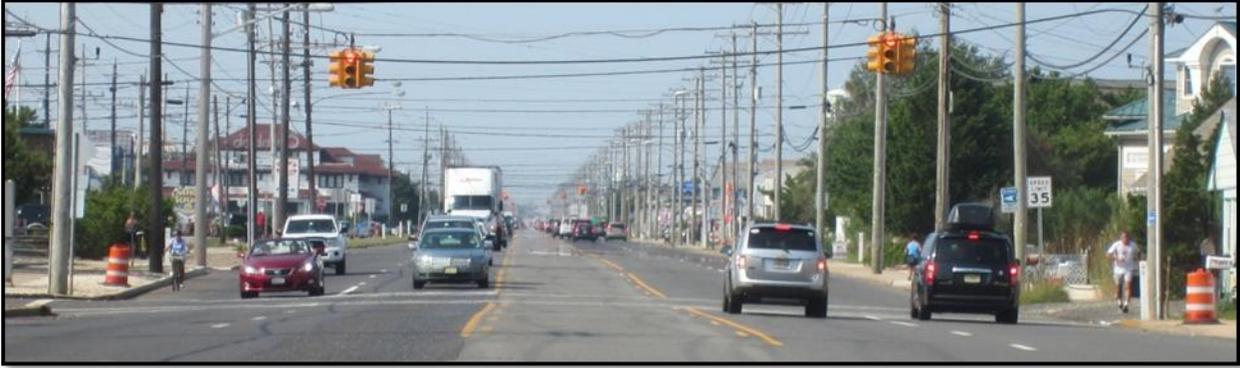
Issue: Bike Lanes	Safety Risk	
<b>Description:</b> Bicycle accommodations are limited along Long Beach Boulevard	Medium

RSA Team's Recommendation	Cost	Potential Safety Benefit
Consider providing quality bicycle facilities on parallel roadways to Long Beach Boulevard to encourage bicycle use of these facilities. (33)	Medium	Medium/High
Consider the installation of additional bicycle facilities along Long Beach Boulevard.(34)	Medium	Medium/High
