Road Safety Audit:

CR 514 (Hamilton Street) between Berry Street
and New Brunswick Border
Franklin Township, Somerset County

MARCH 2018

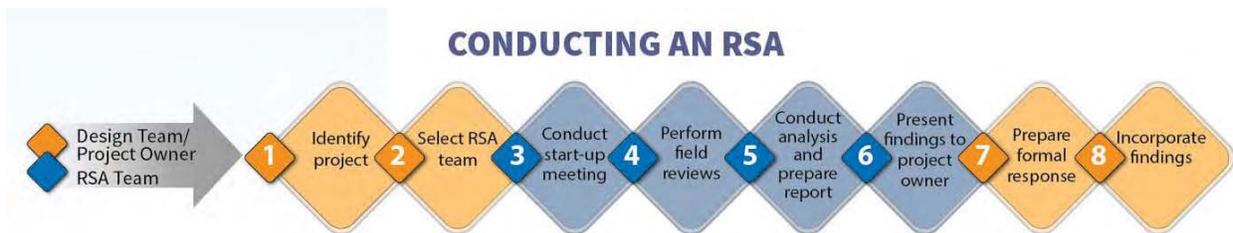
The RSA process, one of FHWA’s proven safety countermeasures, is shown in the figure below.

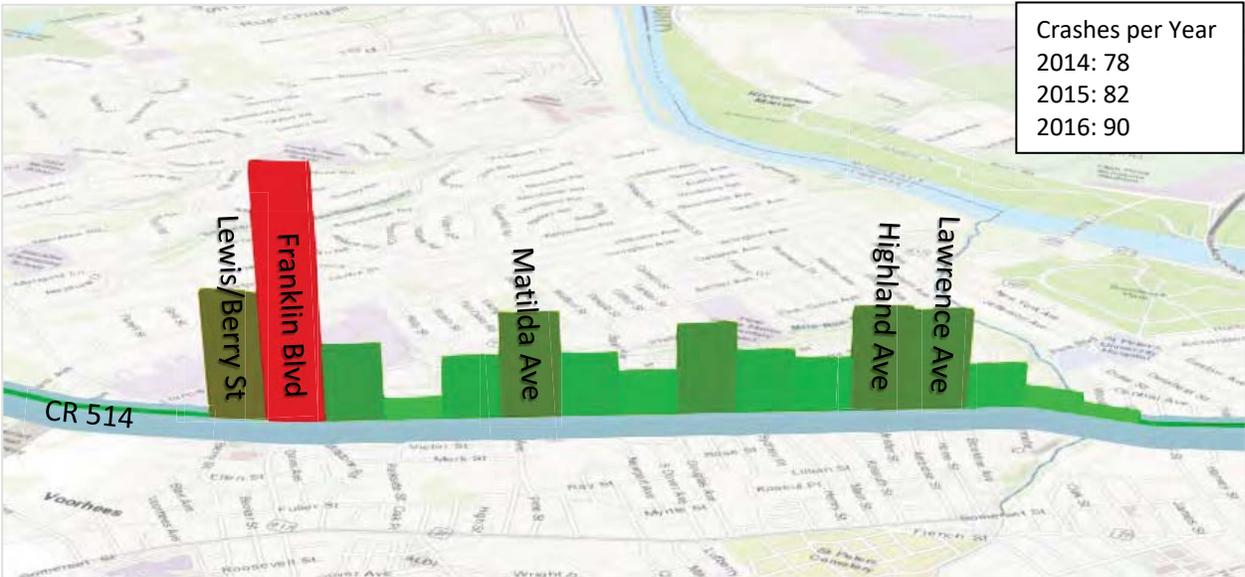
Figure 9 – Total Crash Locations (2014-2016)

Crashes at unsignalized intersections were overrepresented compared to the county road system average. Thirty percent (30%) of crashes occurred at unsignalized intersections compared to 24% on all county roads. More crashes occurred at or near Lewis/Berry Street, Franklin Boulevard and Matilda, Lawrence and Highland Avenues. Crash frequency in 0.1-mile increments for the three-year period from 2014 through 2016, as shown in the following figure, shows the highest concentration of crashes at Franklin Boulevard.

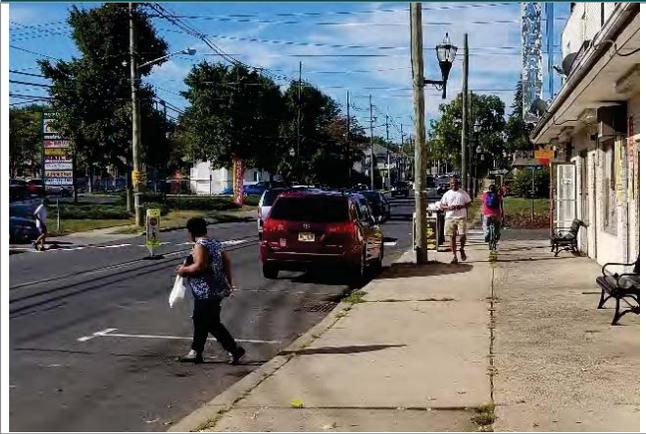
A photograph showing a pedestrian crossing a street midblock. A red SUV is stopped in the street, and other pedestrians are visible on the sidewalk.

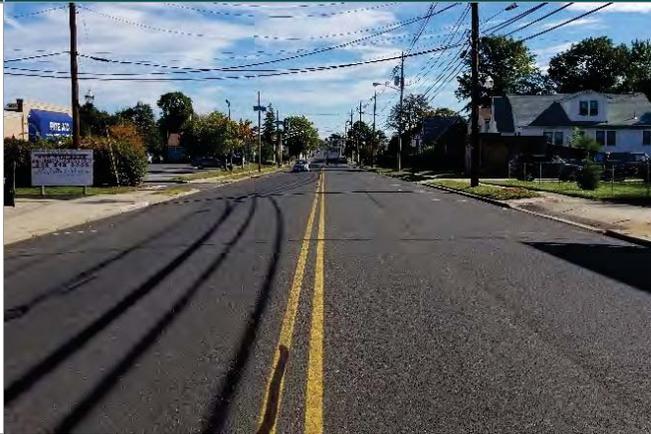
A photograph of a wide street with a double yellow line down the center. There are no dedicated bicycle lanes or facilities visible.
Pedestrians were observed crossing midblock	Lack of on-street bicycle facilities

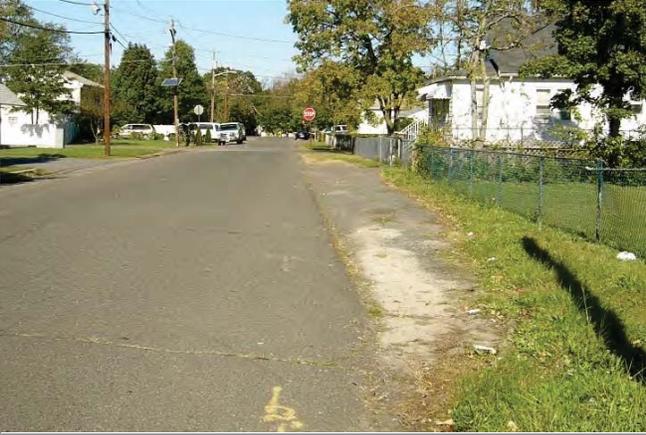
A photograph of a side street with a dirt and grass shoulder instead of a paved sidewalk. A yellow bicycle symbol is painted on the asphalt.

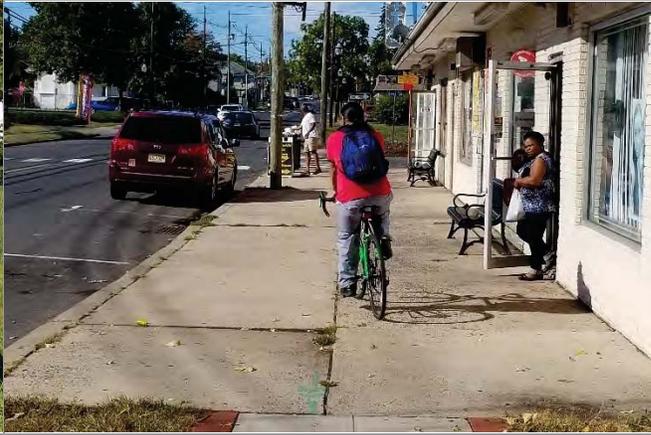
A photograph showing a bicyclist riding on a sidewalk next to a building. A red SUV is parked on the street.
Many side streets lacked sidewalks (Berry St NB)	Many bicyclists were observed riding on sidewalks

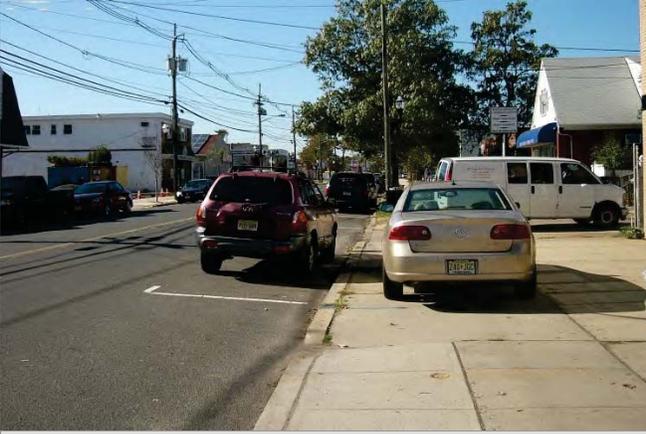
A photograph showing a silver car parked on a sidewalk next to a street. A red SUV is also visible on the street.

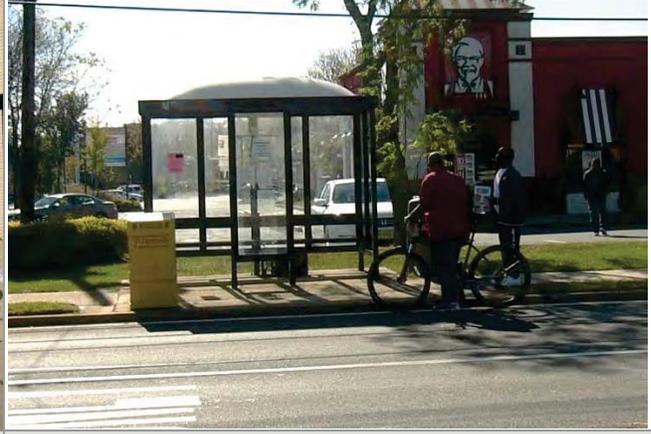
A photograph of a bus stop shelter on a sidewalk. A bicyclist is standing next to the shelter, and there are no bicycle racks visible.

Parking on sidewalks was a common issue	There was a lack of bicycle corals/racks

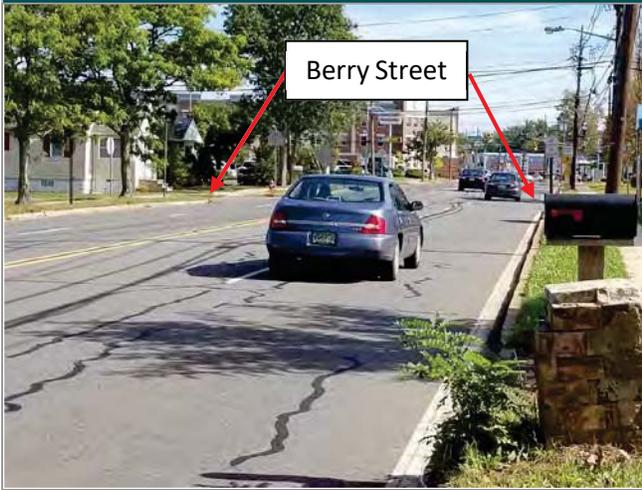
4-lane section at Berry St causes shadowing crashes

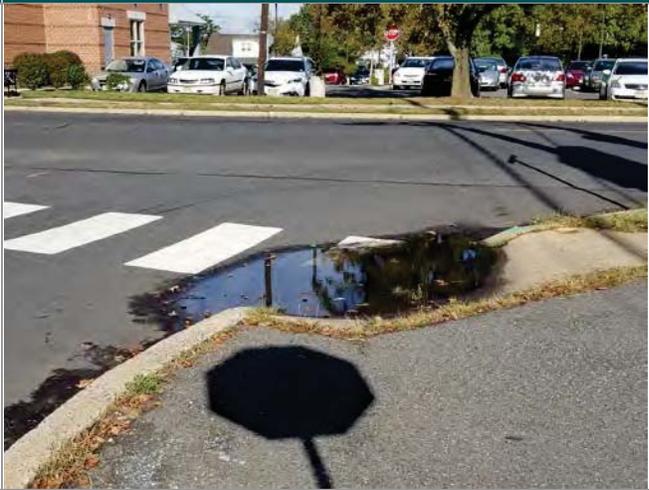
Ponding is an issue at multiple locations

No.	Recommendation	Safety Benefit	Cost	Time Frame	Jurisdiction
3	Consider upgrading all ramps for ADA compliance	✓✓✓ ²	\$\$\$	●	County
4	Consider addressing ponding issues at street junctions	✓ ²	\$\$	●	County
5	Consider corridor-wide signal upgrades (replace 8" traffic signal heads with 12", install backplates with retroreflective border, evaluate clearance intervals, update to countdown pedestrian signal heads, replace push buttons in compliance with ADA, etc.)	✓✓✓	\$\$\$	●	County
6	Consider extending safety improvements listed in this RSA to Francis Street (i.e. speed and/or lane reduction) since this is this is the middle school entrance	✓ ²	\$	●	County
7	Study improvements to existing highway and pedestrian scale lighting	✓✓✓	\$\$	●	County/ Township
8	Investigate converting to a 3-lane section (2 travel lanes, TWLTL and bike lanes; i.e. road diet) west of Franklin Blvd	✓	\$\$	●	County
9	Explore one-way street operation along side streets such as Berry St (one-way away both sides) and Home St (one-way away northern side)	✓✓	\$	●	Township/ County

25	Investigate ponding/drainage issues at intersection corners (Millstone, Chester/Shevchenko, N Dover and Baier Avenues)	✓ ²	\$\$\$	●	County
Education					
26	Consider sidewalk, crosswalk, multimodal education campaign and code enforcement (Safe Routes to School Plan and Street Smart campaign)	✓ ²	\$	●	County/ Township/ RideWise
27	Consider obtaining observations from residents who seem apprehensive to new developments; added traffic may cause safety concerns	N/A	\$	●	County/ Township

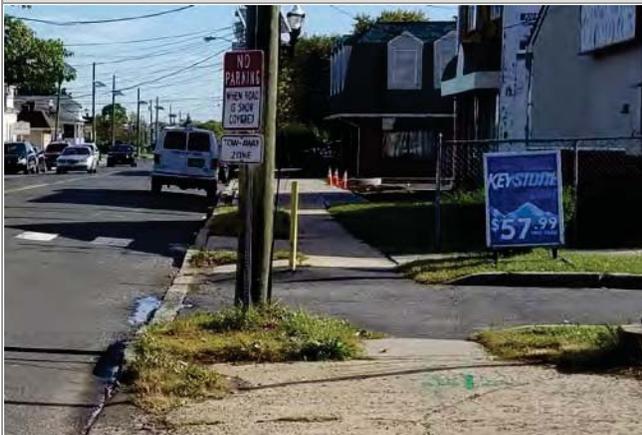
Sidewalk not continuous across some driveways

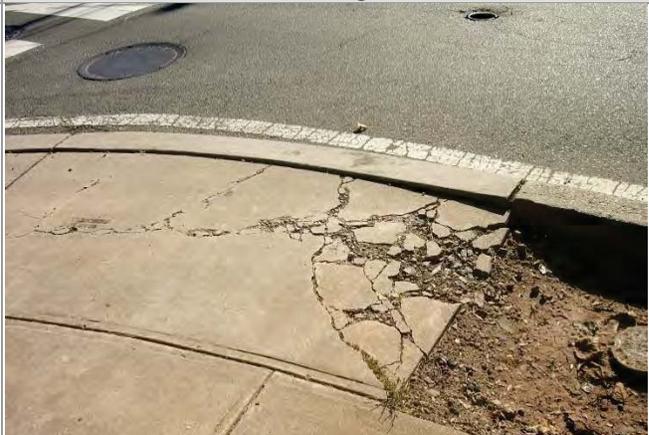
Some curbs and sidewalks are crumbling

61	Consider connecting northern sidewalk between Pershing and Chester/Shevchenko Avenues (missing slabs) and replacement where settlement was	✓	\$	☉	Township

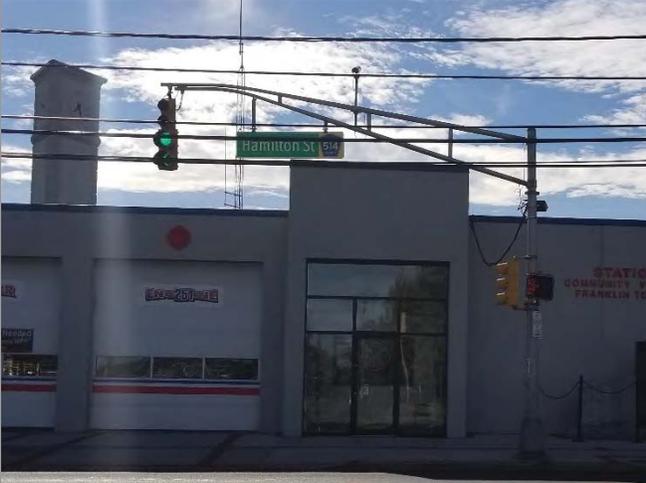
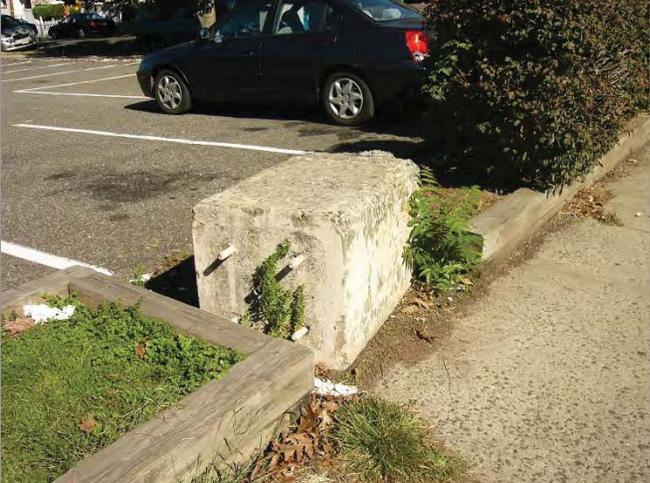
<p>Signal heads are blocked by overhead wiring</p>	<p>The Nora Shopping Center parking lot needs attention</p>

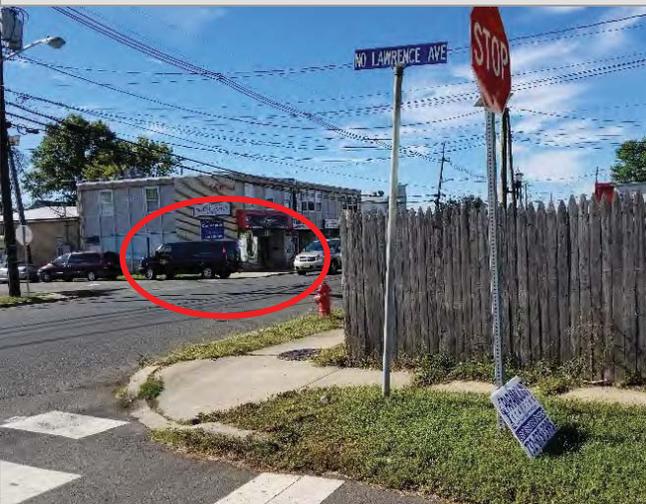
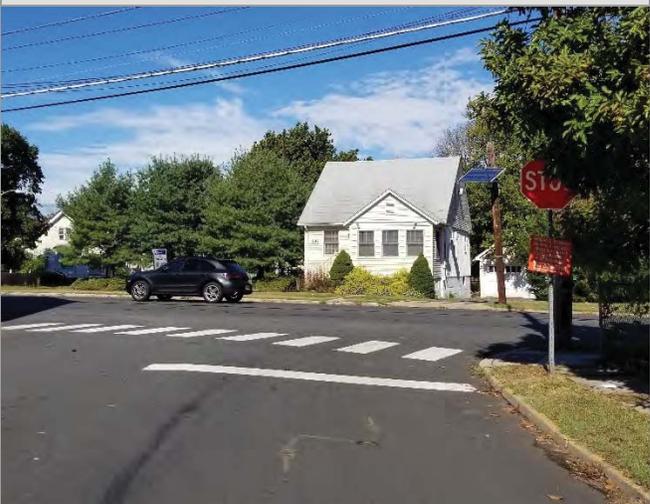
<p>Private fences, hedges and vehicles parked at corner limit driver sight distances and block sidewalk</p>	<p>Overgrown vegetation covers important signage</p>

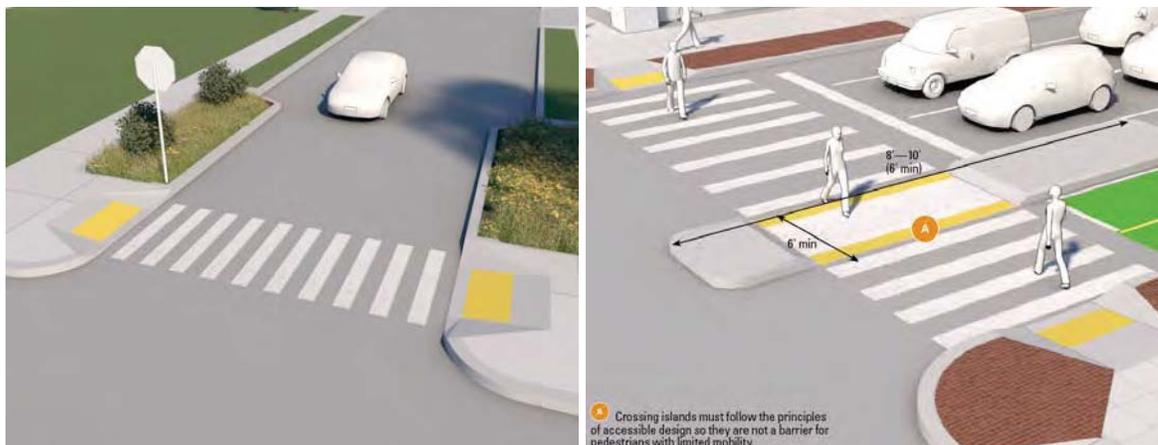
Curb extensions visually and physically narrow the roadway at intersections and midblock locations, creating safer and shorter pedestrian crossings, while increasing the available space for streetscape. They increase the overall visibility of pedestrians by aligning them with the parking lane and help prohibit vehicles from parking in violation of Title 39. Crossing islands, or pedestrian refuge islands, reduce the exposure time of pedestrians to vehicular traffic. They enable pedestrians to make a crossing in two stages — crossing one direction of vehicular travel lanes, pausing at the island, and then completing the crossing. They are recommended where a pedestrian must cross three lanes of traffic in one or both directions but may be implemented on smaller cross sections where space permits.

Figure 11 – Pedestrian Facility Examples
Left: Curb Extension. Right: Crossing Island (Source: CSDG)

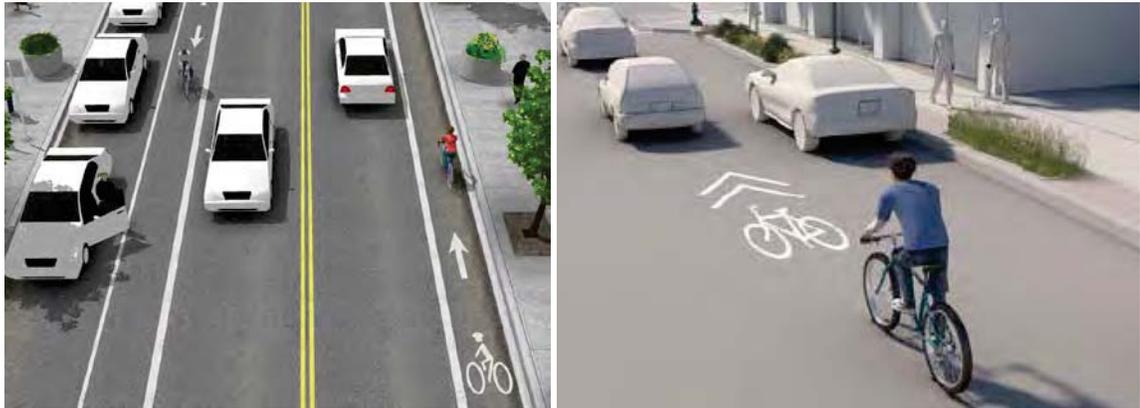
Figure 12 – Bicycle Facility Examples

Bicycle lanes provide an exclusive space for bicyclists using pavement markings and signage. Intended for one-way travel, they are typically located on both sides of a two-way street. Bicycle lanes enable bicyclists to ride at their preferred speed, free from interference from motorists. Where it is not feasible or appropriate to provide dedicated bicycle facilities, shared-lane markings (e.g. “sharrows”) may be used to indicate a shared environment for bicycles and vehicles, such as the ones currently implemented along Hamilton Street in New Brunswick.

Left: Bicycle Lane Adjacent to Parking or Curb (Source: NACTO-UB). Right: Sharrow Markings (Source: CSDG)

Bicycle lanes and shared-lane markings should be extended through intersections and major driveways to enhance continuity, guide bicyclists through the intersection, and improve driver awareness of bicycle activity and movement.

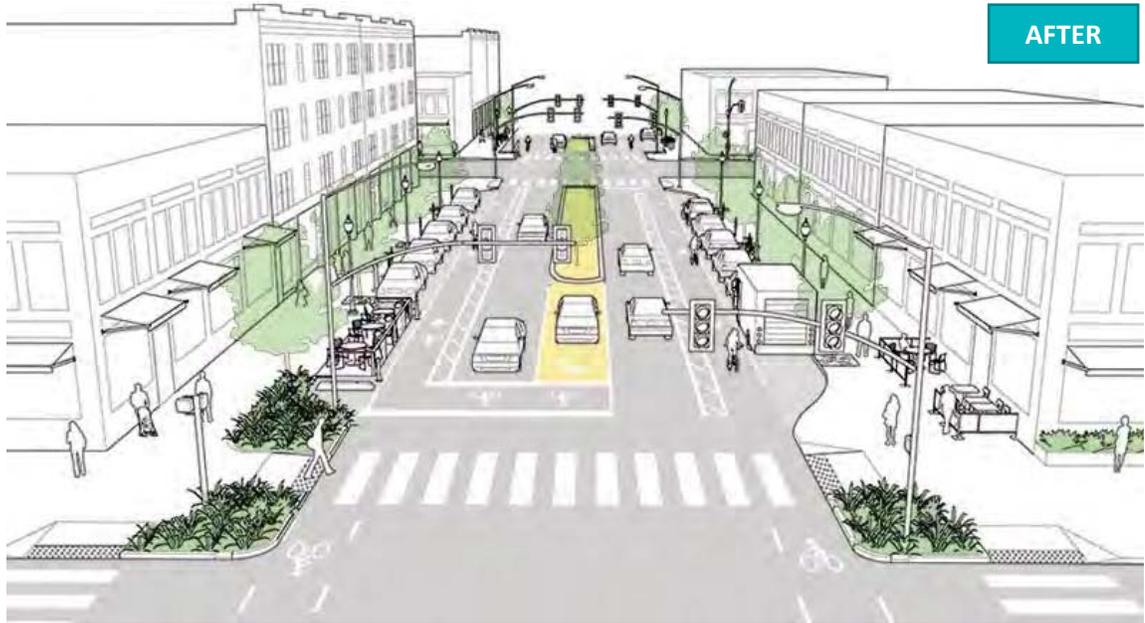
This treatment allows reallocation of existing street space (i.e. roadway cross section) to accommodate multi-modal users. Lane configuration and width for travel, turning movements, parking, and bicycle lanes can be adjusted to optimize use for vehicles, pedestrians, bicyclists and transit. The most common roadway reconfiguration, known as a road diet, involves converting an existing four-lane undivided segment into a three-lane segment with two through lanes and a center two-way left turn lane (TWLTL). On an existing two-lane roadway that currently has room on both sides for parking, the road diet could still be implemented to repurpose the cross section for bicycle lanes, bus stops and/or to widen sidewalks.

Figure 14 – Typical Road Diet Application on a Main Street Typology (Source: NACTO-US)

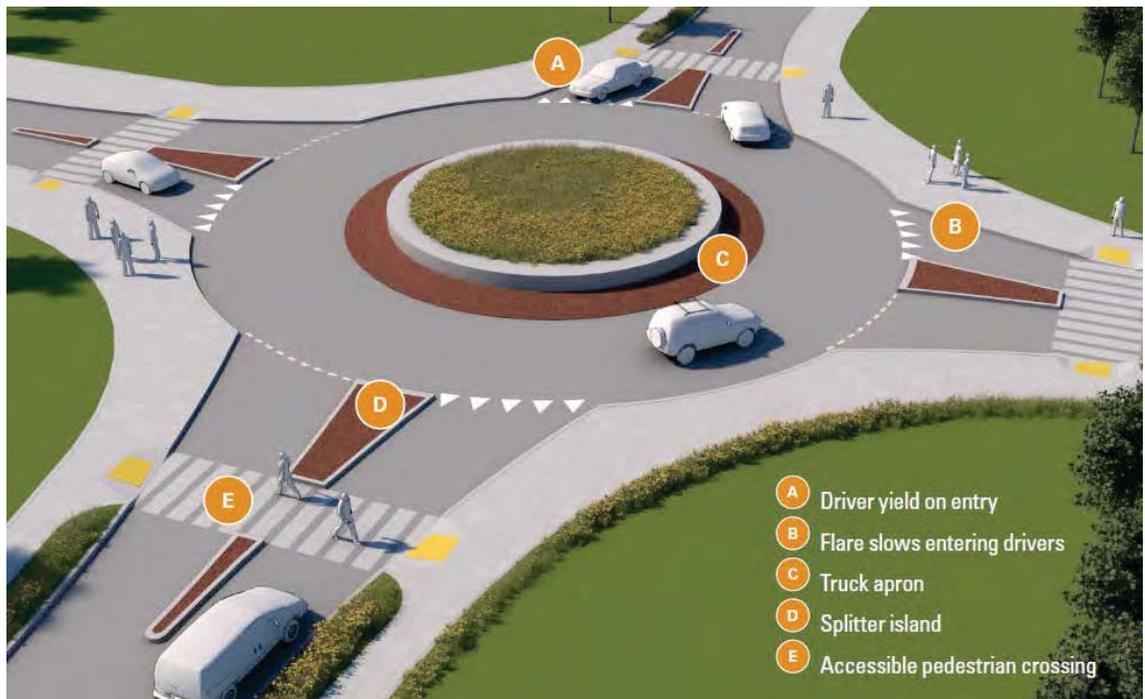
Roundabout design, which was recommended at the intersection of Hamilton Street and Dewald Avenue, should create conditions that reduce vehicle speed and provide a consistent speed into, through, and out of the roundabout. Lower speeds reduce crash frequency and severity for all roadway users, allow safer and easier merging of traffic, provide more reaction time for drivers, and make the facility more accessible for novice users.

Figure 15 – Roundabout Example (Source: CSDG)

Of note, roundabouts typically take up more space than a conventional four-way intersection, but they can also be scaled to fit a wide range of contexts and street typologies. Urban compact roundabouts can balance efficient vehicle flow with the needs of bicyclists and pedestrians.

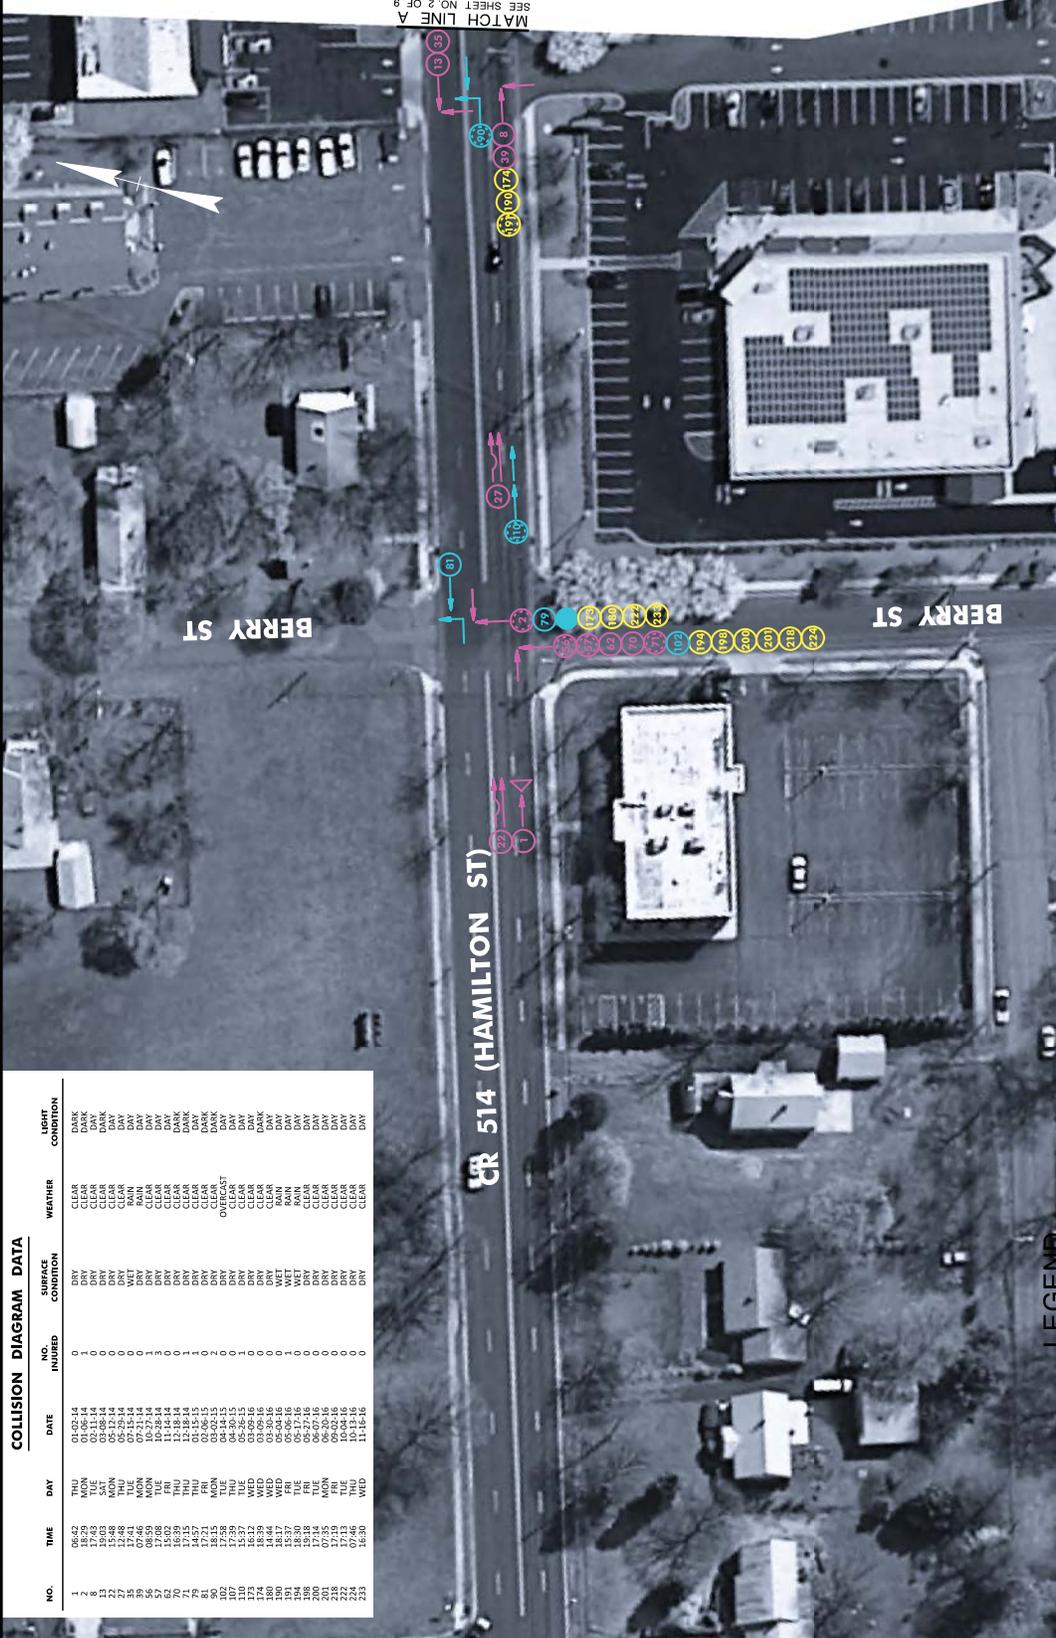
1 9

COLLISION DIAGRAM DATA

NO.	TIME	DAY	DATE	NO. INJURED	SUBSECS CONDITION	WEATHER	LIGHT CONDITION
1	06:62	THU	01-02-14	0	DRY	CLEAR	DARK
2	18:29	MON	01-06-14	1	DRY	CLEAR	DARK
3	15:03	SAT	03-08-14	0	DRY	CLEAR	DARK
13	12:48	THU	05-29-14	0	DRY	CLEAR	DAY
27	12:48	THU	05-29-14	0	DRY	CLEAR	DAY
35	17:41	TUE	07-15-14	0	WET	RAIN	DAY
56	08:59	MON	10-27-14	1	DRY	CLEAR	DAY
62	15:02	FRI	11-04-14	0	DRY	CLEAR	DAY
71	15:33	THU	12-18-14	0	DRY	CLEAR	DARK
79	14:57	THU	01-15-15	1	DRY	CLEAR	DAY
80	16:15	MON	03-02-15	2	DRY	CLEAR	DARK
102	17:39	THU	04-30-15	0	DRY	OVERCAST	DAY
110	15:37	TUE	05-26-15	1	DRY	CLEAR	DAY
174	18:39	WED	03-09-16	0	DRY	CLEAR	DARK
390	18:17	WED	05-04-16	0	WET	RAIN	DAY
391	15:30	FRI	05-07-16	0	WET	RAIN	DAY
398	19:38	FRI	05-27-16	0	DRY	CLEAR	DAY
203	07:35	MON	06-20-16	0	DRY	CLEAR	DAY
225	17:13	TUE	10-04-16	0	DRY	CLEAR	DAY
234	07:46	THU	11-10-16	0	DRY	CLEAR	DAY

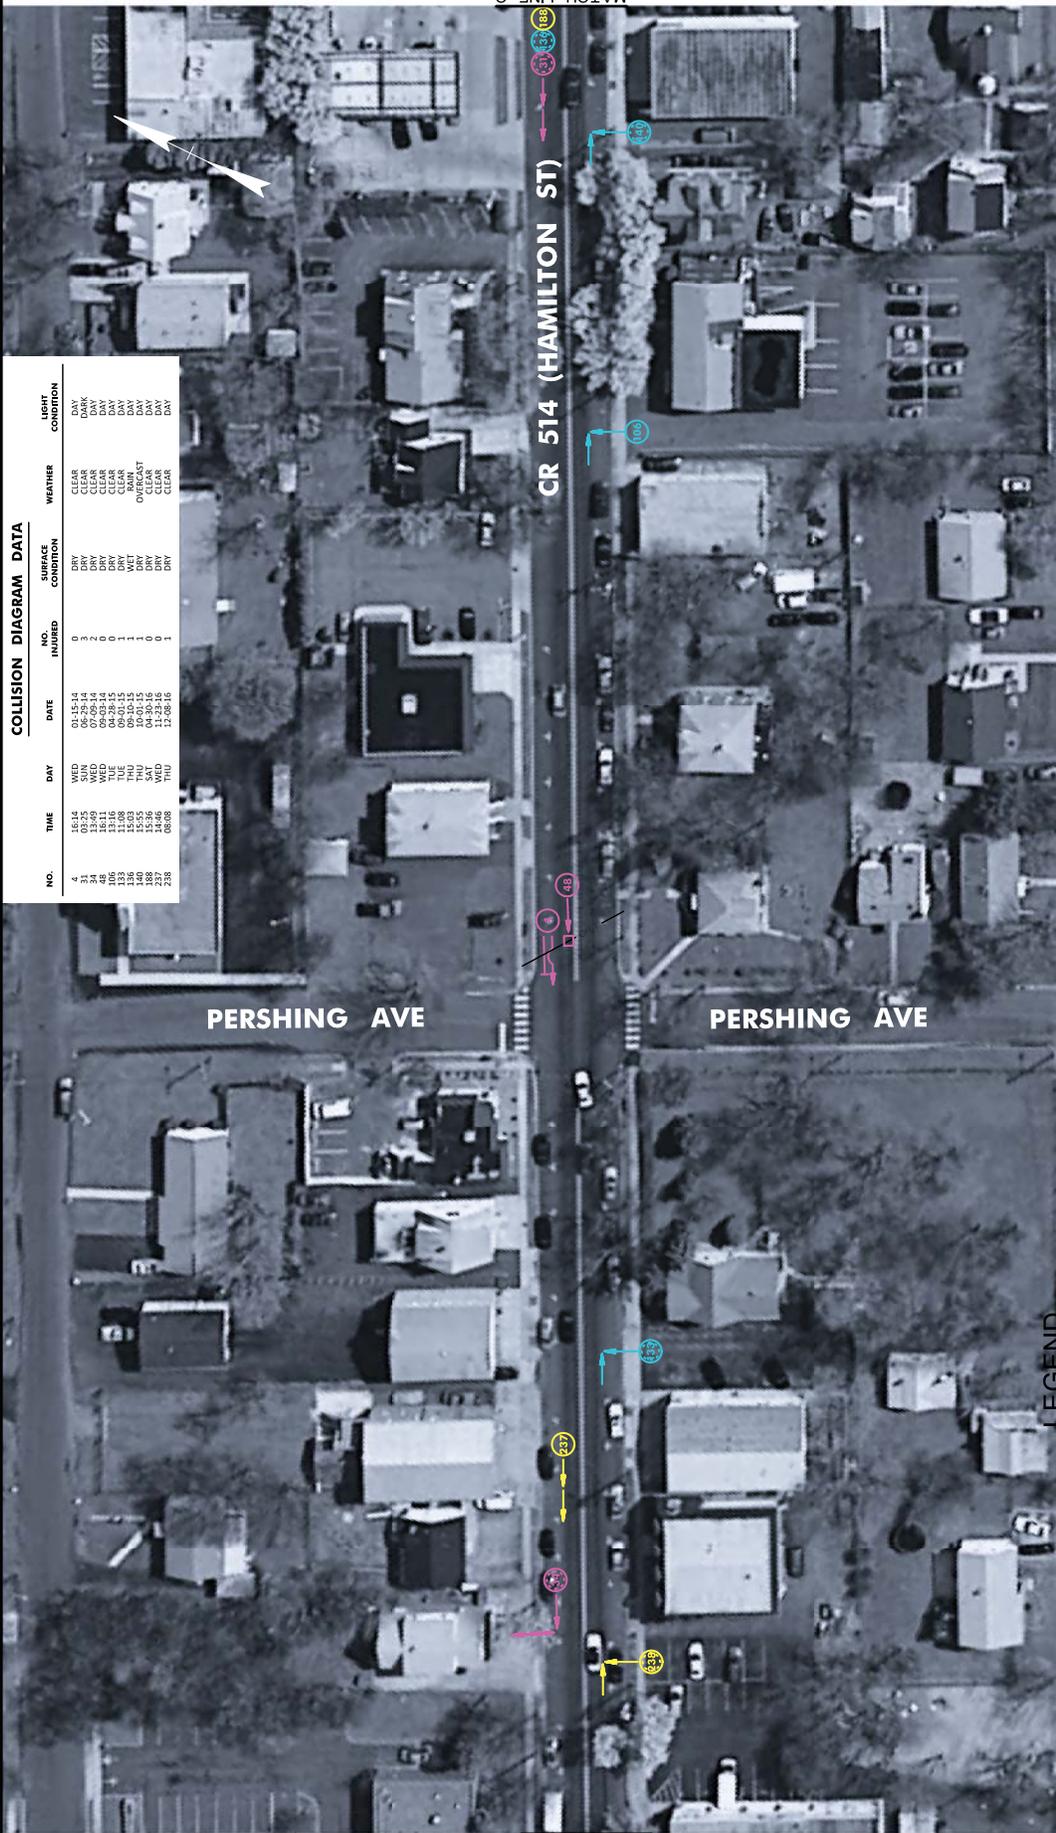
COLLISION DIAGRAM DATA

NO.	TIME	DAY	DATE	NO. INJURED	WEATHER	LIGHT CONDITION
4	16:34	WED	01-15-14	0	DRY	DAY
31	05:25	SUN	06-29-14	3	DRY	DARK
48	16:11	WED	07-09-14	0	DRY	DARK
53	11:08	TUE	07-22-14	0	DRY	DAY
136	15:03	THU	09-20-15	1	DRY	DAY
188	15:36	WED	04-30-16	0	DRY	DAY
238	08:08	THU	11-28-16	1	DRY	DAY

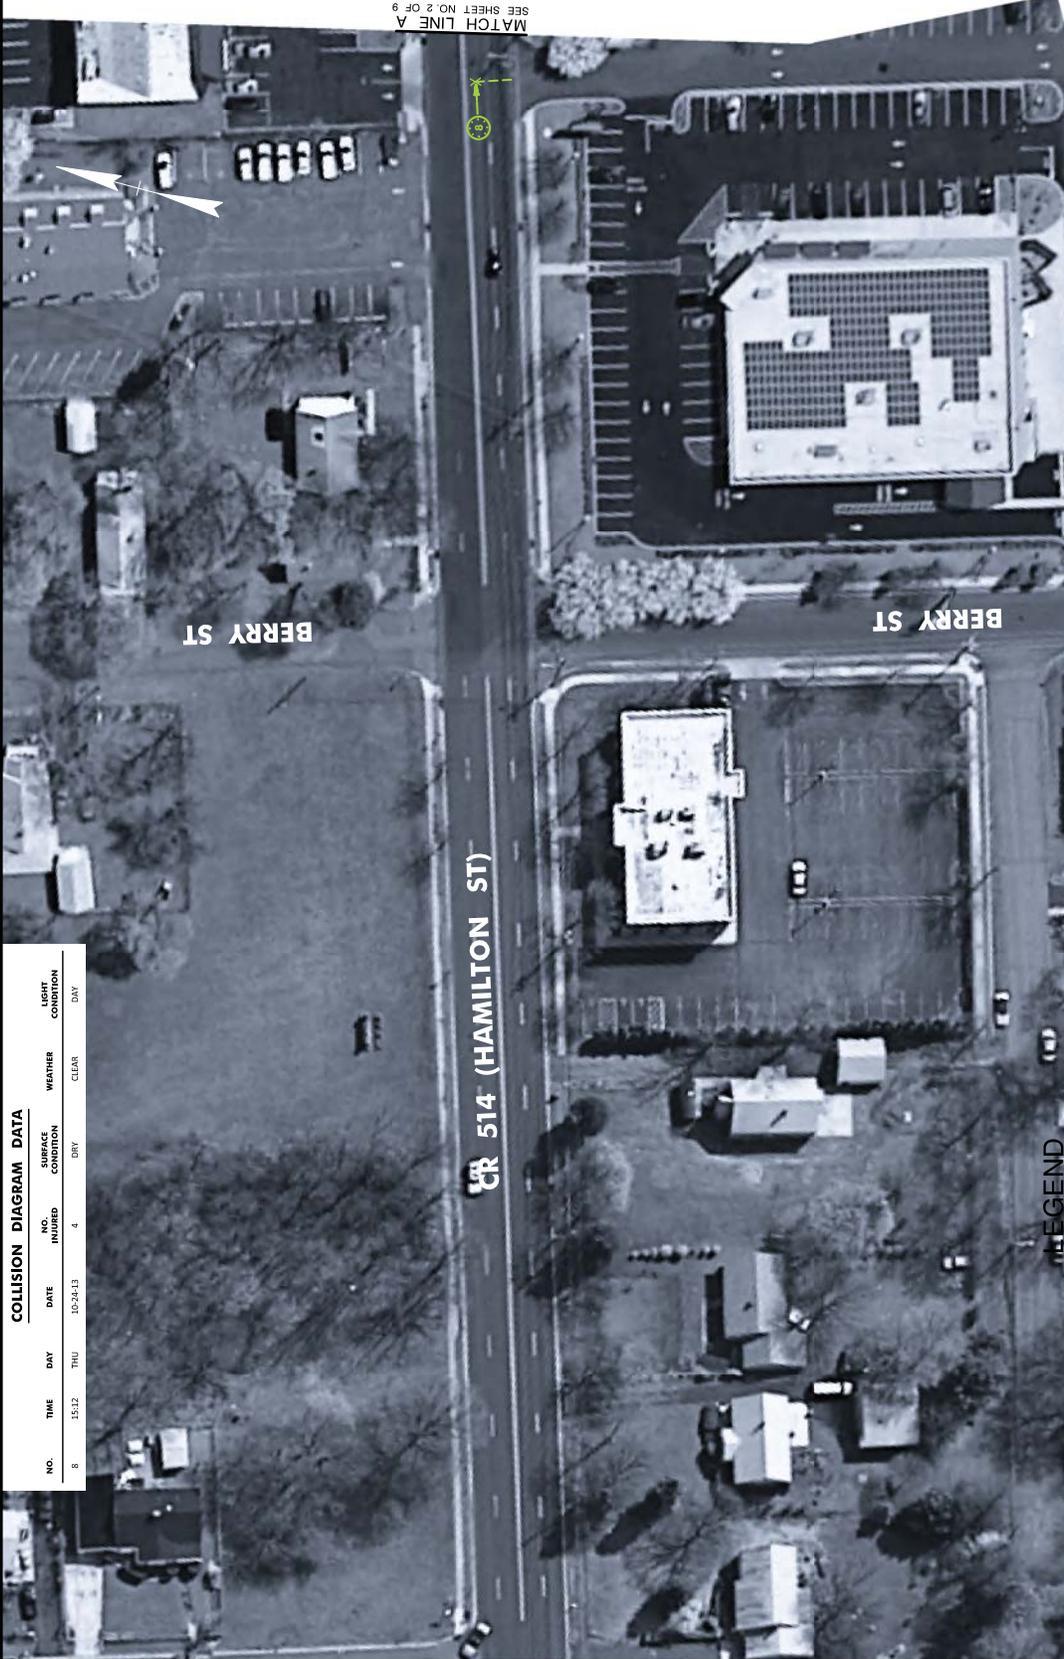
1
9

COLLISION DIAGRAM DATA							
NO.	TIME	DAY	DATE	NO. INJURED	SURFACE CONDITION	WEATHER	LIGHT CONDITION
8	15:12	THU	10-24-13	4	DRY	CLEAR	DAY

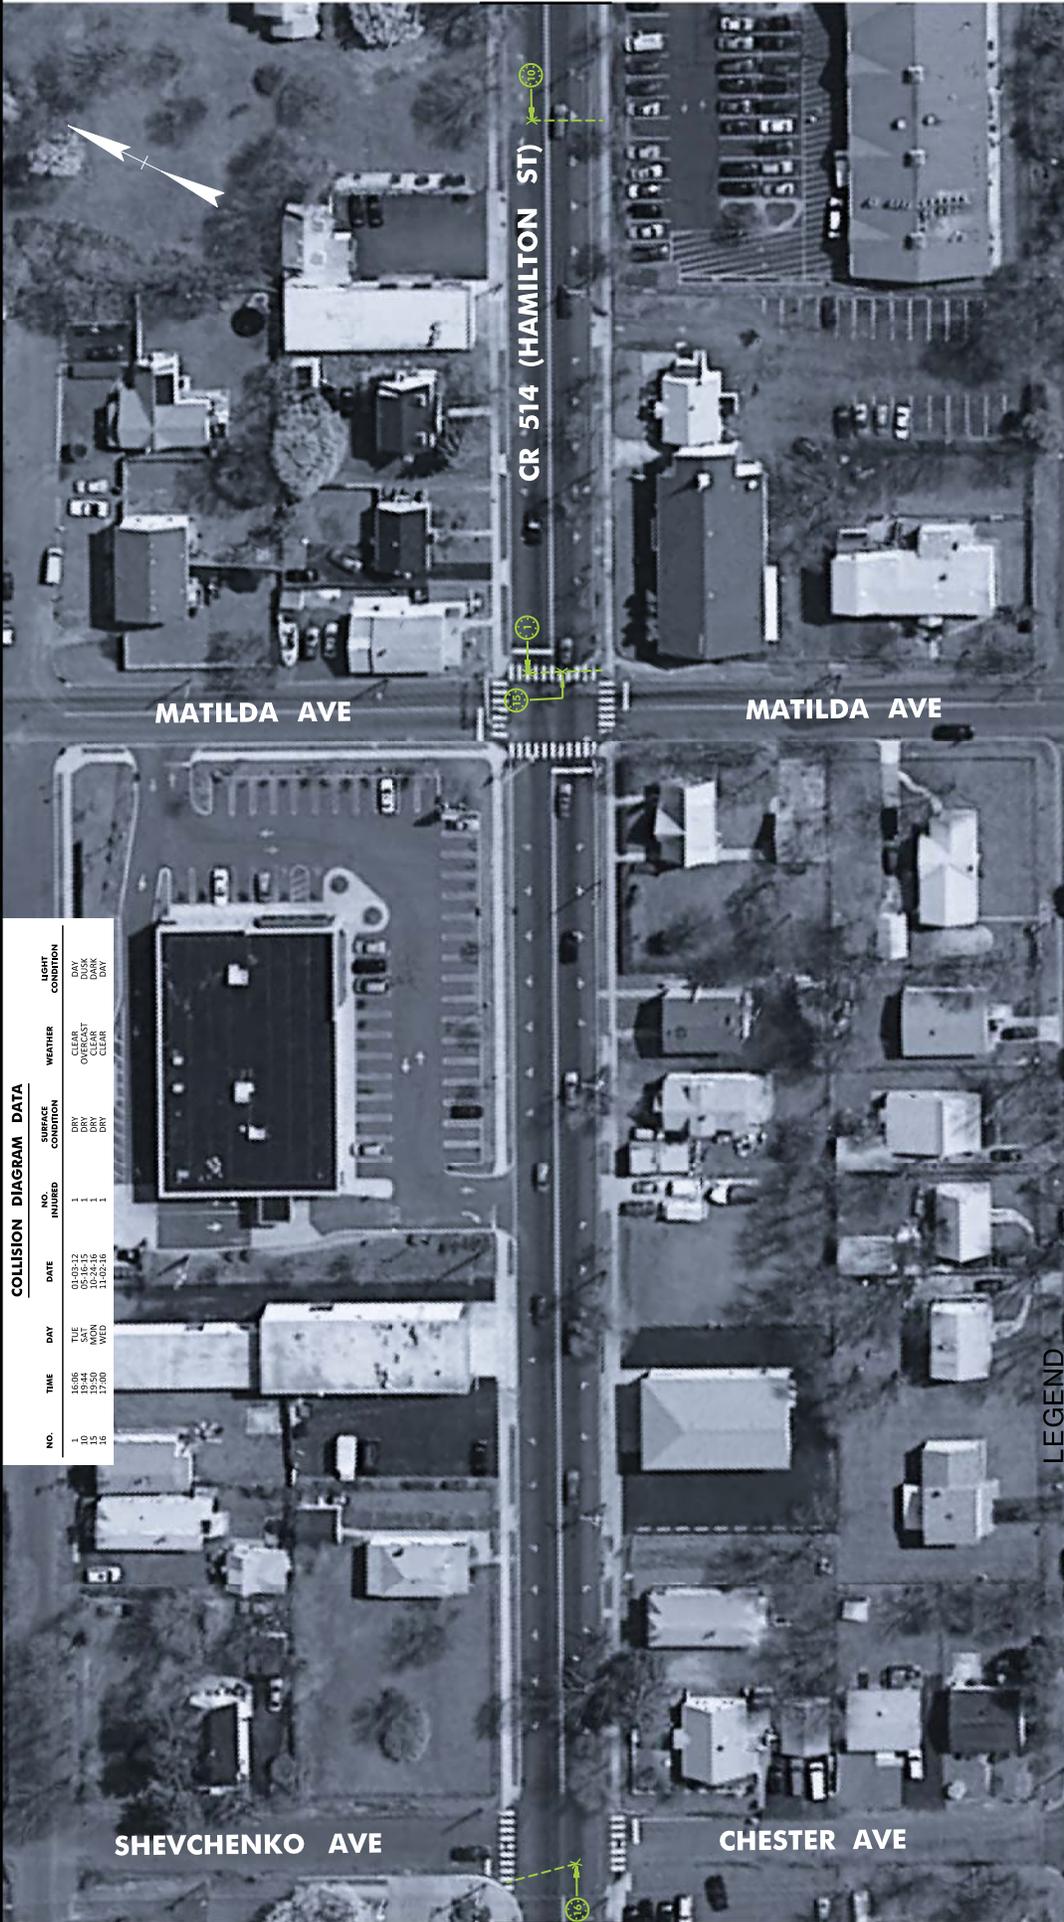
4 9

COLLISION DIAGRAM DATA

NO.	TIME	DAY	DATE	NO. INJURED	NO. KILLED	WEATHER	ROAD CONDITION	LIGHT CONDITION
1	16:06	TUE	01-03-12	1	0	DRY	DRY	DAY
10	19:44	SAT	05-16-15	1	0	OVERCAST	DRY	DAK
15	17:00	WED	11-02-16	1	0	CLEAR	DRY	DAY

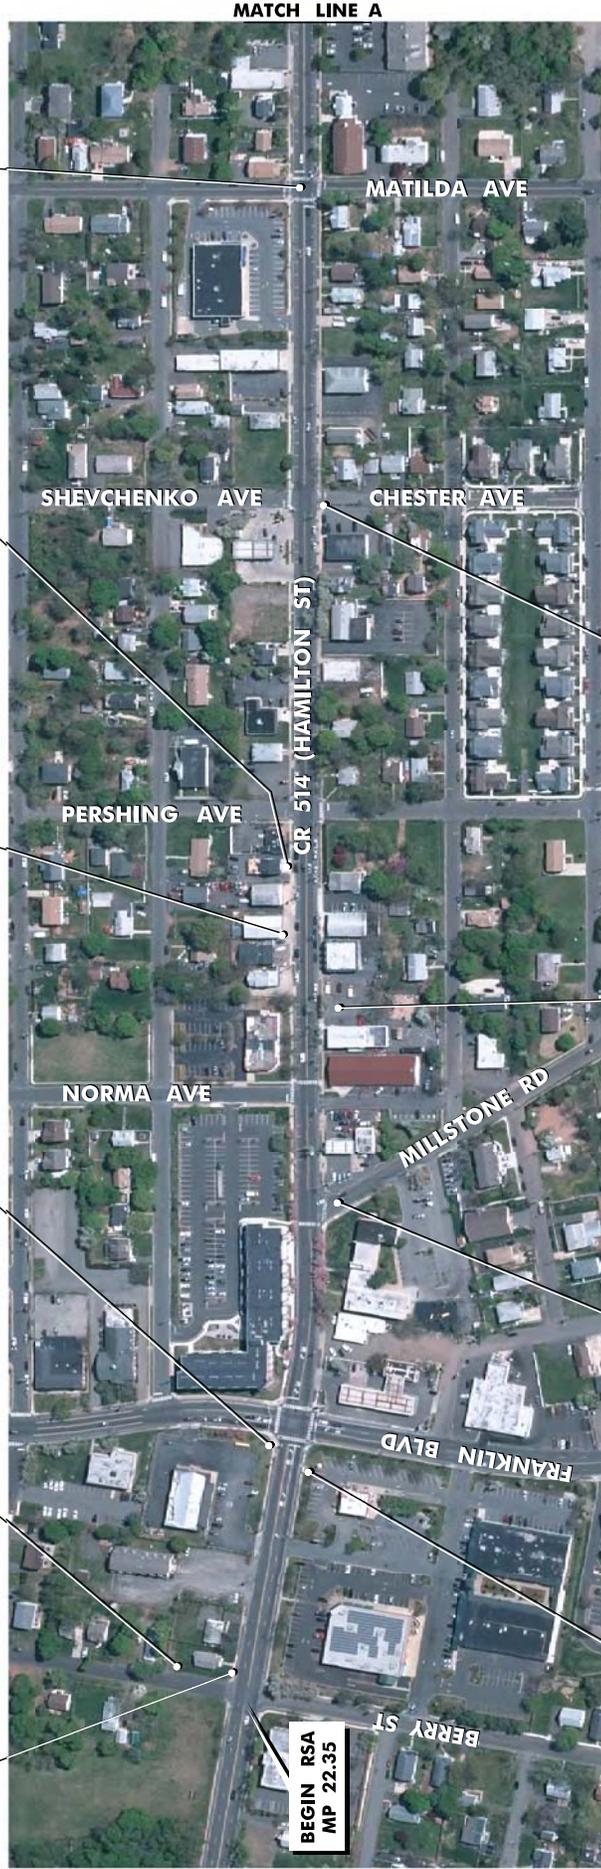
Signal has 8" heads, lacks countdown pedestrian signal heads and ramps are not ADA compliant

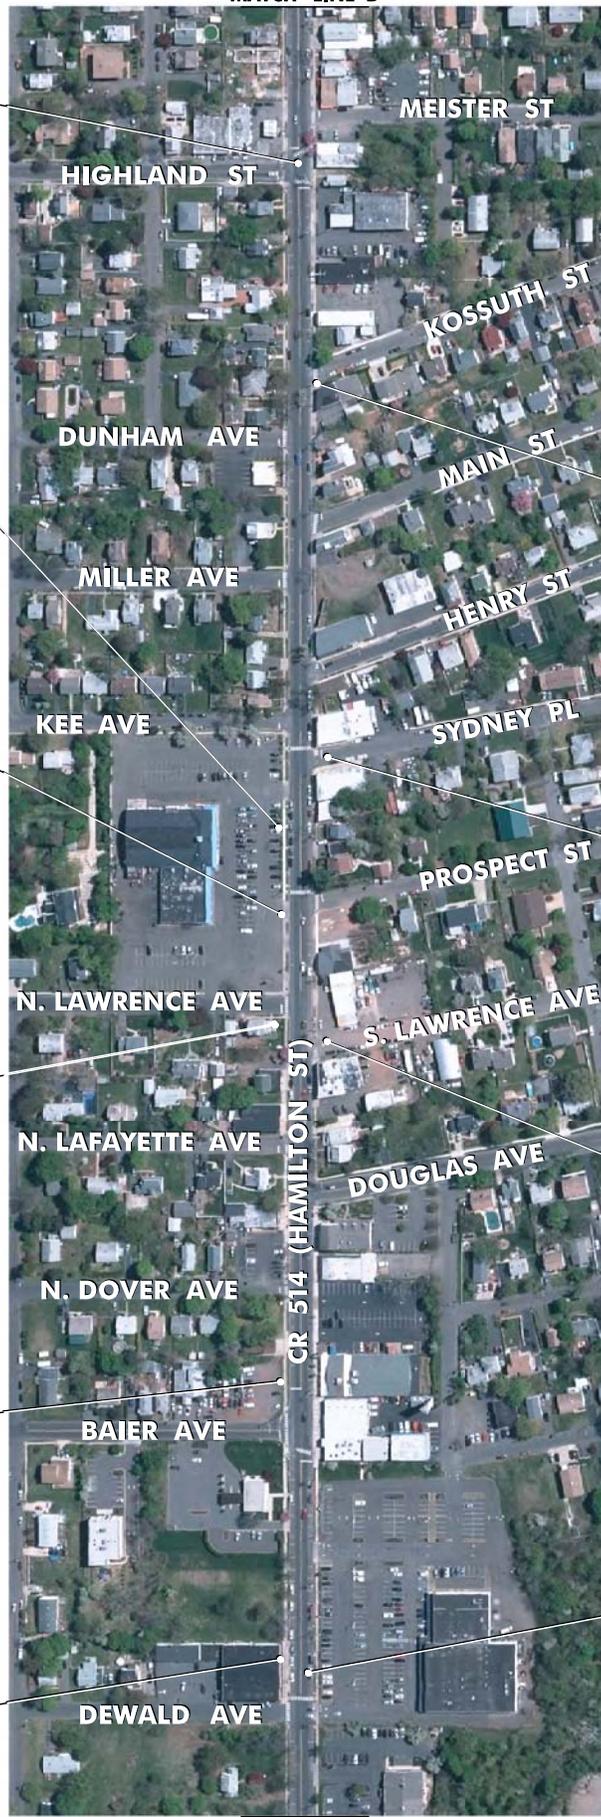
Signal has 8" heads, lacks school crossing signs, for designated crossing and ramps are not ADA compliant

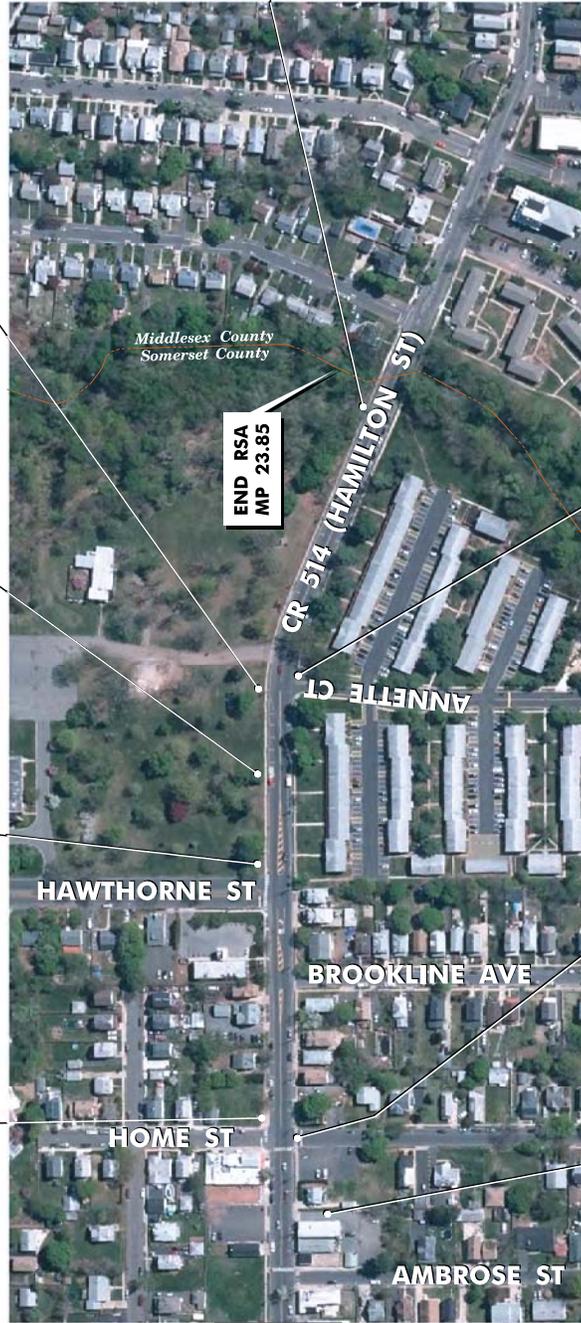
Signs near New Brunswick border do not have 7' clearance, vegetation overgrown into sidewalk (top and bottom photos)

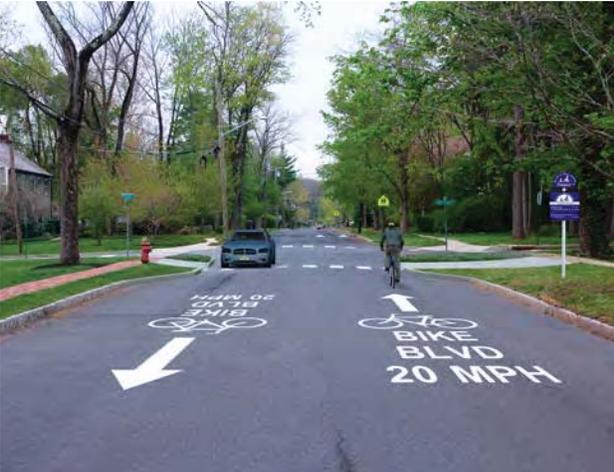
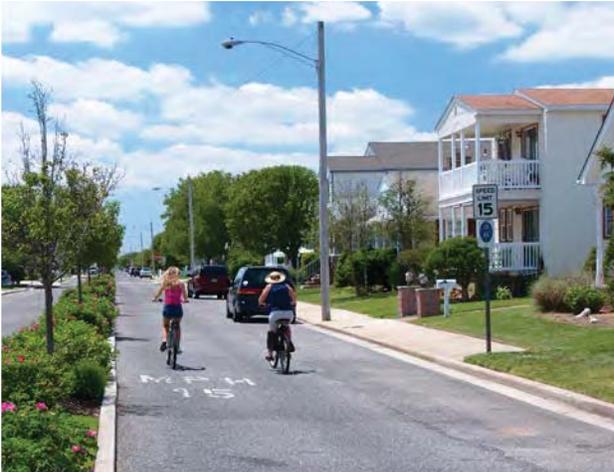
(left) Photo simulation of a bicycle boulevard in Princeton, NJ, includes pavement markings, wayfinding, and traffic calming; (right) Bicycle boulevard on Haven Avenue in Ocean City, NJ, has a 15 mph speed limit and uses curb extensions and a raised median to slow traffic and reduce cut-through traffic along this local residential street.

Volume management techniques discourage motor vehicle through traffic on designated bicycle boulevards. Bicycle boulevards should be designed for traffic volumes under 1,500 vehicles per day.

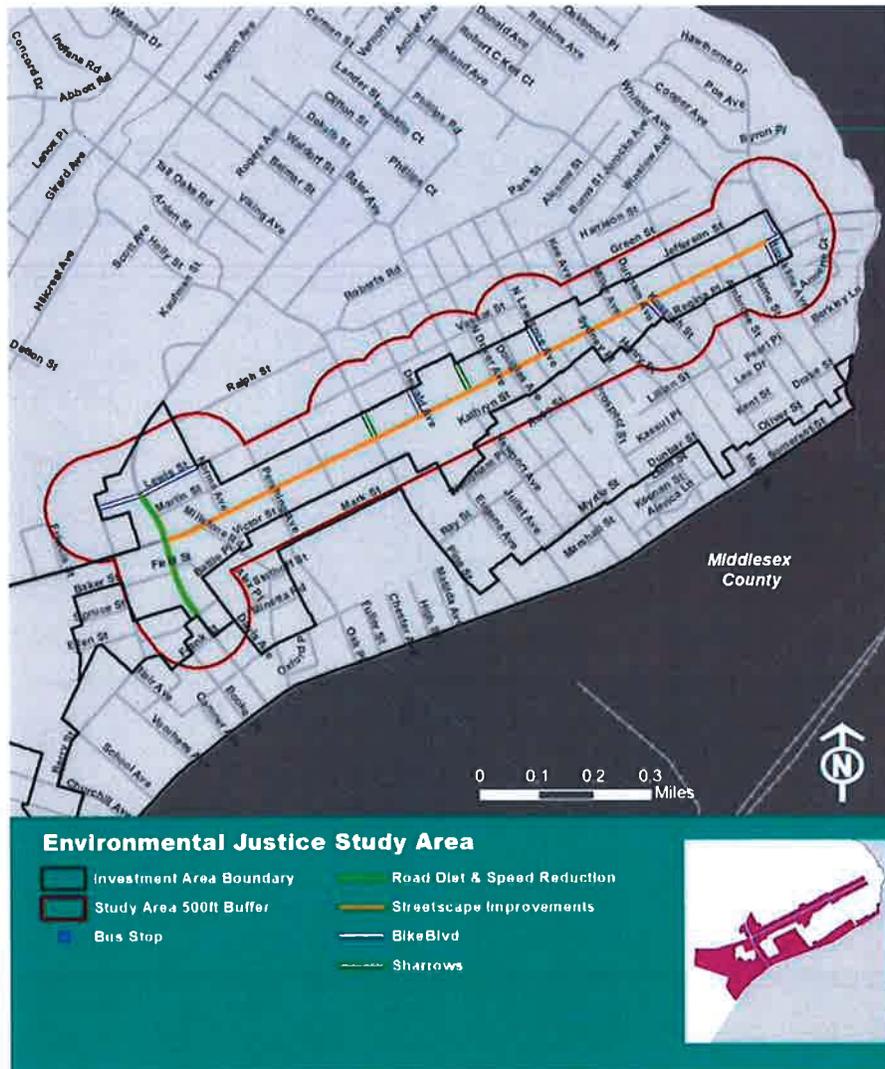
Figure 17 Study Area

The study area for the EJ analysis was determined based on a 500 foot buffer around the segments where improvements have been proposed, as shown in (Figure 17). The EJ analysis for the study area included all block groups that overlapped the 500 foot buffer.
