Somerset County Roadway Safety Study
Subregional Project

ROAD SAFETY AUDIT REPORT

MAIN STREET/FINDERNE AVENUE IN BRIDGEWATER TOWNSHIP

November 2021

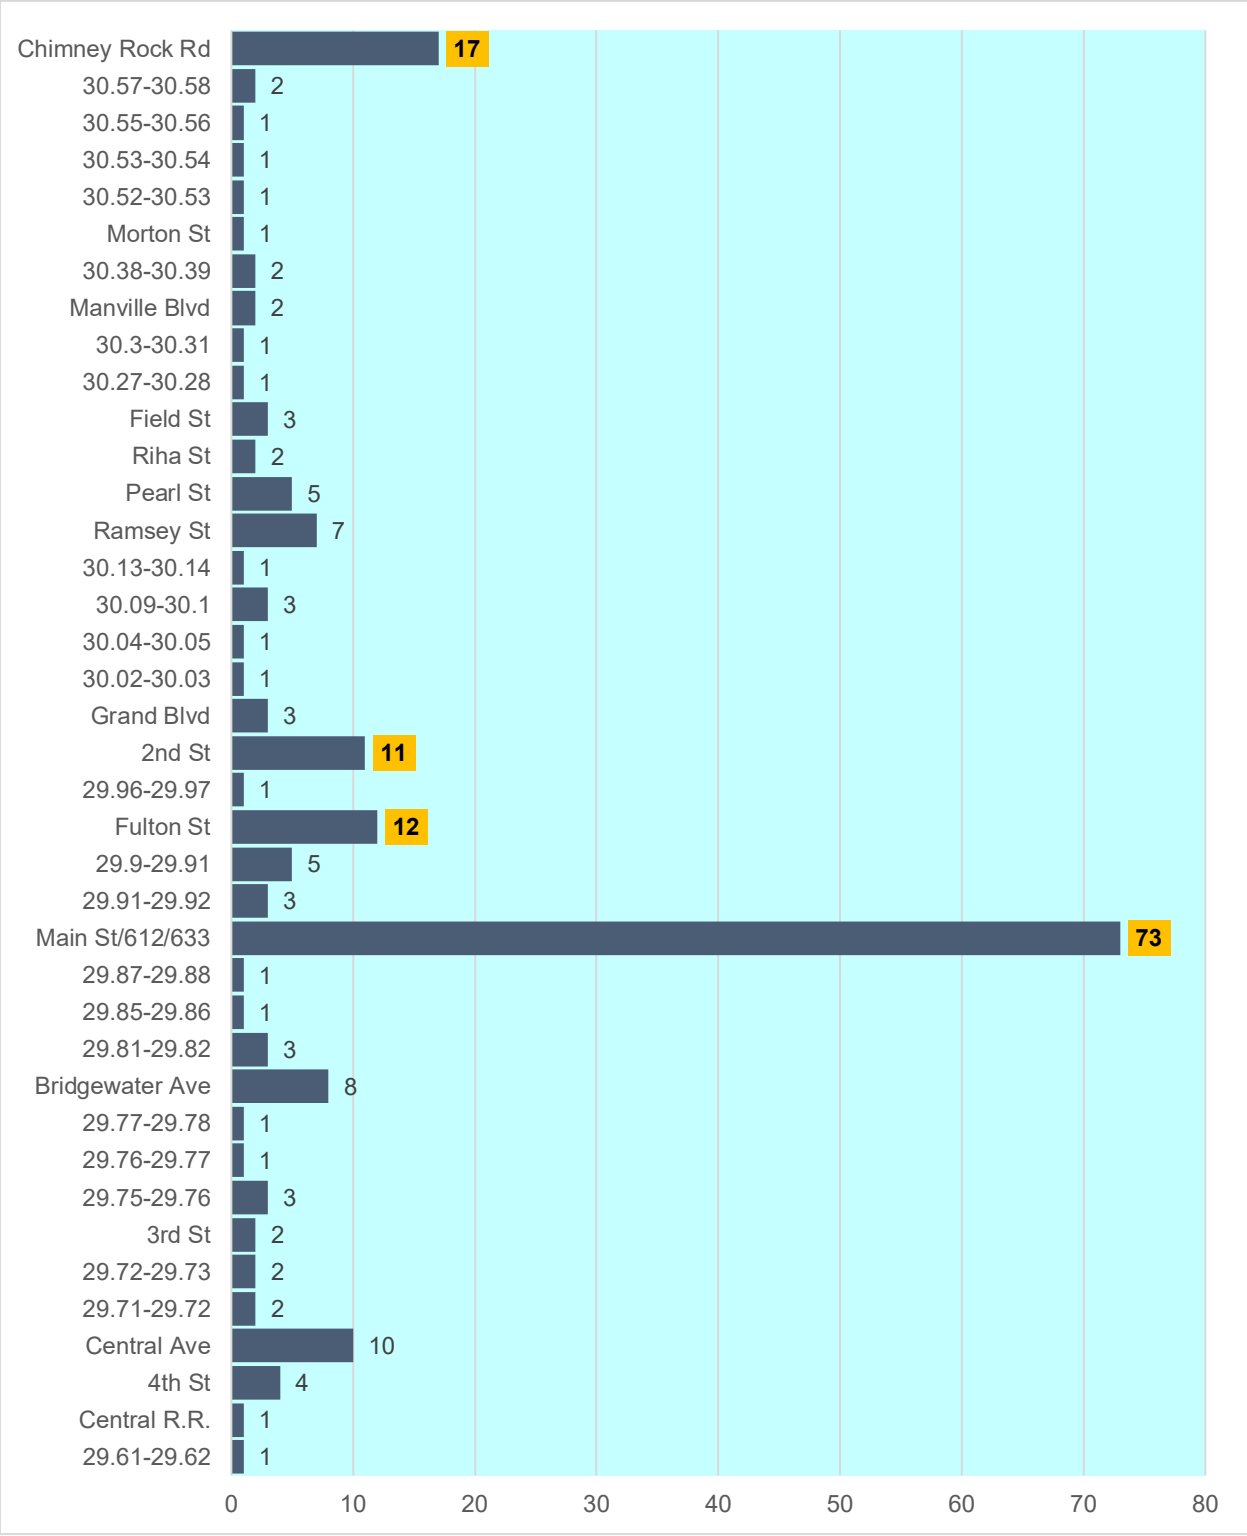
Figure 11 – Vehicular Crash Totals by Milepost

A histogram of crash history, grouped in 0.02-mile segments, is provided in **Figure 11** and indicated that the signalized intersection of Main Street (CR 533/612) & Finderne Avenue (CR 533/633) experiences the highest occurrence of crashes on study segment corridor as shown highlighted in yellow in **Figure 11.** This intersection is also ranked as having the highest crash frequency and severity in the County on NJTPA's intersection NSL for Somerset County. The crashes at this location account for 36.5% of all study area crashes. Other crash hotspots include intersections with Chimney Rock Road (17 crashes), Fulton Street (12 crashes),

and Second Street (11 crashes), highlighted in yellow in **Figure 11.** A three-dimensional representation of this crash histogram for the 2016 through 2020 timeframe, imposed onto a map of the study area, is shown on **Figure 12.**

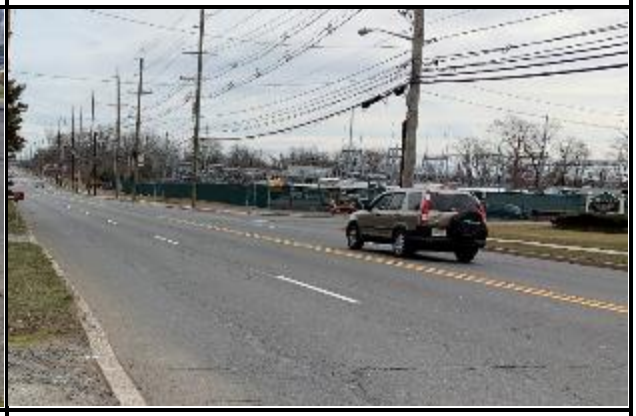
Pedestrian & Cyclist	Pedestrian & Cyclist

Sidewalk on north side of Main Street often interrupted by wide asphalt curb cuts and parked/standing vehicles	Cycling on Finderne Avenue restricted to narrow multiuse path over bridge with minimal delineation from travel lanes

Sidewalks along Main Street lacking maintenance and are discontinuous	Vehicular-centric corridor could benefit from road diet, dedicating cyclist space while slowing vehicles

History of pedestrian crashes at Finderne Avenue & Main Street involving vehicles making permissive turns	Heavily-used cycling route lacking updated wayfinding to connect local communities

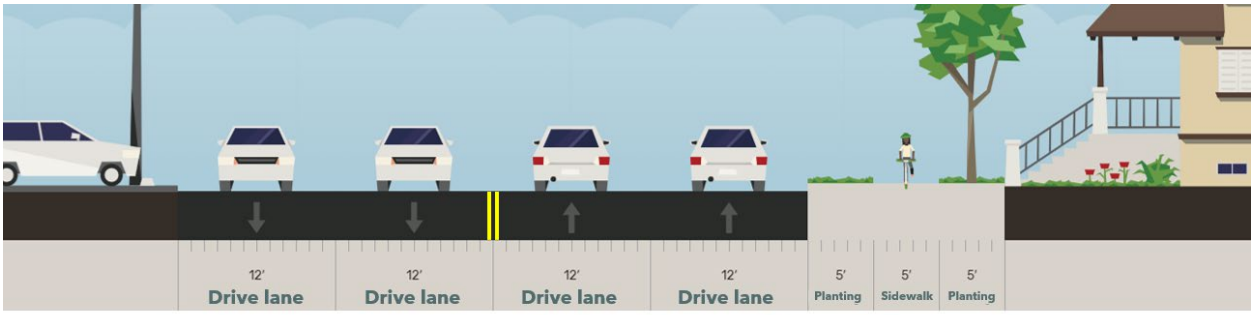
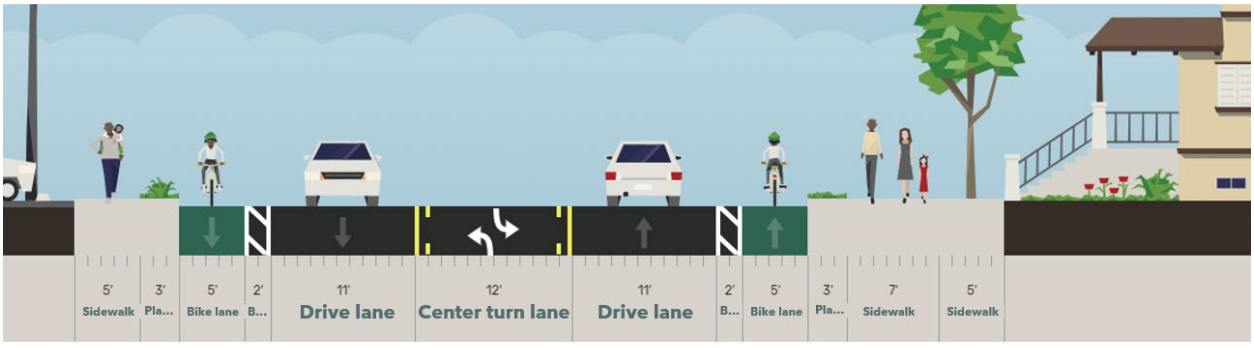
Figure 18 – Road Diet on Main Street Facing East, West of Ramsey Street, Before and After[23]

Main Street is of a similar cartway width (46' to 48') as this example and could potentially accommodate one 11' travel lane, 5' bike lane, and 2' buffer in each direction of travel with a center two-way left turn lane. With a 71-foot ROW, there is an opportunity to enhance sidewalks including installing a sidewalk on the north side of Main Street and widening the existing sidewalk on the south side of Main Street (**Figure 18**). Both sidewalks could be increased to a minimum 6' feet in width and should be separated from the

No.	Recommendation	Cost	Time Frame	Jurisdiction
KEY STUDY RECOMMENDATION – Main Street from Fulton Avenue to Chimney Rock Road				
11	Evaluate the feasibility of a road diet, and construct if feasible. The road diet could include left turn refuges, bike lanes, pullout areas for transit stops, and/or curb extensions with striped parking in between.	$$	🕐🕐🕐	County
Finderne Avenue from Bridgewater Avenue to South Avenue				
12	Evaluate intersection sight distance at side streets and explore ways to mitigate issues.	$$	🕐🕐	Municipality/ County
13	Explore ways to reduce cut-through traffic on side streets, including dead ends and speed tables; perform an origin-destination study; consistently apply NB right turn restrictions at side streets.	$$	🕐🕐	Municipal
South Avenue				
14	**Investigate feasibility of prohibiting EB left turns to mitigate intersection sight distance issue.**	$$	🕐🕐	Municipality/ County

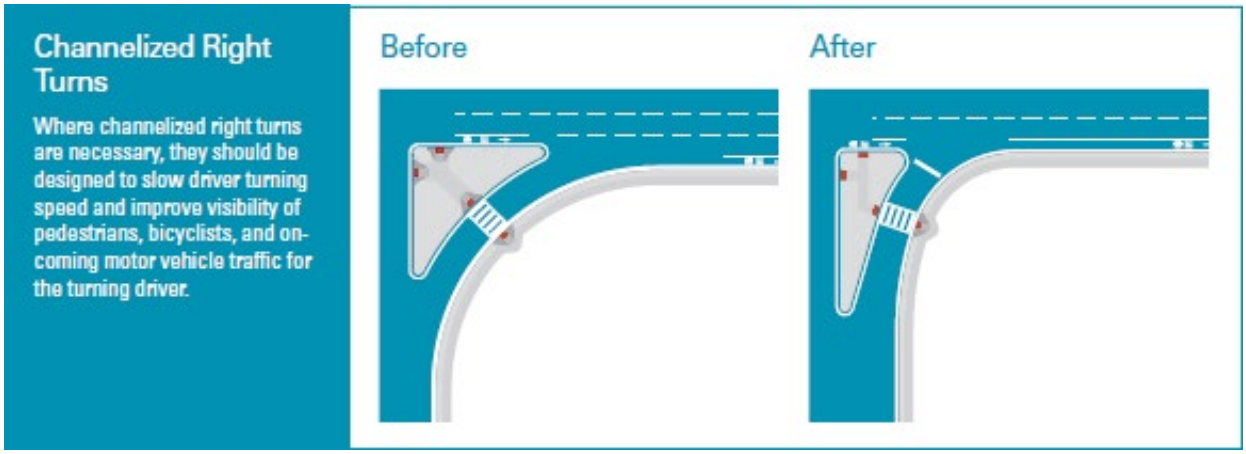
Figure 25 – Redesign of Channelized Right Turns[31]

Channelized Right Turns at Finderne Avenue & Main Street
Channelized right turns introduce additional conflict points for a pedestrian crossing at an intersection. While these channelized right turn islands cannot be eliminated due to needed capacity at Finderne Avenue & Main Street, the design of these islands could be re-worked alongside ADA improvements for the non-compliant curb ramps at this intersection. By narrowing the channelized right-turn island, vehicular turning radii become less sweeping, right turning movements are slowed, and drivers turning right are forced to stop or yield to approaching traffic while being provided with a better sight line to vehicles to the left, as shown in **Figure 25**.
